Reference: Facility Operating License No. DPR-65
Docket No. 50-336
Licensee Event Report 93-004-00

LICENSEE EVENT REPORT (LER)

FACILITY NAME (1) Millstone Nuclear Power Station Unit 2

TITLE (4) Reactor Trips on Steam Generator Low Water Level

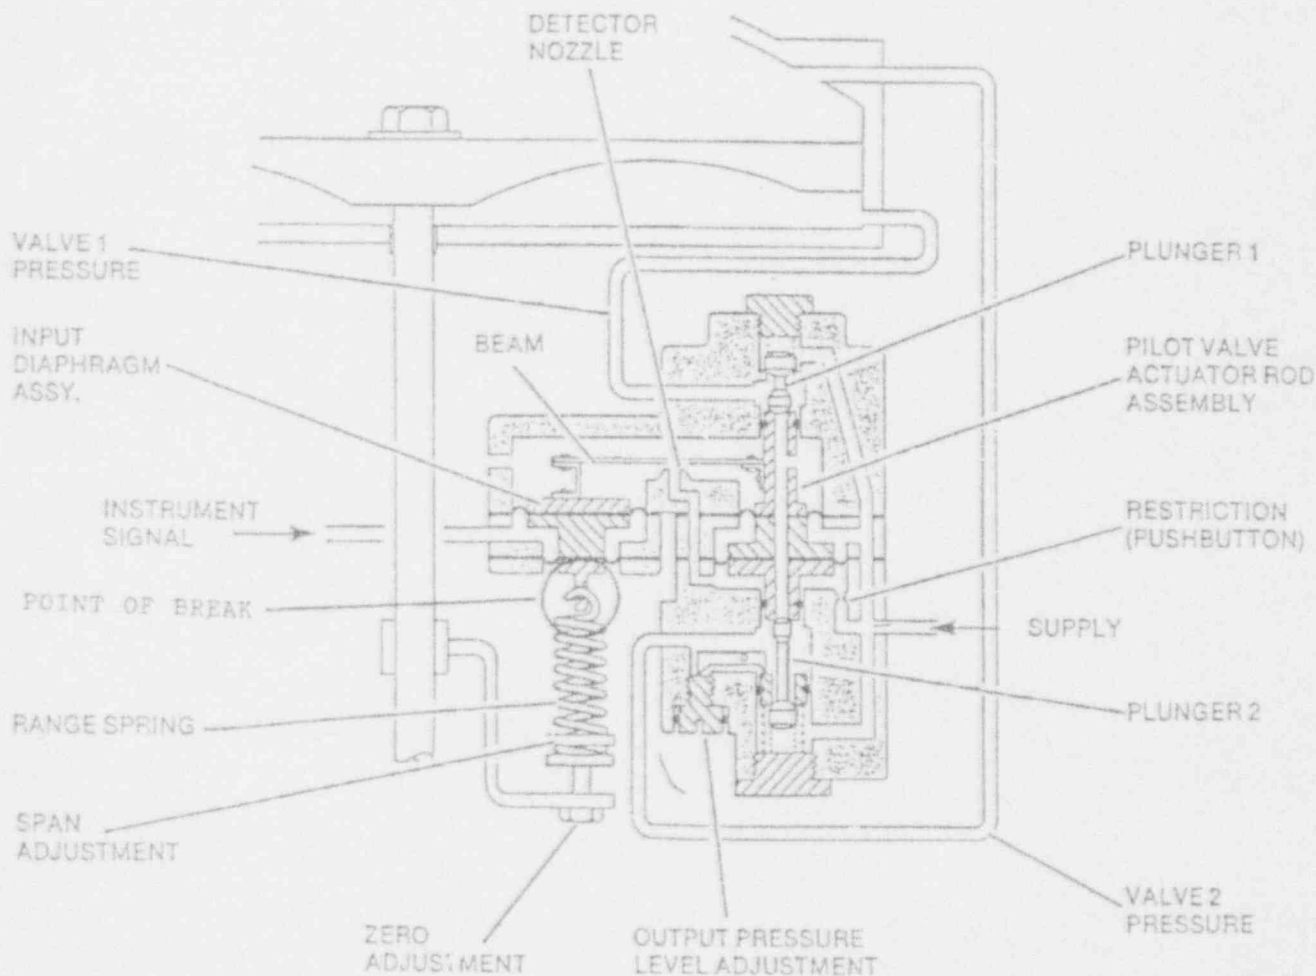
Figure 1
Atmospheric Steam Dump Valve Positioner

The cause of the initiating event on February 22, 1993, was the "A" steam generator ADV failing open. The ADV failed open when the spring attachment fitting broke at the point where the spring attaches to the inner diaphragm assembly. The break at the attachment point resulted from a combination of misalignment of the feedback spring and bending of the range spring attachment (possibly during installation), and positioner vibration during normal plant operation. See Figure 1 for a diagram of the ADV valve positioner.

The valve positioner for the "A" steam generator ADV was replaced and the feedback spring was realigned. The valve positioner for the "B" steam generator ADV was replaced, and the as found feedback spring alignment was satisfactory.

- To establish more frequent replacement schedules for the ADV positioners.
- To provide additional operator training on steam generator level control. Specific simulator training will provide the operators with enhanced skills to respond to feedwater system transient events.
