Millstone Nuclear Power Station, Unit No. 2
Request for Enforcement Discretion
Reactor Coolant System - Structural Integrity
Limiting Condition for Operation

Use of a Proposed Alternative to
ASME Section XI in Accordance with the
Requirements of 10CFR50.55a(3)(ii)

UNIT: Millstone Unit 2 NCR # 293-026 DATE: 1/25/93
TIME: 09:50

System: Service Water Supply to Vital AC Switchgear Rooms Cooling Coils X-181A & 181B

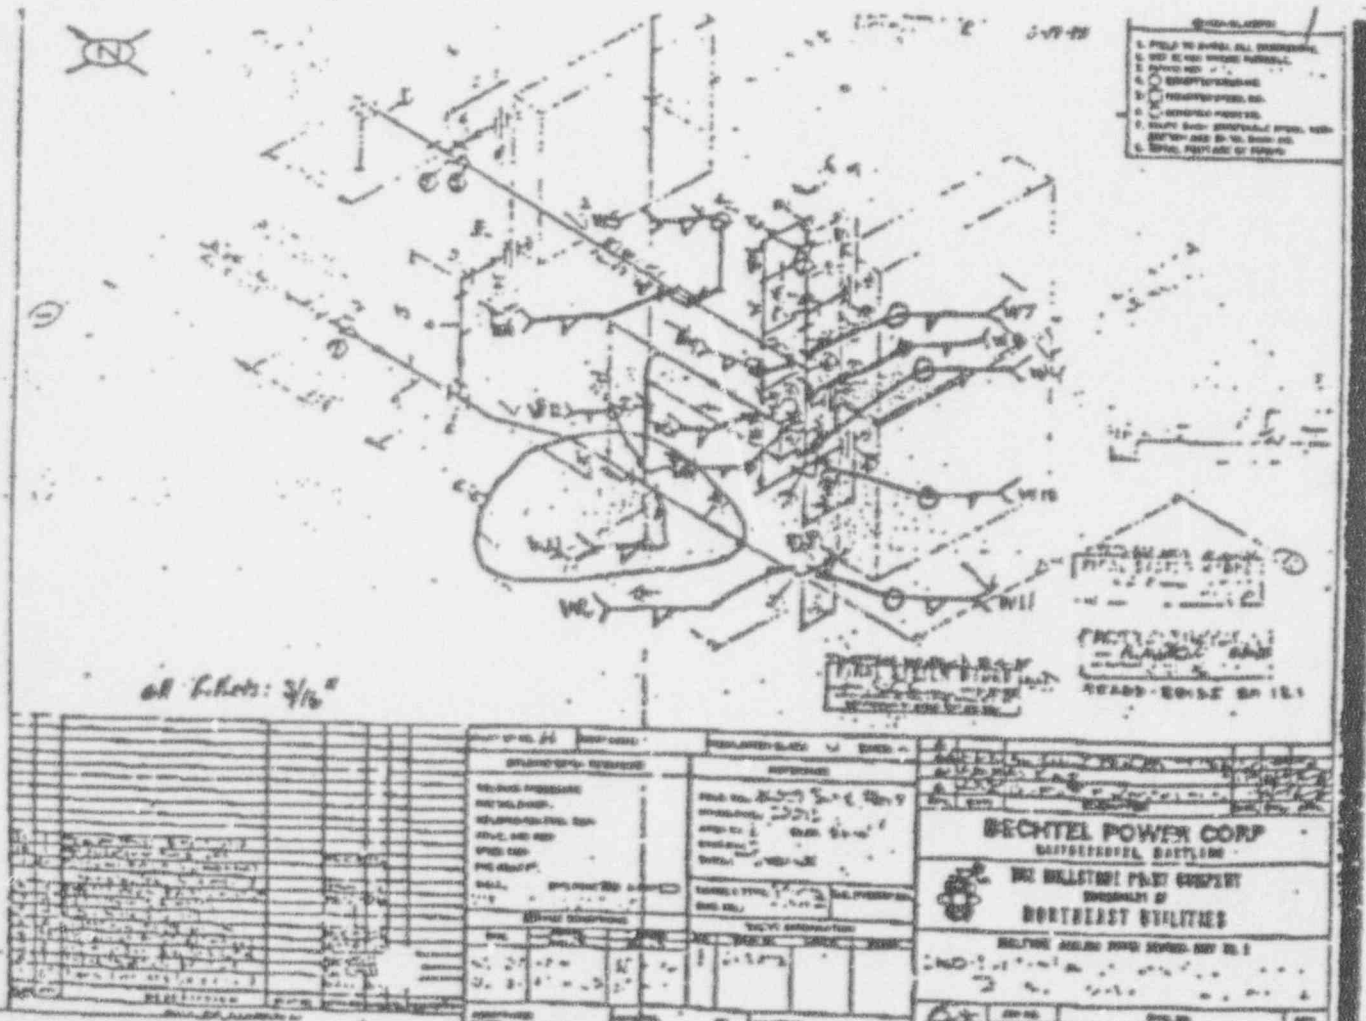
AWO M2-92-17685
weld Map

Flaw Location: The small weeping leak is located at 3:00 looking north at weld W-1 of AWO M2-92-17685.

The supply piping (2"-HUD-130) to cooling coil X-181B (lower coil) developed a small weeping leak when the system hydrostatic pressure test was performed. All other joints meet the requirements of the hydrostatic pressure test. The small weeping leak is located at 3:00, looking north at weld W-1 of AWO M2-92-17685 (see attached weld map).

AWO M2-93-01582 has been written to rework the leak at the next available opportunity (i.e. plant non-operational). The joint will be repaired in accordance with ASME Section XI and the following steps;

- The weld in the area of the leak will be excavated and if necessary the entire weld will be removed.
- The excavated area will be LP inspected, to ensure solid base metal is present.
- The weld will be repaired in accordance with the WUSCO weld manual.
- The weld will be visually inspected per CWS-004.
- Once the weld is reworked the pipe will be hydrostatic pressure tested in accordance with SP-21219.
