Carolina Power & Light Company

LICENSEE EVENT REPORT 1-92-023 SUPPLEMENT TWO

NOTIFICATION OF A 10CFR21 REPORTABLE OCCURRENCE

Local Leak Rate Test Failure of Both RCIC Steam Line Isolation Valves

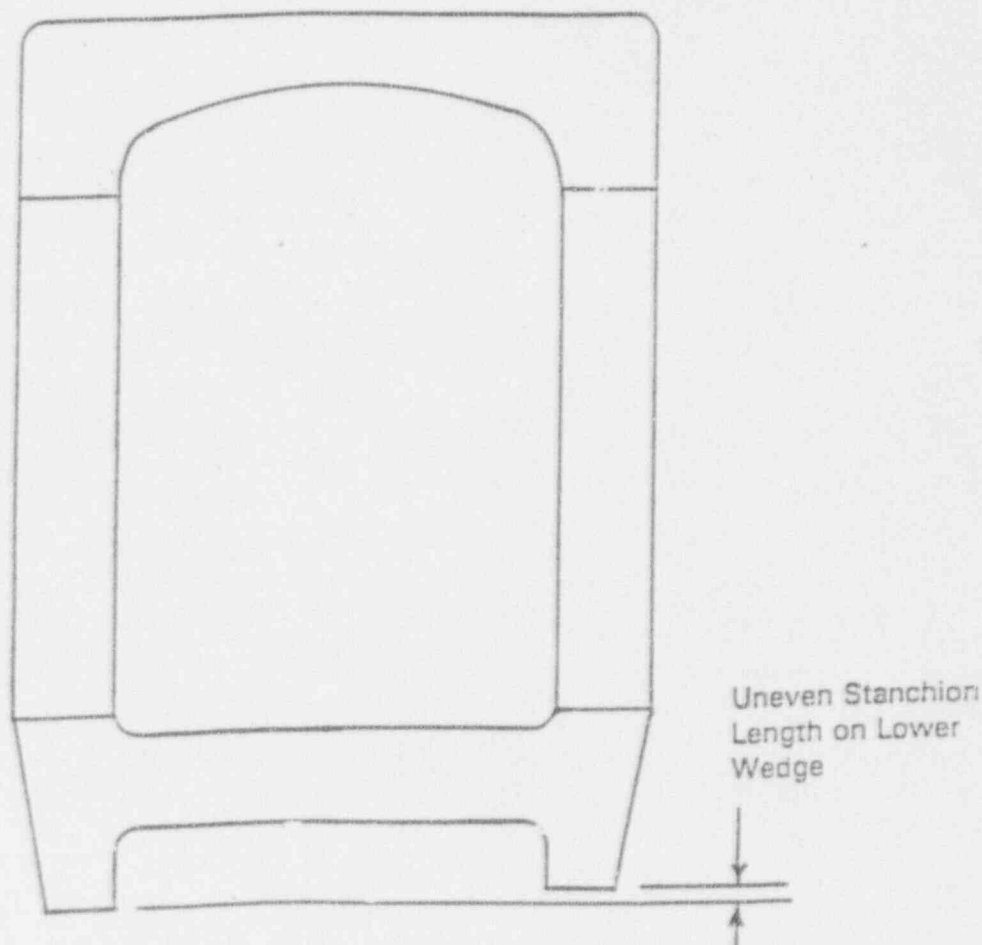
Figure 1

During an inspection of the 1-G31-F001 in September of 1991 and the recent inspections of the 1-E51-F008 and the 2-G31-F001 valves, the associated lower wedge stanchions were identified to be shorter than the other stanchion. If not accounted for by adjusting the lower wedge geometry, uneven stanchion lengths cause the lower wedge to cock as the valve seats. Any cocking of the lower wedge results in uneven contact with the upper wedge during seating. This uneven contact causes the wedge pieces to load predominately on only one incline which results in uneven transmission of the stem wedging force to the discs. This contributed to the failure of the valves to seal when subjected to the low LLRT pressure.

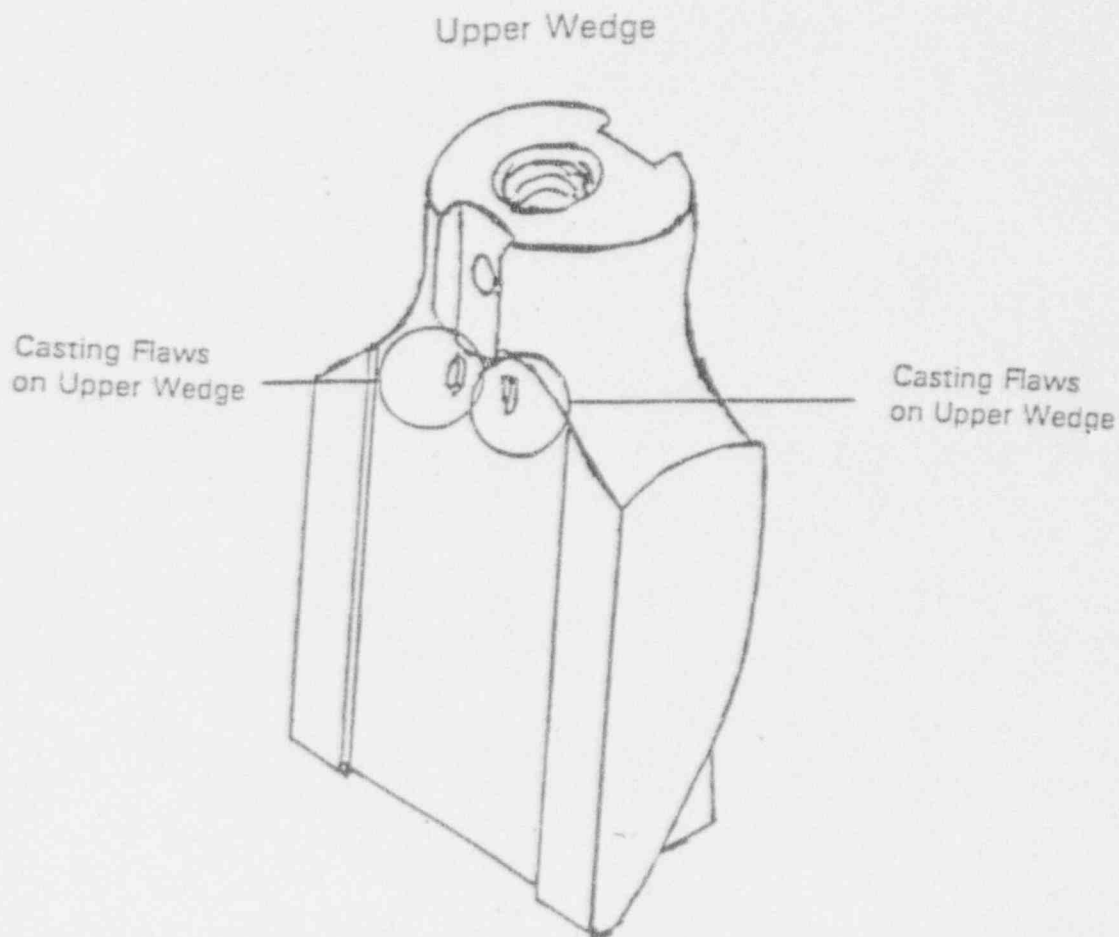
Figure 2

Inspections of the 1-E51-F008, 2-G31-F001, and 2-G31-F004 identified discontinuities in the cast surface of the upper wedges. The 2-G31-F001 and 2-G31-F004 valves were found to have a casting flaw (raised metal) on the upper portion of the upper wedge (see Figure 2). These casting flaws prevented the upstream disc from sitting flush against the machined surface of the upper wedge. Although the upstream disc does not provide a seal against differential pressure, these flaws may have prevented proper wedging and uniform loading of both the upstream and downstream discs. Additionally, these casting flaws caused gouges on the inside edge of the upstream discs.

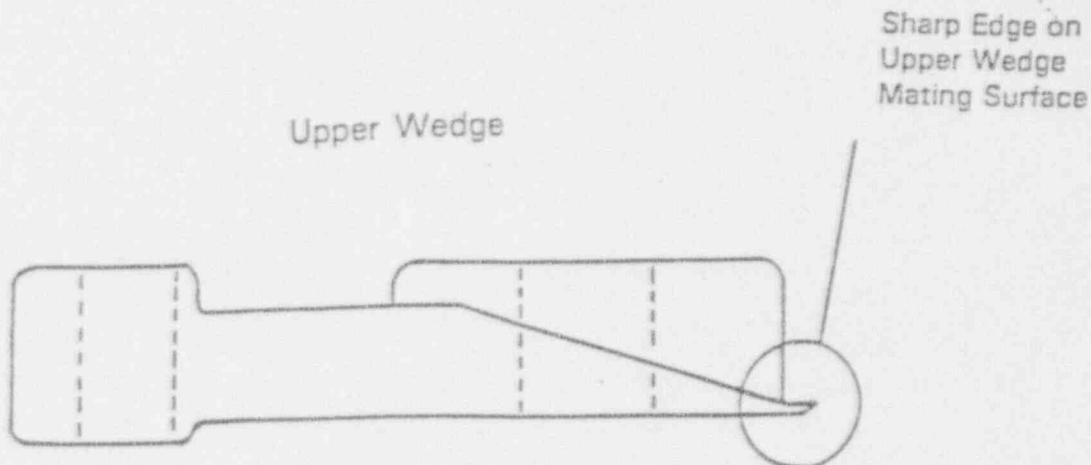
Figure 3

The 1-E51-F008 valve was found to have a sharp "lip" on the upper wedge where the wedge begins to taper (See Figure 3). During wedging, this lip would contact a slight protrusion on the lower wedge which would cause binding of the two wedges. This binding could cause an uneven distribution of the seating force to the valve discs and subsequent seat leakage.

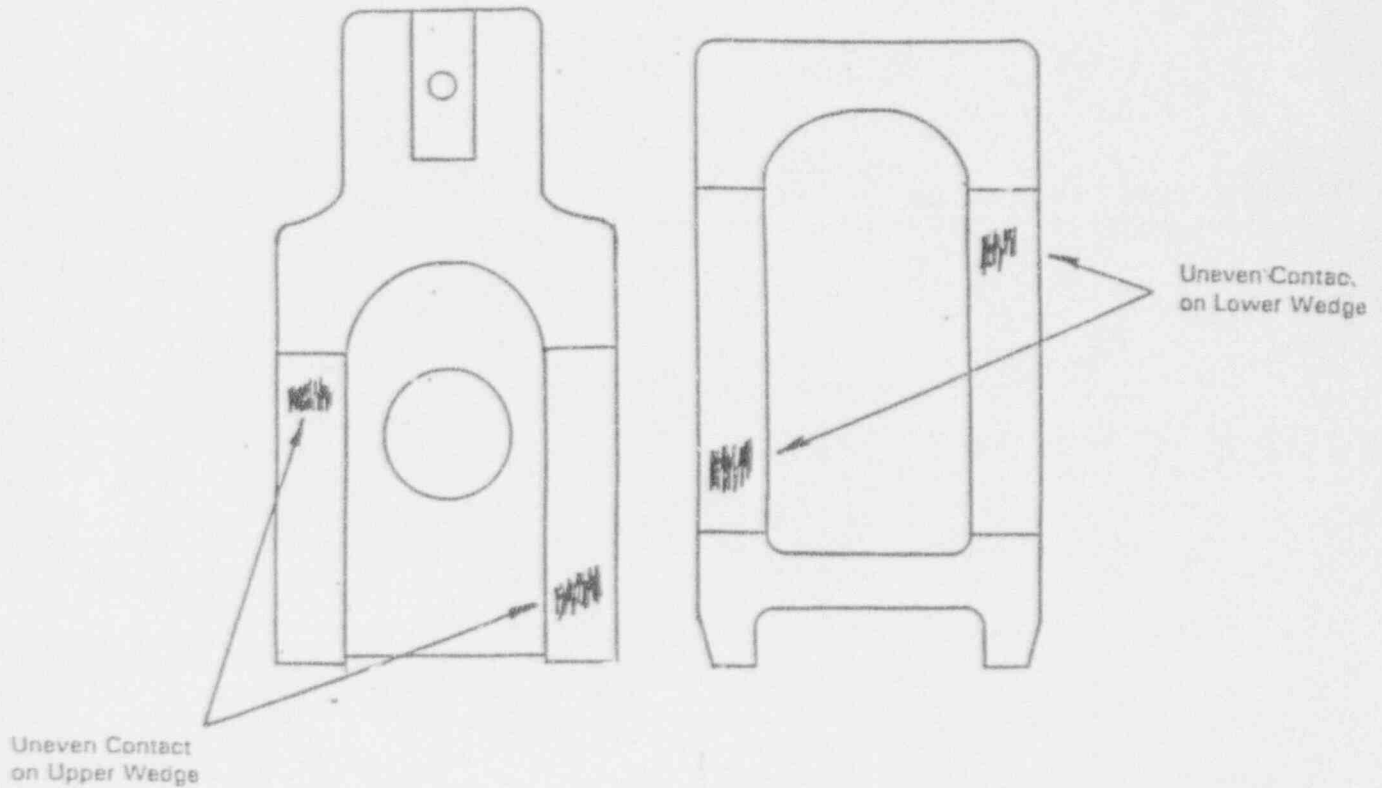
Figure 4

Non-uniform contact between the upper and lower wedges has been identified on the 1-B21-F016, 1-E51-F008, 2-E51-F013, 1-G31-F001 (in September 1991), 2-G31-F001 and 2-G31-F004 valves (See Figure 4). This non-uniform contact results in an uneven distribution of the seat force and potential seat leakage.

The non-uniform contact between the upper and lower wedges has resulted from several different causes. The mating surfaces between the upper and lower wedges are hand-ground surfaces. This process may result in low spots or slightly different wedge angles which cause uneven contact and wedging. The uneven contact for the 1-E51-F008 valve may have been caused by a poor lower wedge casting.
