Subject: McGuire Nuclear Station Unit 2
Docket No. 50-370
Licensee Event Report 370/93-02

TITLE(4) A Unit 2 Manual Reactor Trip was Initiated Due to an Equipment Failure.

Metallurgical Analysis Report

Sellows-type relay from Moore valve positioner on 2CF23

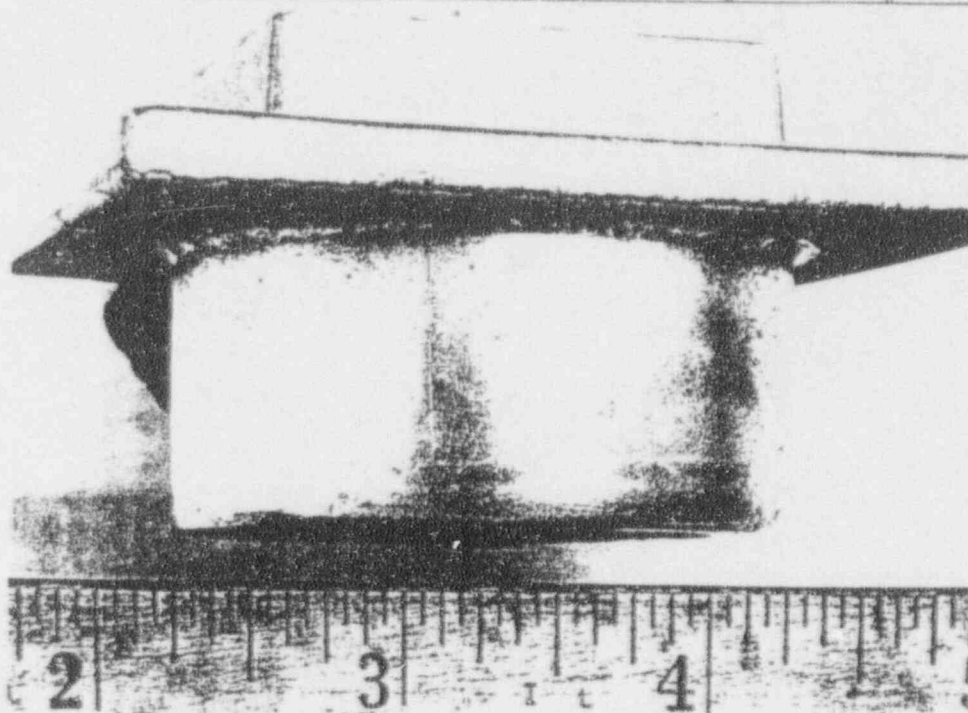
Prior to disassembling the relay to examine the internal bellows, a vertical crack was noticed in the shield (Figure 1). The crack was 0.6" in length, with the first 0.2" near the solder joint filled with solder (Figure 2). The first half of the crack coincided with a scratch mark, several of which were found on the shield of every relay examined.

The vertical crack in the outer shield was attributed to liquid-metal embrittlement of the brass by the lead-tin solder. This crack occurred during manufacture, as solder was present in the crack. Brasses are susceptible to LME by lead and tin alloys even at very low stresses. The scratch which the crack followed was a forming artifact and likely a site of residual stress in the shield. The presence of the crack did not affect the operation of the relay.

Figure 1 Vertical crack in outer shield of relay, as received. Portion of crack near solder joint is filled with solder. Ma-2513.

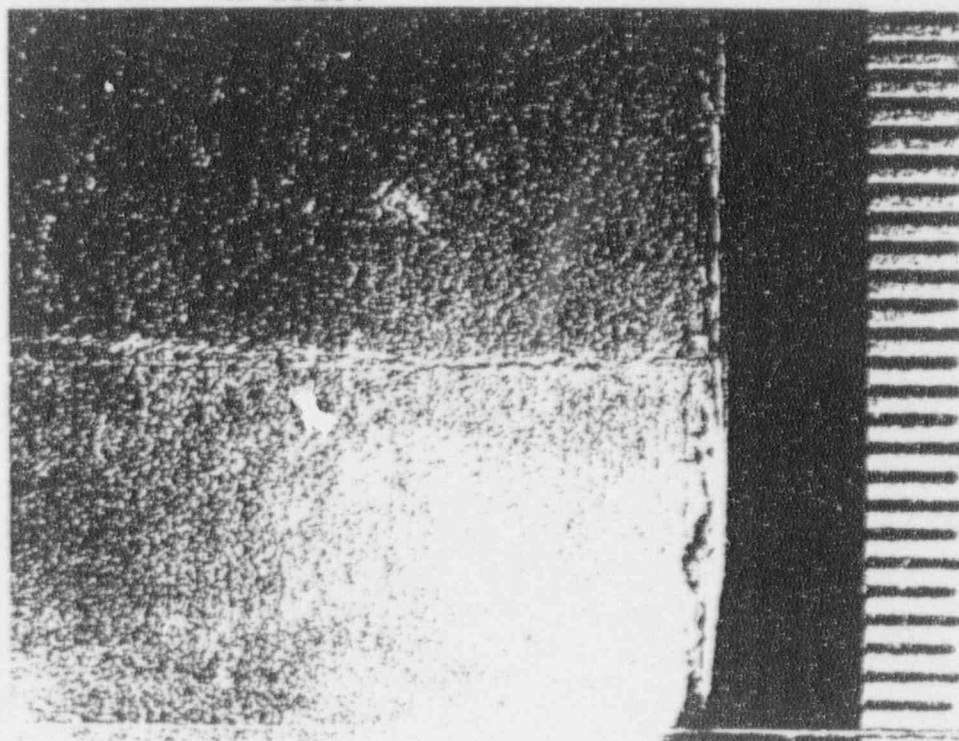
Figure 2 Detail of crack in shield after shield was removed. Solder is visible in crack. Scratch mark which crack followed is visible at left. Gauge - 1/64". Ma-2514.

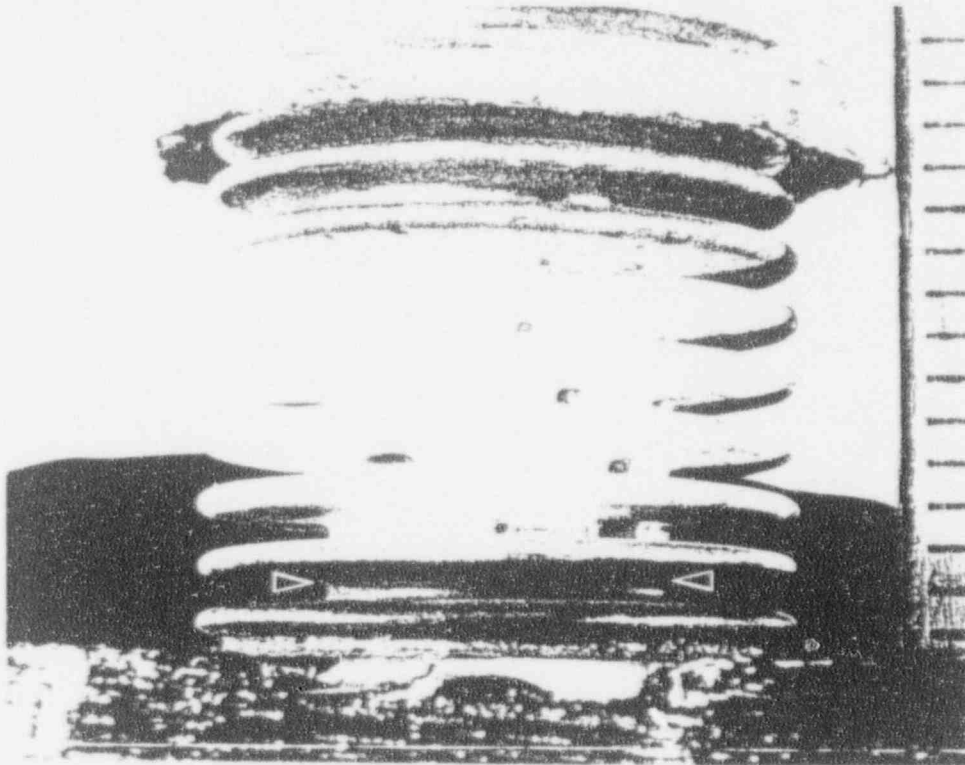
The shield and outer bellows were cut off through the solder joints and around the top cap. No cracking was seen in the outer bellows. The inner bellows was cracked below the second convolution from the bottom, the same location as in Report #1436 (Figure 3). The crack covered ~140° of the circumference.

The crack in the inner bellows of the 2CF23 valve positioner relay was attributed to fatigue cracking.

Figure 3 Inner bellows revealed by sectioning. Crack is visible under second convolution from bottom (arrows). Gauge = 1/16". Ma-2515.

This failure is the latest in a series of incidents in the valve positioner relays involving fatigue cracking. Continued use of a device of this design should result in more failures under the alternating stresses being imposed. A relay design using a viton elastomer diaphragm has been substituted for the metal bellows design. In the case that these replacement devices might also be sensitive to fatigue damage, the source of the alternating stresses should be pursued and corrected.

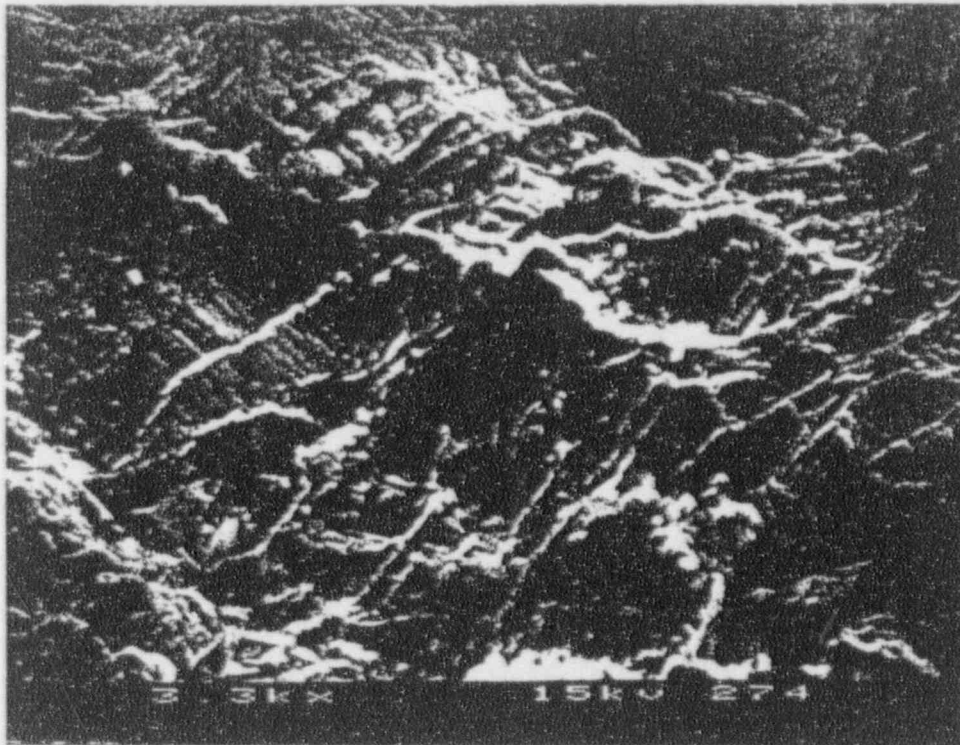
The bellows crack was pulled apart to examine the fracture morphology. Fatigue striations were identified both near the crack tip and near the center of the fracture (Figure 5). The striation spacing was very fine, typical of vibration or high-cycle loading. Crack propagation was from exterior to interior.

No stress corrosion cracking was observed around the origin area of the bellows crack. Stress corrosion cracks appeared to have initiated the fatigue crack which failed the 2CF20 bellows earlier. Geometrical and metallurgical stress concentrations may have been sufficient to initiate a fatigue crack in the short service time under vibrational stress.

Figure 5 SEM photo of fatigue striations near center of bellows crack. Crack traveled from OD to ID (upper right to lower left in photo). (3300X) S-1904.

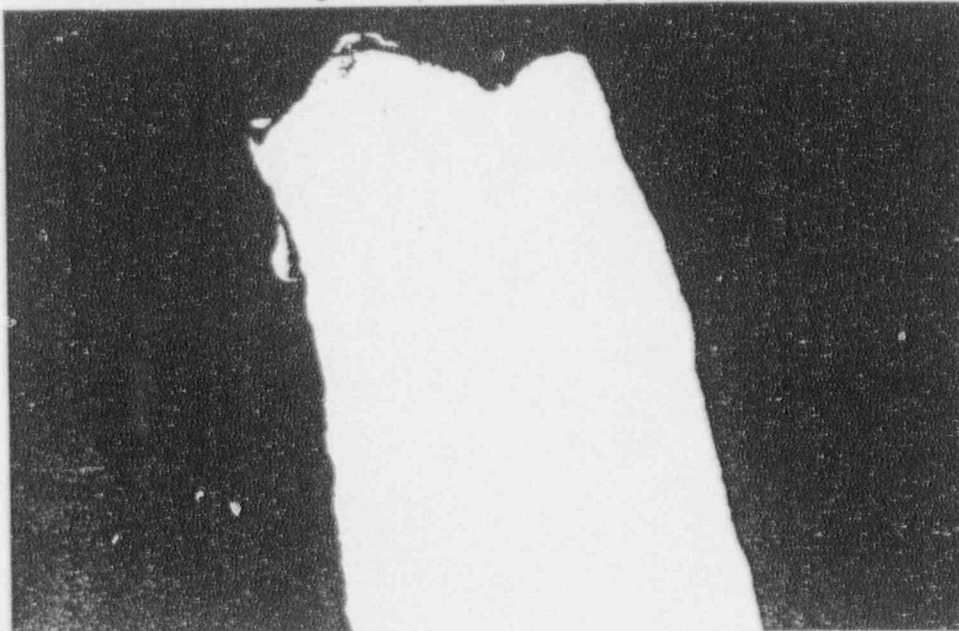
A cross-section was taken through the center of the bellows crack. No secondary or parallel cracking was seen around the fracture (Figure 6). The crack path was transgranular.

Figure 6 Cross-section through bellows, near center of crack. No parallel cracking visible near main fracture (top); minor 2° crack is mechanical damage. (500X) Mi-2637.

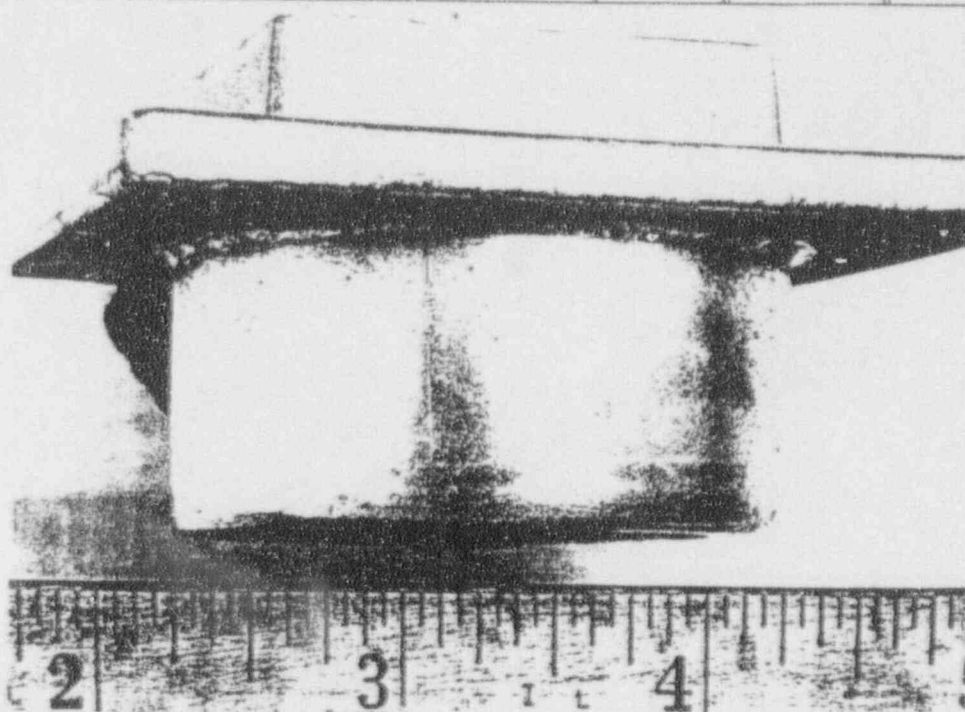
Figure 1 Vertical crack in outer shield of relay, as received. Portion of crack near solder joint is filled with solder. Ma-2513.

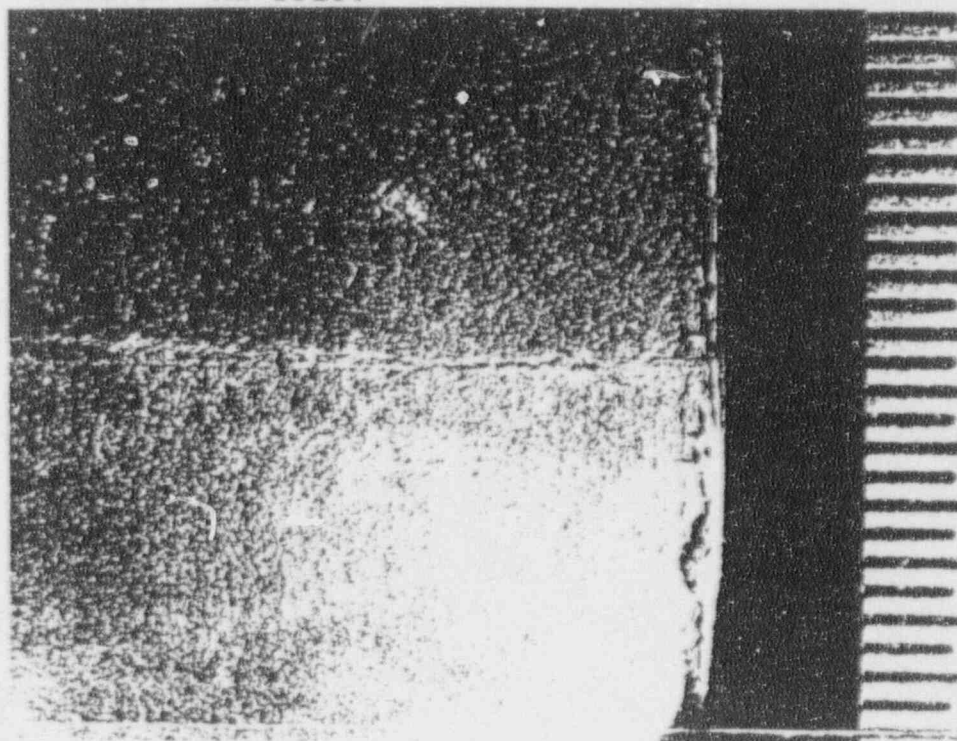
Figure 2 Detail of crack in shield after shield was removed. Solder is visible in crack. Scratch mark which crack followed is visible at left. Gauge - 1/64". Ma-2514.

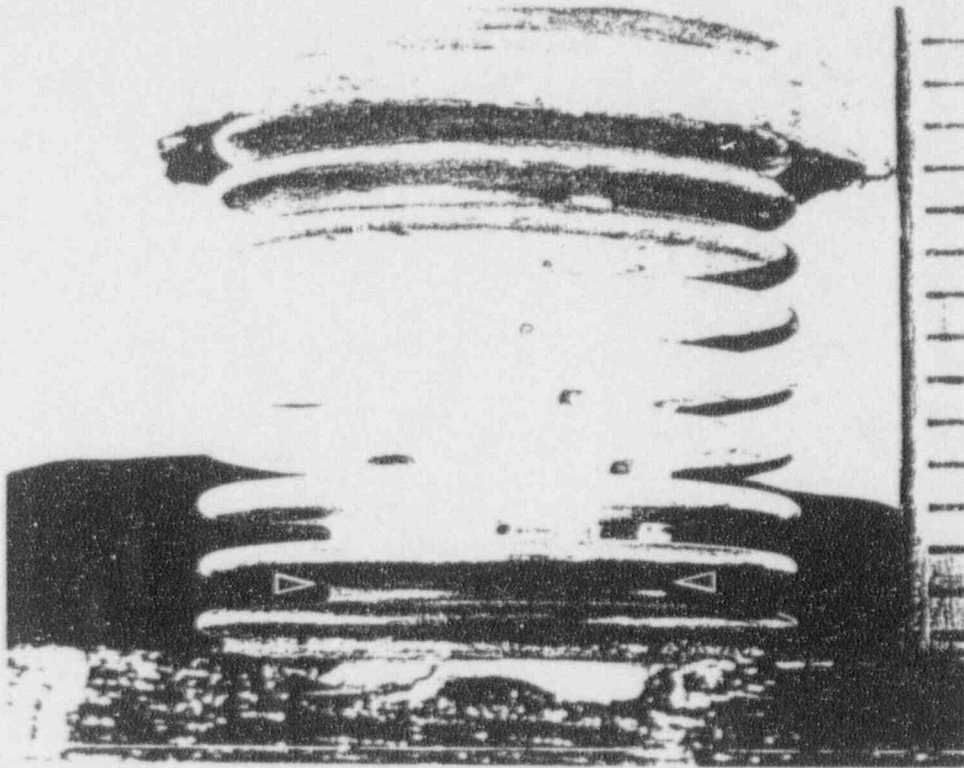
Figure 3 Inner bellows revealed by sectioning. Crack is visible under second convolution from bottom (arrows). Gauge = 1/16". Ma-2515.

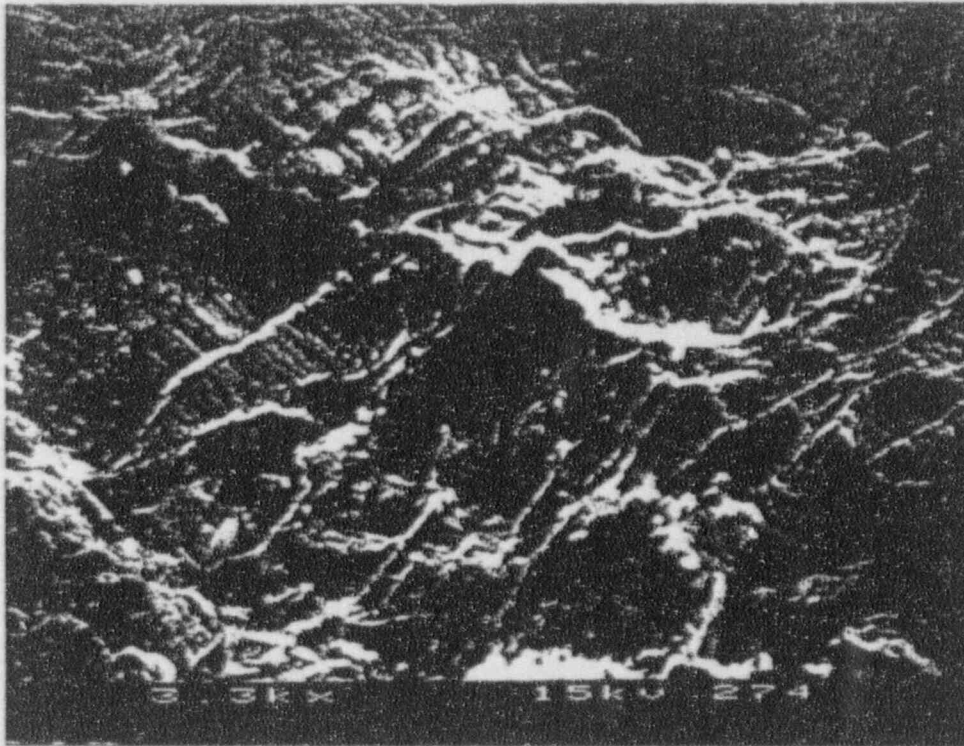
Figure 5 SEM photo of fatigue striations near center of bellows crack. Crack traveled from OD to ID (upper right to lower left in photo). (3300X) S-1904.

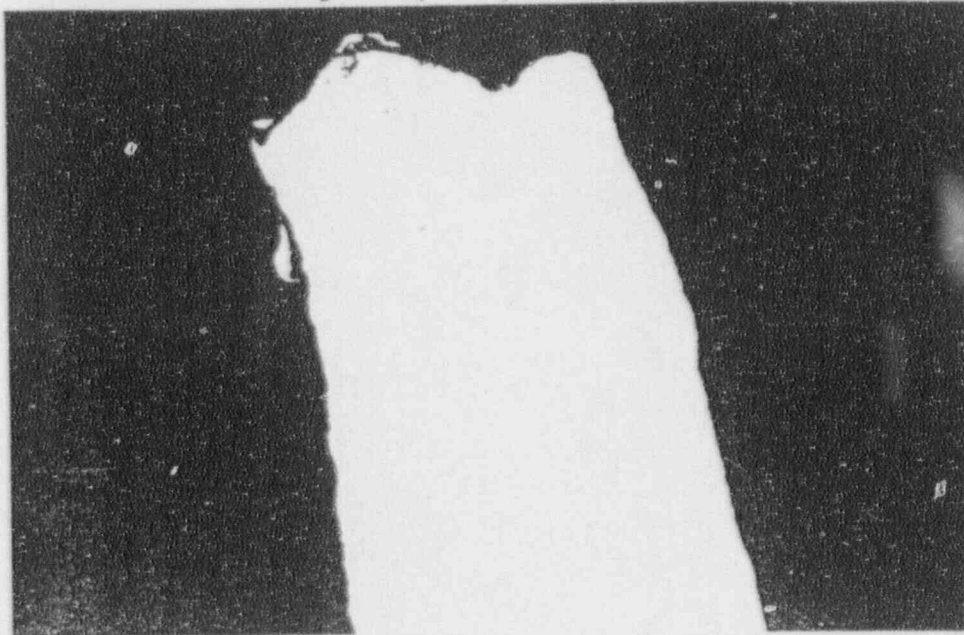
Figure 6 Cross-section through bellows, near center of crack. No parallel cracking visible near main fracture (top); minor 2° crack is mechanical damage. (500X) Mi-2637.
