NATIONAL BOARD BULLETIN

THE CHINESE FLANGE
INVESTIGATION

1992 • VOLUME 48 • NUMBER 2

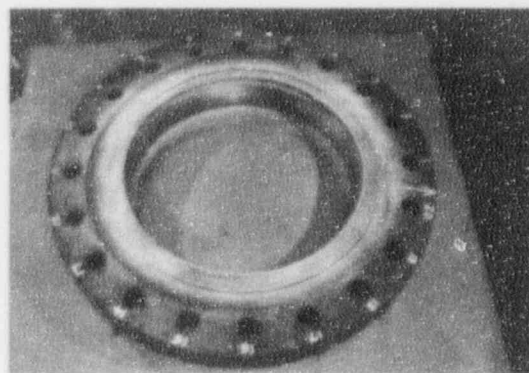
Figure 1: Gasket side of flange.

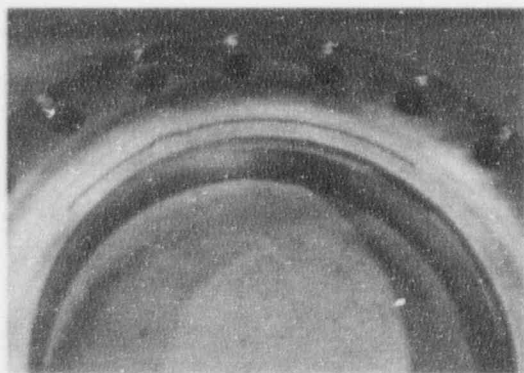
Figure 2: A close-up of the gasket side showing the "crack" indication.

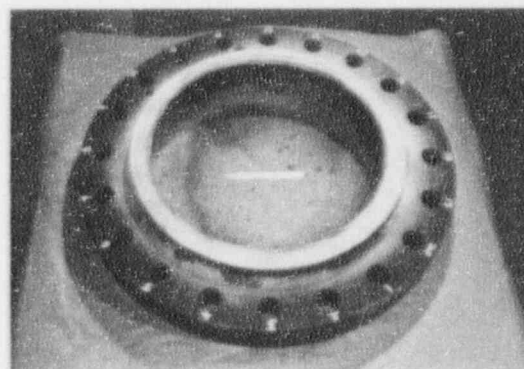
Figure 3: Pipe side of flange.

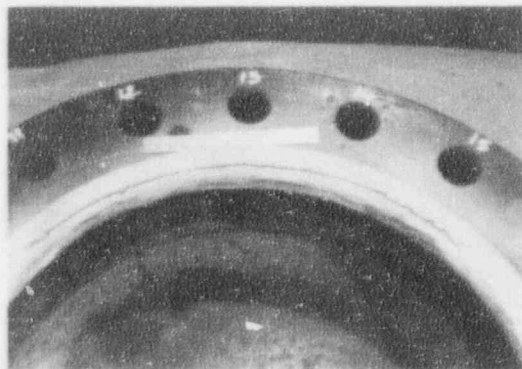
Figure 4: A close-up of the pipe side showing the "crack".

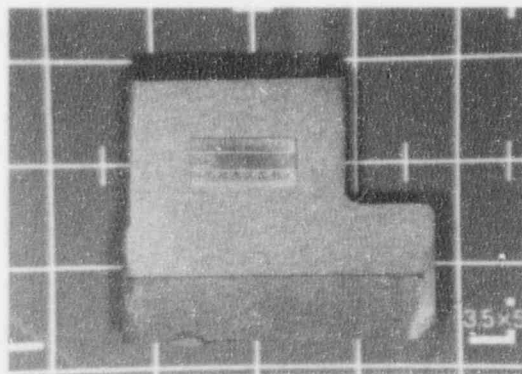
Figure 5: A macro of a radial section. Etched 50% HCl, 15 minutes.

Figure 5 shows the radial macro section of the flange. Note the insert ring welded to the main flange. When another similar piece was further sectioned to retrieve specimens for mounting and polishing, the insert separated from the main flange. The general microstructure (ferritic-pearlitic) at 25X (Nital etch) is shown in Figure 6.

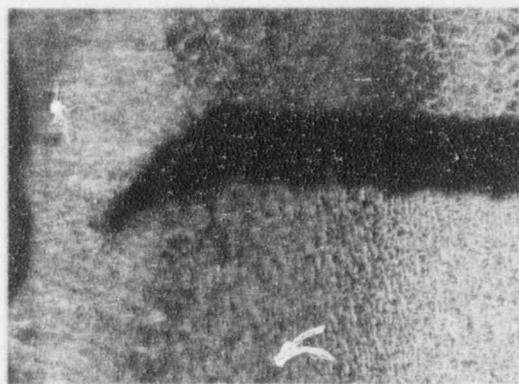
Figure 6: Photo showing general microstructure in the main flange (lower half), insert (upper half) and weld metal (left edge), 25X, Nital etch.

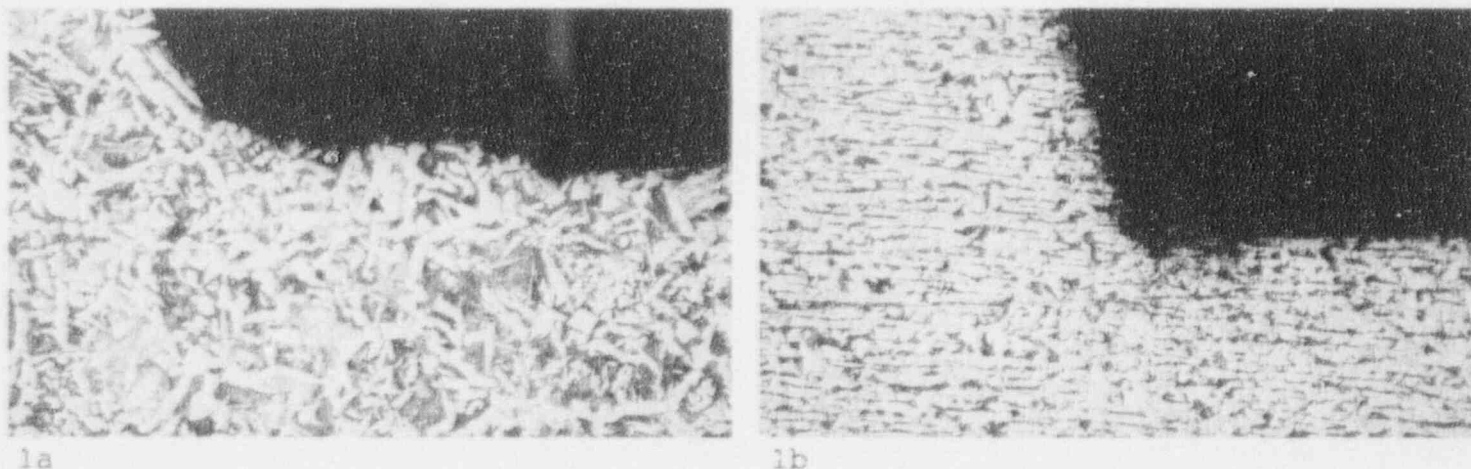
The suspicion is that the material was not forged, but was fabricated from rolled plate. The decision was made to cross section and metallurgically prepare portions of the material to observe the nature of the microstructure. The photomicrographs shown in Figure 1a and 1b are evidence the flange and blank, respectively, are fabricated from rolled plate. The somewhat elongated grains particularly noticeable in the photomicrograph of the blank are typical of hot rolled steel.

Figure 1. Appearance of Grain Structure of a) the Flange, and b) the Blank Showing Elongated and Grains Indicative of Hot Rolled Plate.

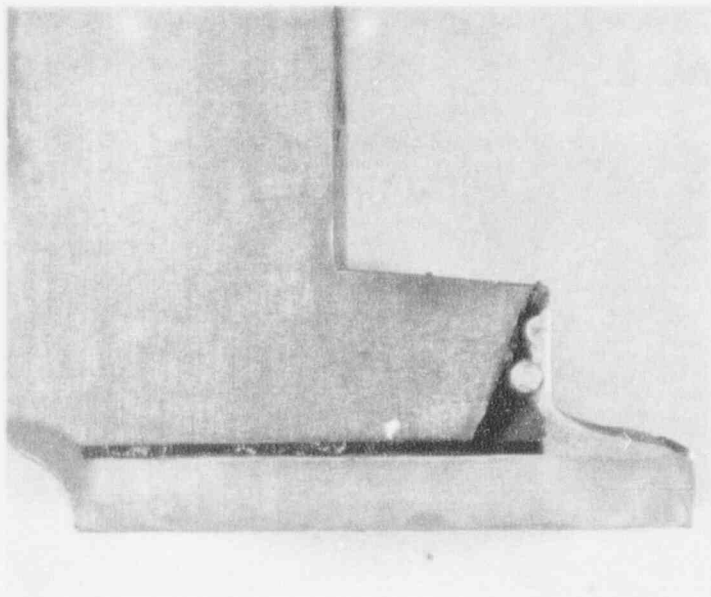
It can be seen the "slugging" has resulted in very little substratum for the fillet weld shown in Figure 2a and 2b.

Figure 2. Appearance of Non-fused Filler or Slugging.

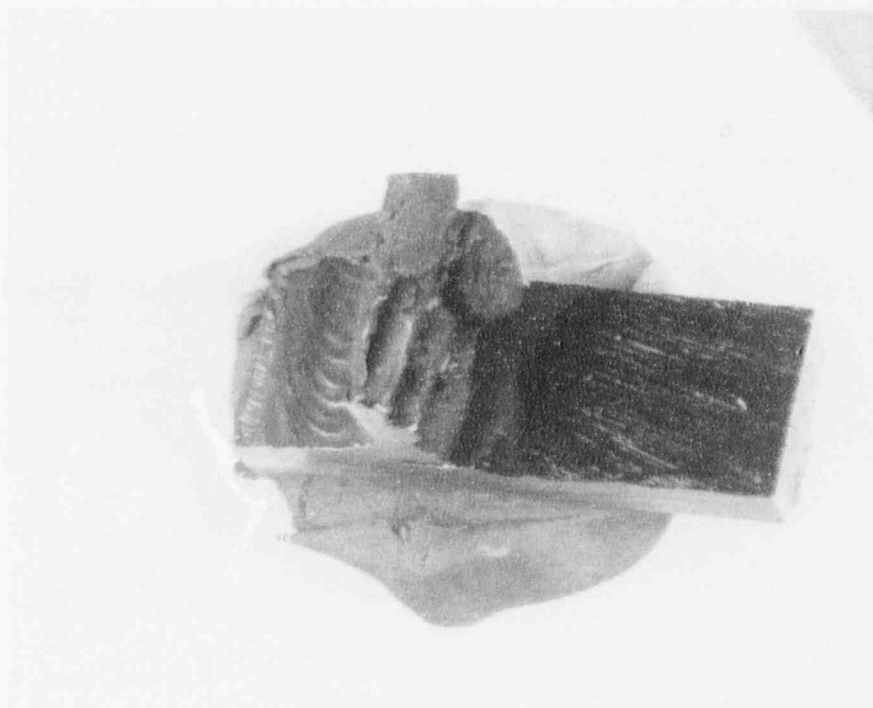
Finally, the nature of the non-fused filler was to be determined. By simply cross sectioning the flange, the sample picture in Figure 2c was easily separated from the rest of the flange manually. The non-fused filler was found to be a pair of 1/8 inch rounds evidently welded to increase the size of or repair defects in the flange. Figure 2b shows the "slugging" extending around the flange. This situation was found in several other locations around the circumference.

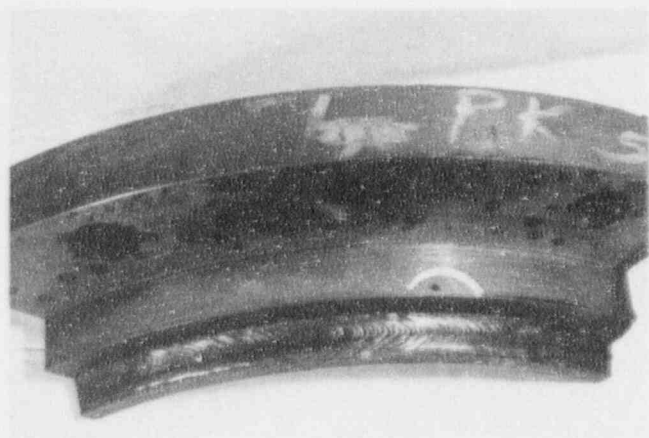
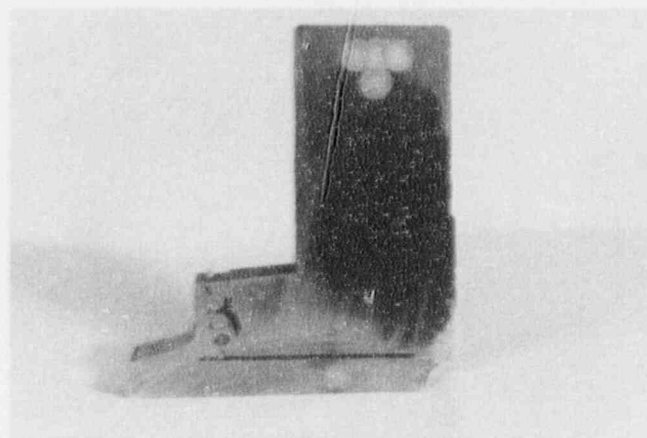
Slip-on raised-face flange.

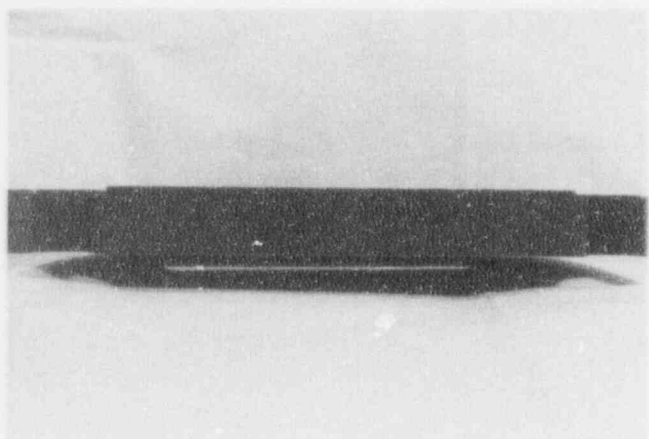
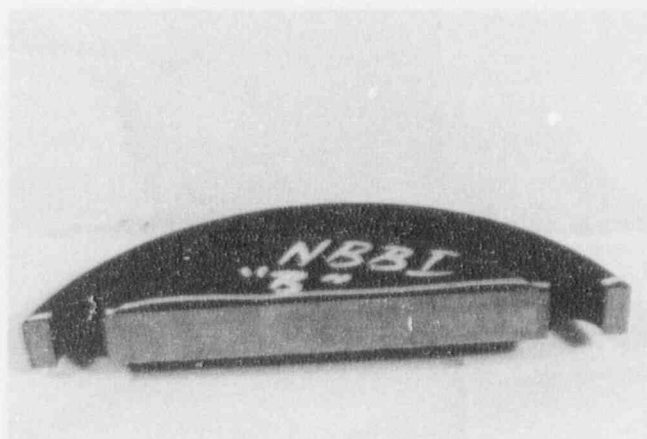
Blind flange marked as A105 is a rolled plate product.

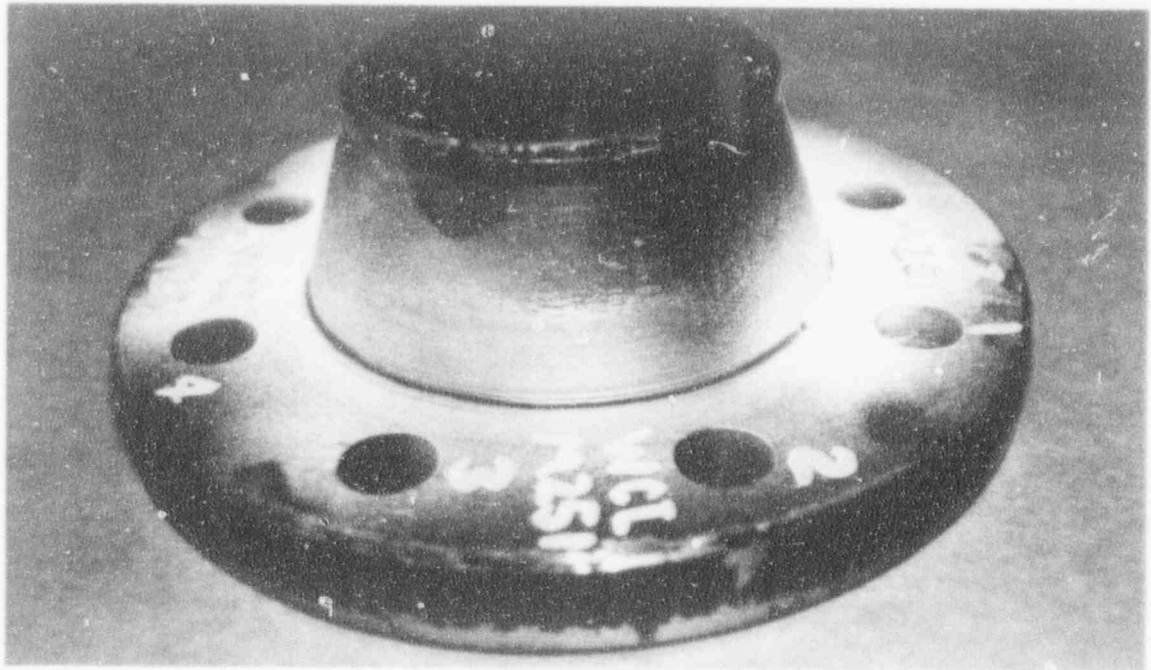
When the flange was first received, a visible crack was evident at the transition between the flange and the weld neck. There also appeared to be machining grooves in this same vicinity. To verify the extent of cracking, the flange was subjected to penetrant testing. As can be seen in Figures 2 and 3 below, there was more cracking evident than could be detected visually. In fact, more than 75% of the circumference exhibited cracking.

Figure 2, Penetrant test indications

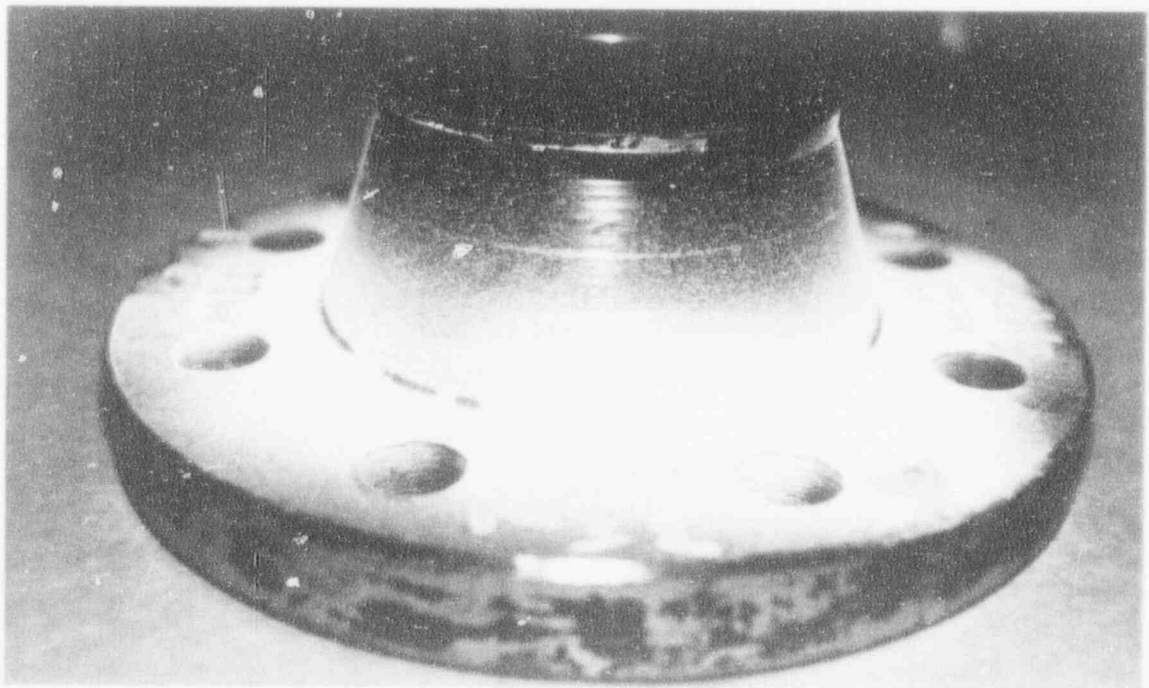
Figure 3, Penetrant test indications

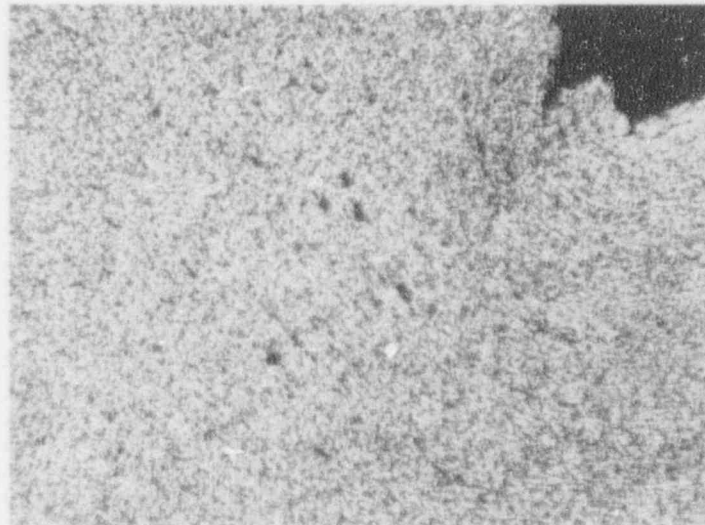
Figure 4, Section A microstructure at visible crack location
(50X, Nital etch)

Figure 4 vividly depicts the presence of material flow lines which is indicative of a forged material. Further, the fact that the grain structure appears relatively equiaxed indicates that this material was most likely subjected to a normalizing heat treatment following the forging operation. Another observation here is the fact that the apparent crack did not appear to have a sharp end condition, plus it was quite wide compared to its depth. Neither of these characteristics are typical for a crack.

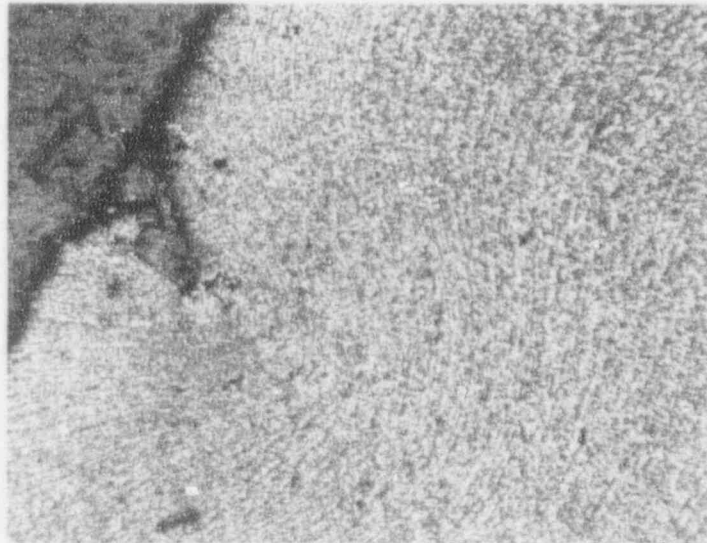
Figure 5, Section B microstructure at crack location
(50X, Nital etch)

This cross section also shows an uncharacteristic crack indication. Further, there is increased evidence of flow lines at the end of the indication. Based on these observations, it is felt that the indications noted on this flange are the result of poor forging practice which resulted in a forging lap at the weld neck-flange transition.

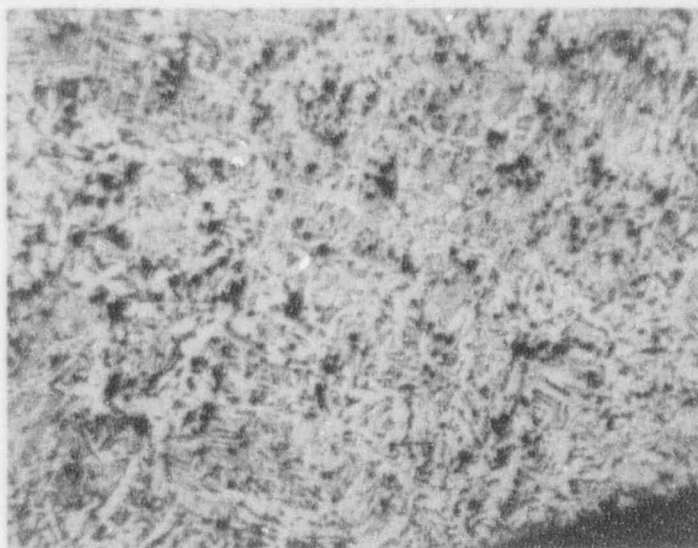
Figure 1, Weld Neck, 50X, Nital Etch

Several features are revealed through these photomicrographs. First, the material does not appear to be a forging, nor do they appear to be normalized. However, it is difficult to determine from this brief analysis whether the materials are rolled plate or cast. The presence of extensive numbers of spherical inclusions, and the microstructural appearance suggests the possibility of these being cast materials; however, it is difficult to positively determine without further polishing and microstructural analysis. Should you wish to pursue this further, please let us know. The fact that there is no sign of flow lines is evidence that these are not forgings.

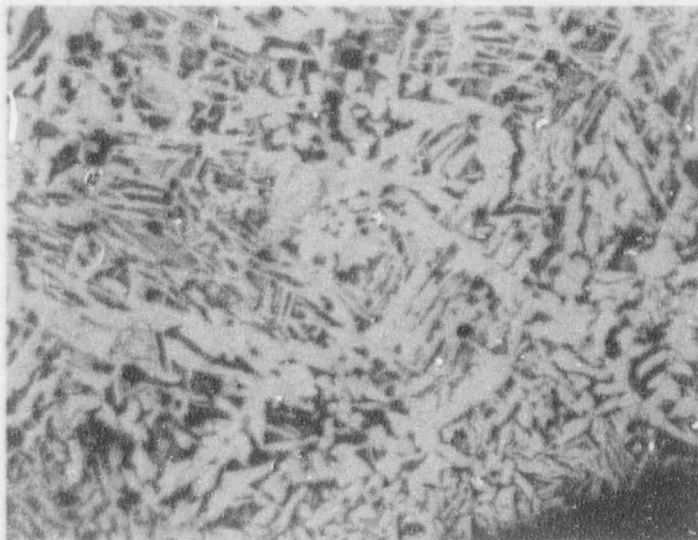
Figure 2, Weld Neck, 100X, Nital Etch

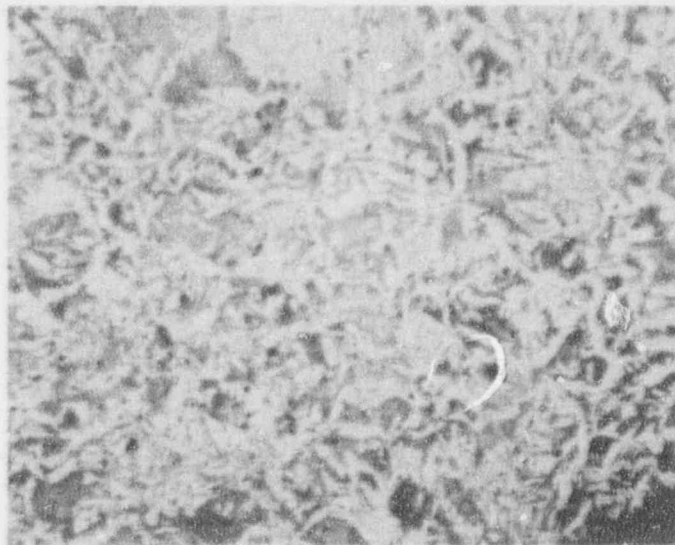
Figure 3, Slip-on, 50X, Nital Etch

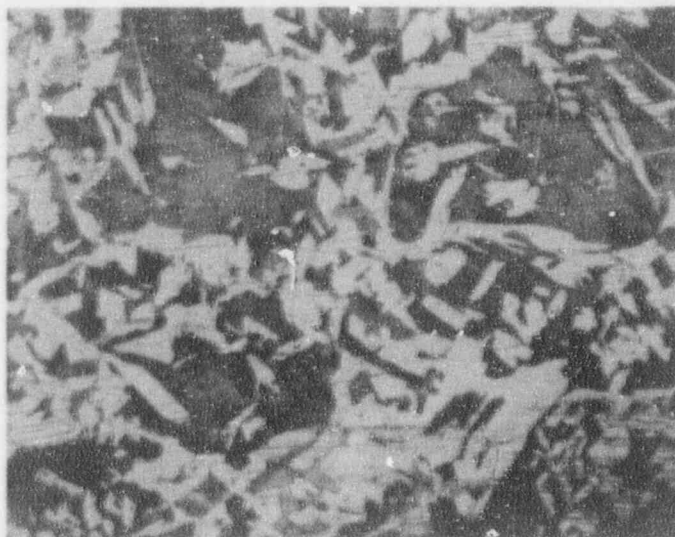
Figure 4, Slip-on, 100X, Nital Etch

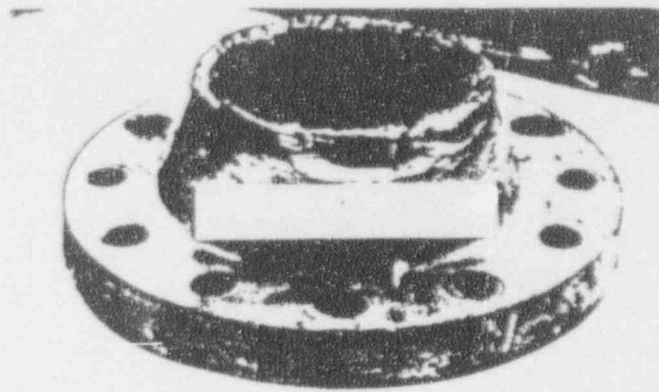
Fig. 1. This is a 6" weld neck flange that leaked during hydrostatic testing. An attempt was made to remove and weld repair the defect but because it went deeper into the neck, the attempt was abandoned.

- (a) A general view showing the flange on the side where the repair was attempted. The hole just above the ruler is the excavation left after attempting to remove the defect.
- (b) A close-up view of the excavation showing the crack-like forging defect (indicated by an arrow) and also some slag or oxide inclusions (indicated by two arrows) which looked like porous in the material.

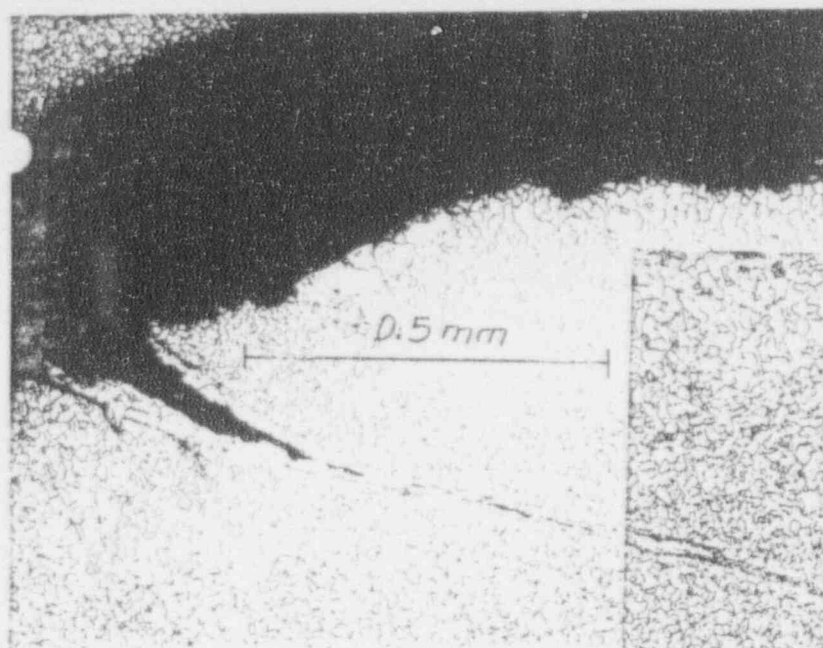
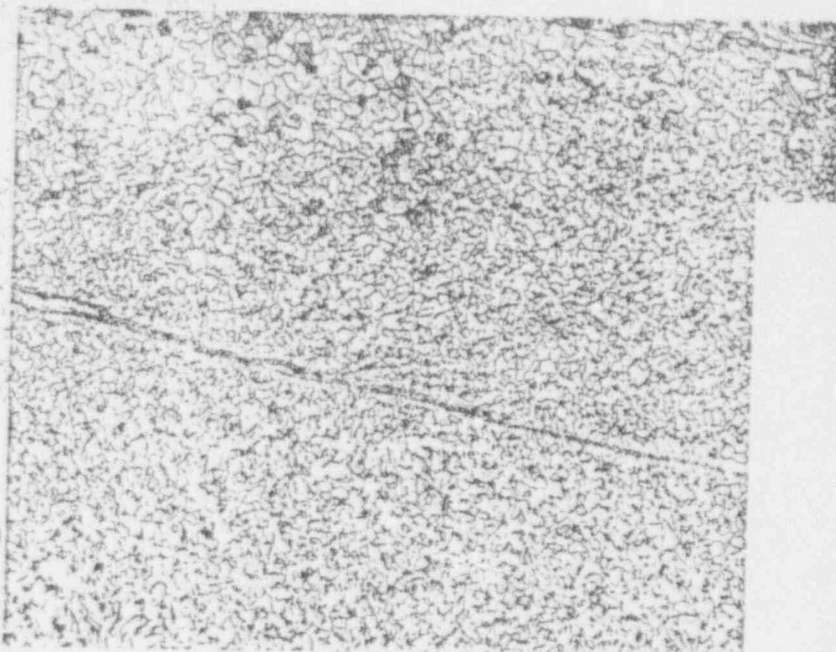
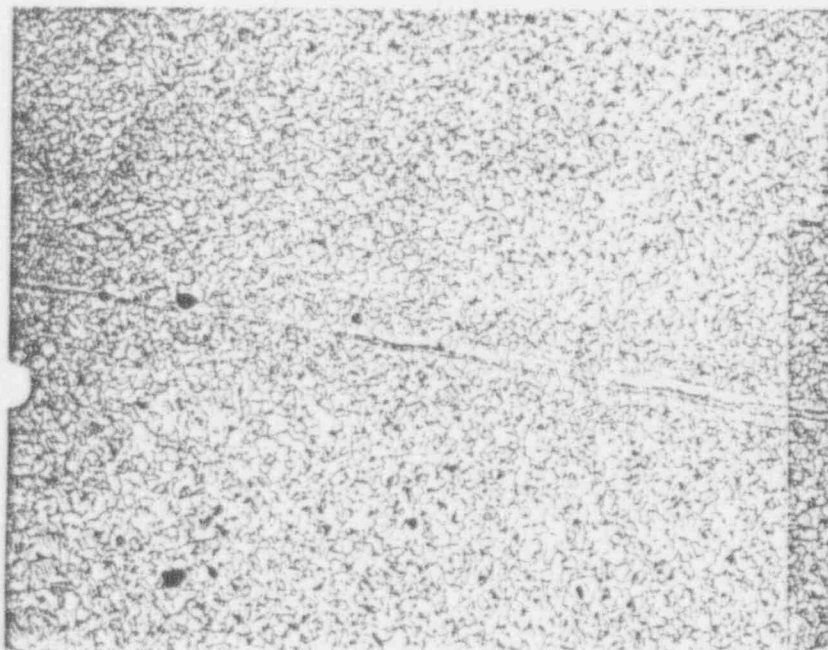
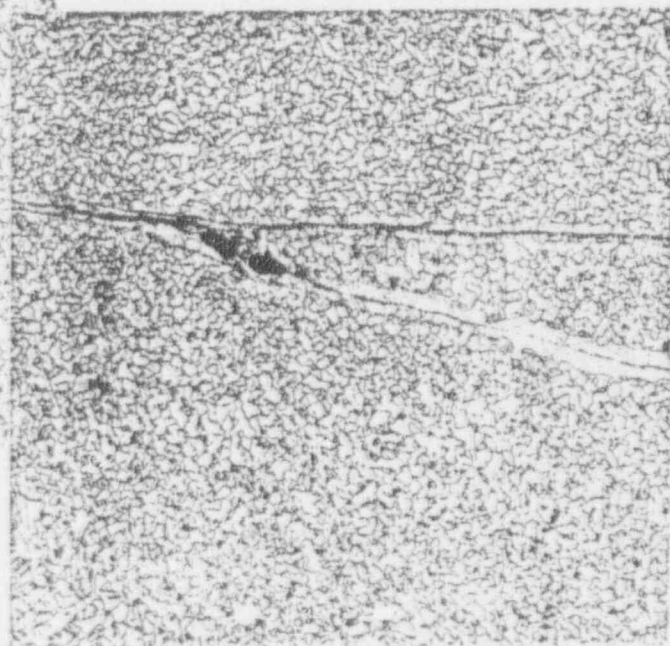
Fig. 3. Photomicrograph through the crack as shown in Fig. 2e. The right-hand side edge of (a) continues on the left-hand side edge of (b). Notice that the decarburization (lack of pearlite) associated with the lap surface as well as the presence of slag or oxide inclusions. This is a minor lap attached to the main crack, which is indicated above.

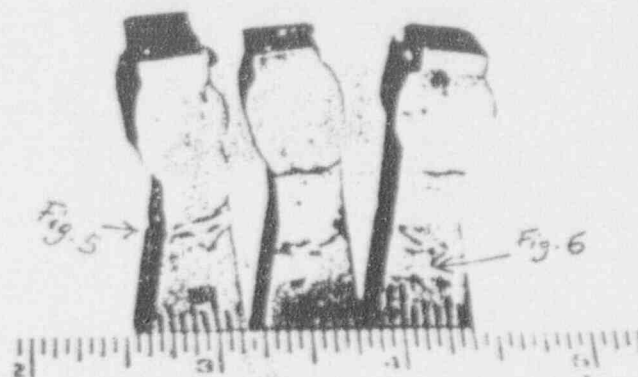
Fig. 4. Metallographic samples taken from the 8" weld neck flange that leaked during hydrostatic testing. The neck of the flange was radiographed near the weld joining it to the pipe and a area 110 mm long was found with crack-like indications and cavities or porous. These were oxide inclusions embedded in the metal at the neck of the flange.

Metallographic examination was carried out on the spots indicated by the arrows. That on the left is shown in Fig. 5; the arrow on the right-hand side corresponds to the area shown in Fig. 6.

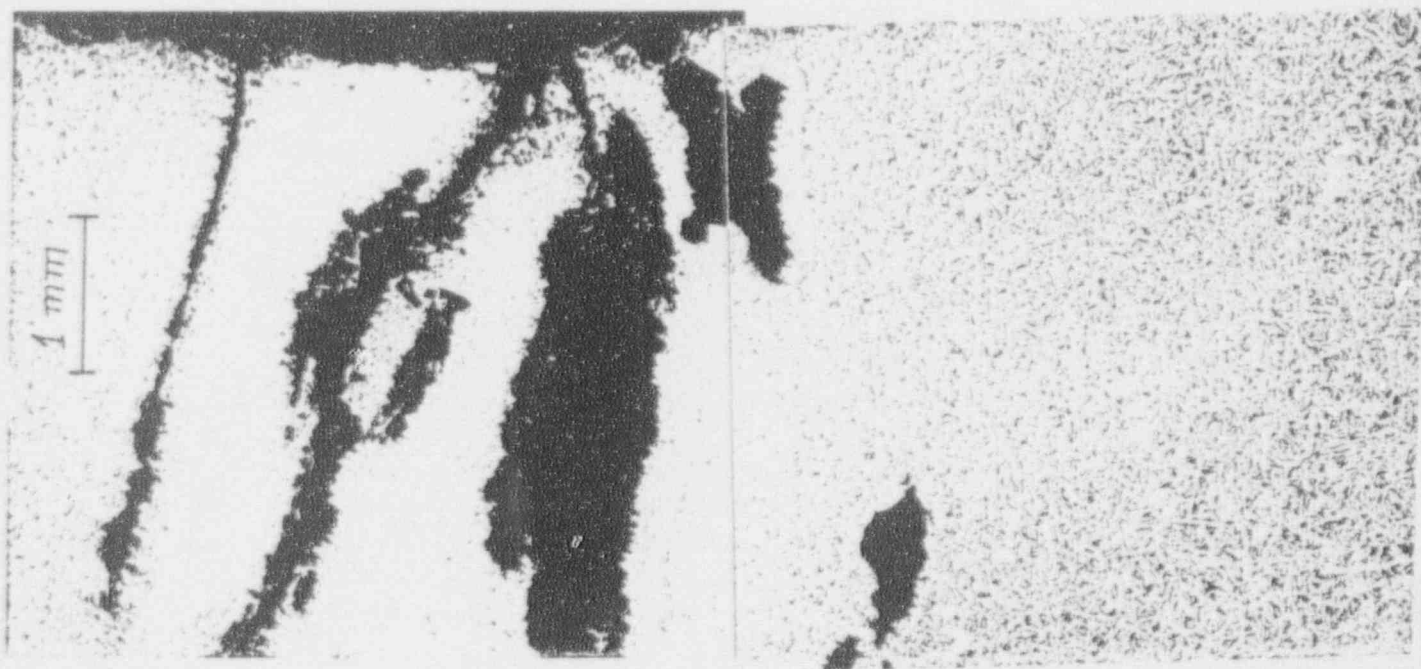
Fig. 5. Photomicrograph taken on the spot indicated with an arrow in Fig. 4. Notice that the cavities were filled with oxide but later on partially removed by polishing and metallographic etching. Also notice that the magnification used is relatively low and yet the Widmanstätten microstructure can be clearly seen. This gives an idea of the coarseness of this type of structure.

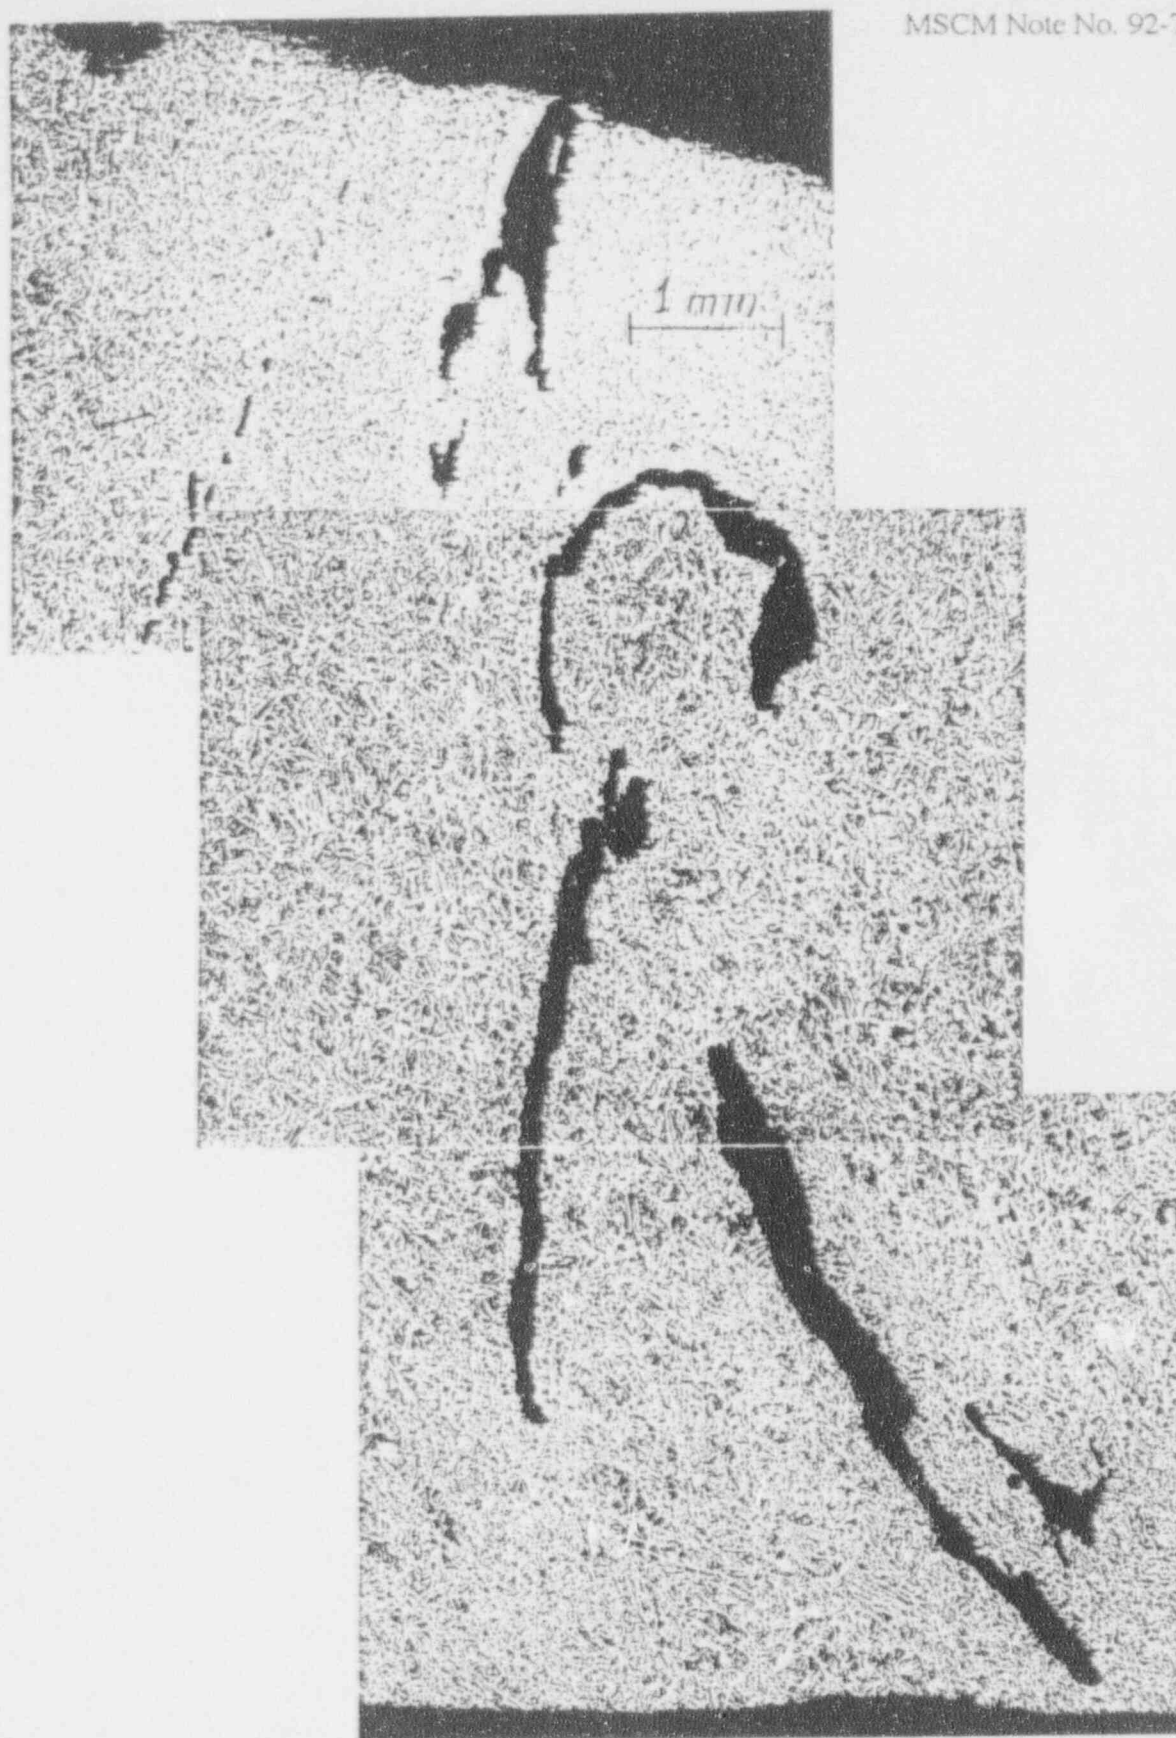
Fig. 6. Photomicrograph taken on the spot indicated with the arrow on the right-hand side of Fig. 4, showing other discontinuities found in the 8" flange. Notice that the Widmanstätten microstructure can be clearly seen despite the relatively low magnification used.

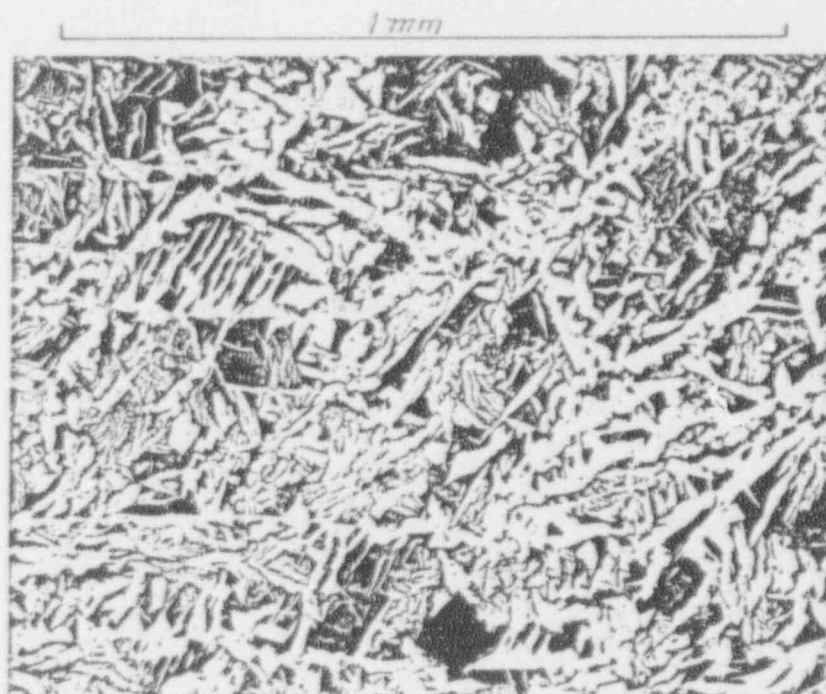
Fig. 7. Widmanstätten and very coarse structure found in the 8" flange and indicating overheating during the manufacturing process. This type of structure is usually associated with low impact properties and ductility. Hardness taken on this sample was 146-152 HV.

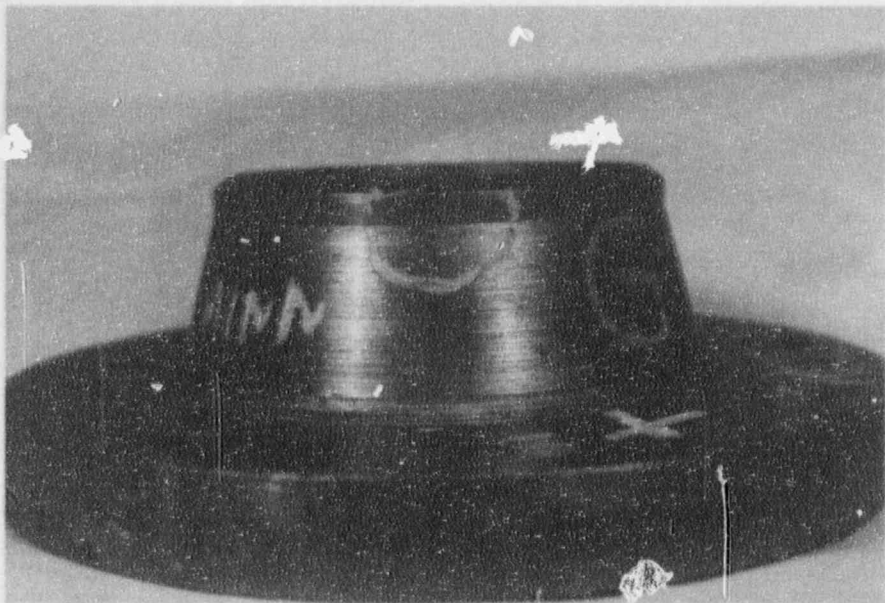
Flange exhibits laps or seams to an edge depth of approximately 50% of wall thickness.
