Carolina Power & Light Company

Brunswick Stream Electric Plant

BRUNSWICK STEAM ELECTRIC PLANT, UNIT NOS. 1 AND 2
DOCKET NOS. 50-325 & 50-324/LICENSE NOS. DPR-71 & DPR-62
REPLY TO NOTICE OF VIOLATION

BRUNSWICK STEAM ELECTRIC PLANT, UNITS 1 AND 2
NRC DOCKET NOS. 50-325 & 50-324
OPERATING LICENSE NOS. DPR-71 & DPR-62
REPLY TO NOTICE OF VIOLATION

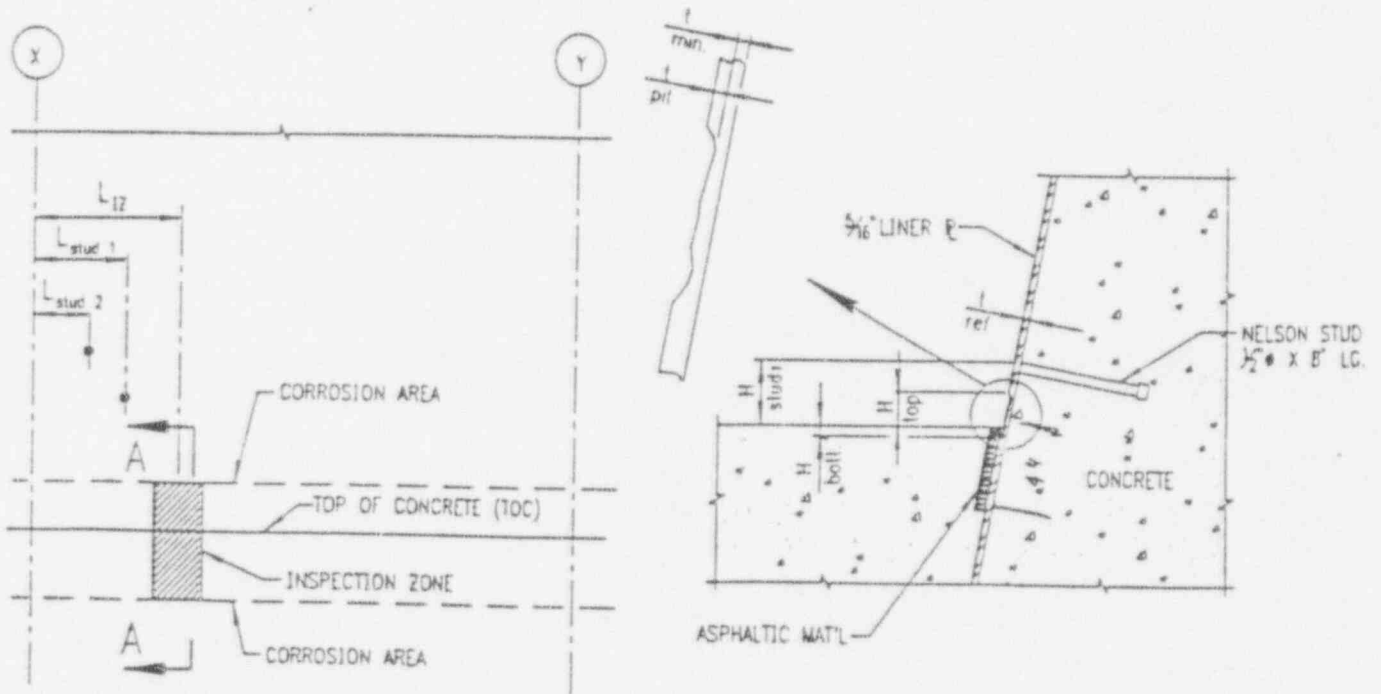
Contrary to the above, the depth and extent of corrosion of the drywell liner plate at the intersection of the interior concrete floor and interior drywell liner plate around the entire circumference of the drywell was not measured or evaluated when the inspections were performed in 1987, 1989, 1990, and 1991 in the Unit 1 drywell and in 1988, 1990, and 1991 in the Unit 2 drywell.

The examination of the Unit 2 liner determined that five areas required base metal repairs to restore the liner plate to an acceptable thickness, and these repairs are complete. United Engineers and Constructors has prepared a calculation to document the as-found condition of the liner and determined the liner to be operable with the corroded areas. The original UFSAR assumption that the liner yields before it buckles remains valid. The minimum

CORROSION AREA AND ORIGINAL SEAL

acceptance criteria for liner thickness and repair evaluation are documented in Engineering Evaluation Report (EER) 93-0173 revision 2. To minimize recurring corrosion, this area of the liner was recoated with an epoxy coating and an enhanced seal was installed in the expansion joint between the liner plate and the concrete floor that will prevent the liner from contacting the shallow standing water present in this area (see Attachment 2). This same process will be used for Unit 1, with the inspections and repairs (if required) being performed prior to the restart of Unit 1.

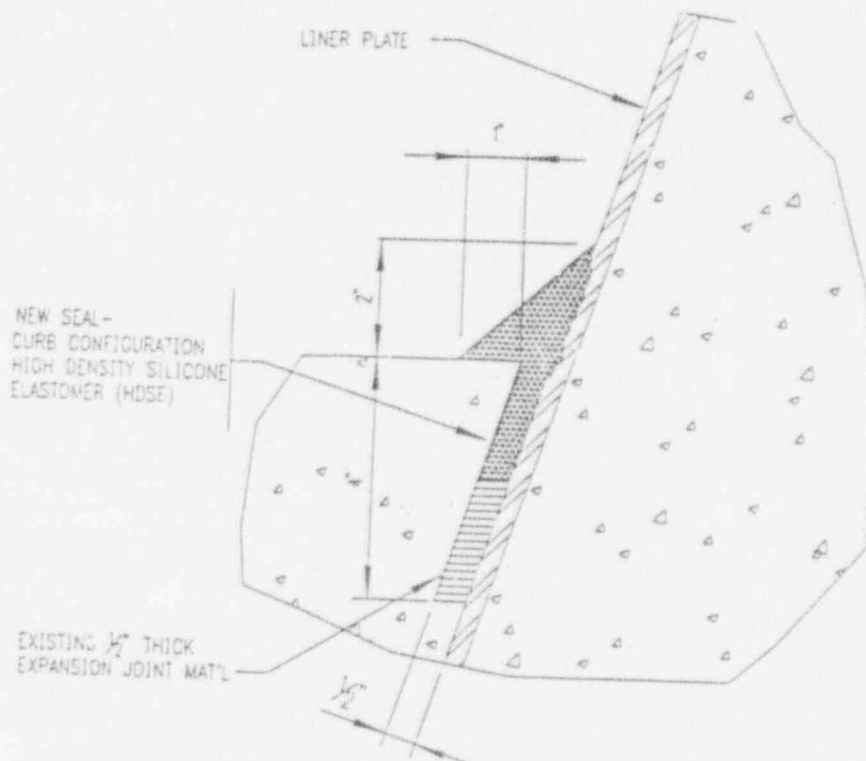
NEW SEAL CONFIGURATION
