PEACH BOTTOM ATOMIC POWER STATION

SUBJECT: Licensee Event Report
Peach Bottom Atomic Power Station - Unit 3

This LER concerns a Technical Specification violation when the Reactor was unvented and pressure - temperature data was not obtained.

Reference:	Docket No. 50-278
Report Number:	3-93-003
Revision Number:	00
Event Date:	03/10/93
Report Date:	04/07/93
Facility:	Peach Bottom Atomic Power Station RD1, Box 208, Delta, PA 17314

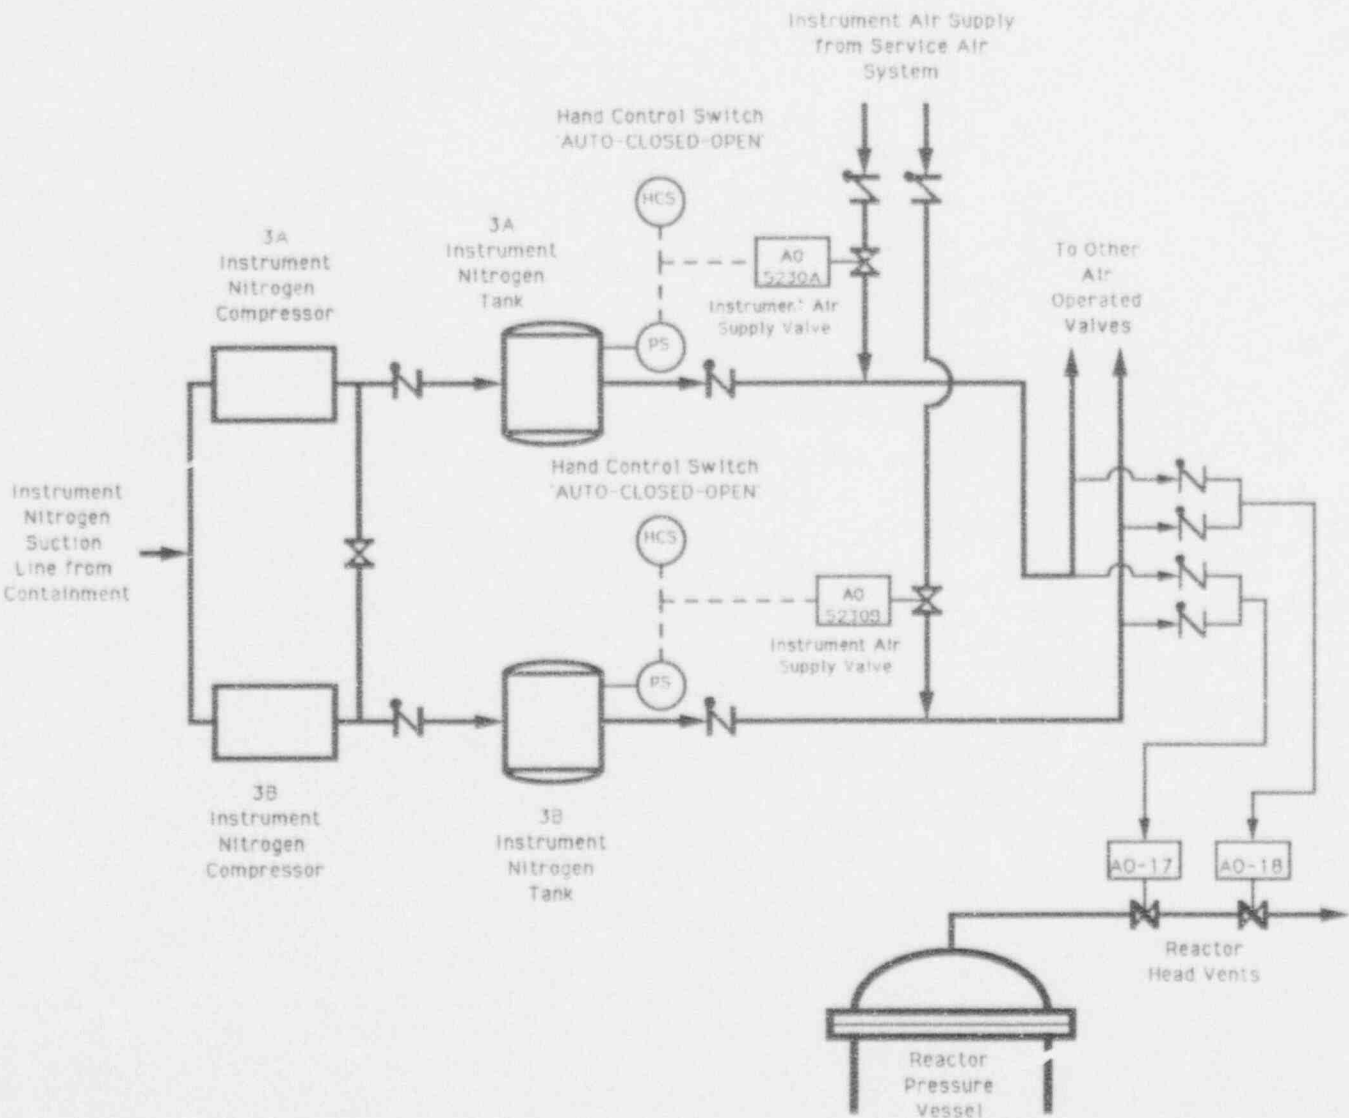
On 03/10/93 at approximately 2245 hours, during the shift turnover process by the Reactor Operator (RO) (Utility:Licensed), it was discovered that the Reactor vessel head vents (AO-17 & 18) (see attached diagram) were closed. A Nuclear Plant Operator (NPO) was immediately dispatched to investigate the problem. The NPO identified that the backup Instrument Air Supply Valves (AO-5230A & B) (EIIIS:V) (EIIIS:LD) which provide an instrument air supply to the head vents were closed. Since AO-5230A & B were found closed, the head vents eventually drifted shut as pressure in the supply lines decayed away. While the plant is shutdown, the primary air supply is the backup Instrument Air Supply system and the Instrument Nitrogen Supply system is out of service. The instrument air supply valves and the Reactor vessel head vents were immediately restored to their proper position. Tech Spec 4.6.A.2 specifies that "Reactor vessel temperature and reactor coolant pressure shall be permanently logged every 15 minutes whenever the shell temperature is below 220 degrees F and the reactor is not vented". Therefore, this condition resulted in a violation of Tech Spec because the appropriate 15 minute Surveillance Requirements were not performed for several hours when the reactor was not vented. Further investigations have determined that during the performance of General Procedure (GP)-2 "NORMAL PLANT START-UP" on 03/10/93 at approximately 0930 hours, an NPO did not fully move the control switches (HS-3-36B-5230A & B) for AO-5230A & B to the "AUTO" position. During normal power operation, AO-5230A & B are maintained in the "AUTO" positions to provide an instrument air supply to the head vents in the event that the normal instrument nitrogen supply is lost. In this condition, the instrument air supply valves will automatically open to supply instrument air if the pressure in the instrument nitrogen tank drops below a specified value.

The cause of the event has been determined to be that AO-5230A & B were found closed which provide an instrument air supply to the head vents. AO-5230A & B were closed due to a sluggish control switches (EHS:HC) and the misalignment of the labels on the control box. When the NPO (Utility:Non-Licensed) positioned the switches during GP-2, it was believed that the control switches were placed in the "AUTO" position. However, because of the sluggishness of the switch and the labeling misalignment deficiencies, the switches had not made up in the "AUTO" position and were still in the "CLOSED" position. Additional investigation determined that the same switches on the other unit were also sluggish and also had a labelling misalignment concern. These switches are General Electric model CR2940 and are used in various applications throughout the plant. However, given the fact that this is the only event identified to date, and the large number of positive checks of switch operations (Check-Off-Lists, Surveillance Test performance, system operations, blocking, etc), this error is considered an isolated occurrence at this time.

After discovery of the event, the instrument air supply valves and the Reactor vessel head vents were immediately restored to their proper position.

The control switch labels for AO-5230A & B and the same valves on the other unit will be better human factored. In addition, the sluggish switches will be inspected and corrective actions will be implemented as appropriate.
