Duke Power Company
Catawba Nuclear Station
4800 Concord Rd.
York, S.C. 29745

Subject: Catawba Nuclear Station
Docket No. 50-413
LER 413/93-002

Attached is Licensee Event Report 413/93-002, concerning TECHNICAL SPECIFICATION 3.0.3 ENTERED DUE TO INOPERABLE PUMP DISCHARGE VALVES.

Technical Specification 3.0.3 Entered Due To Inoperable Pump Discharge Valves

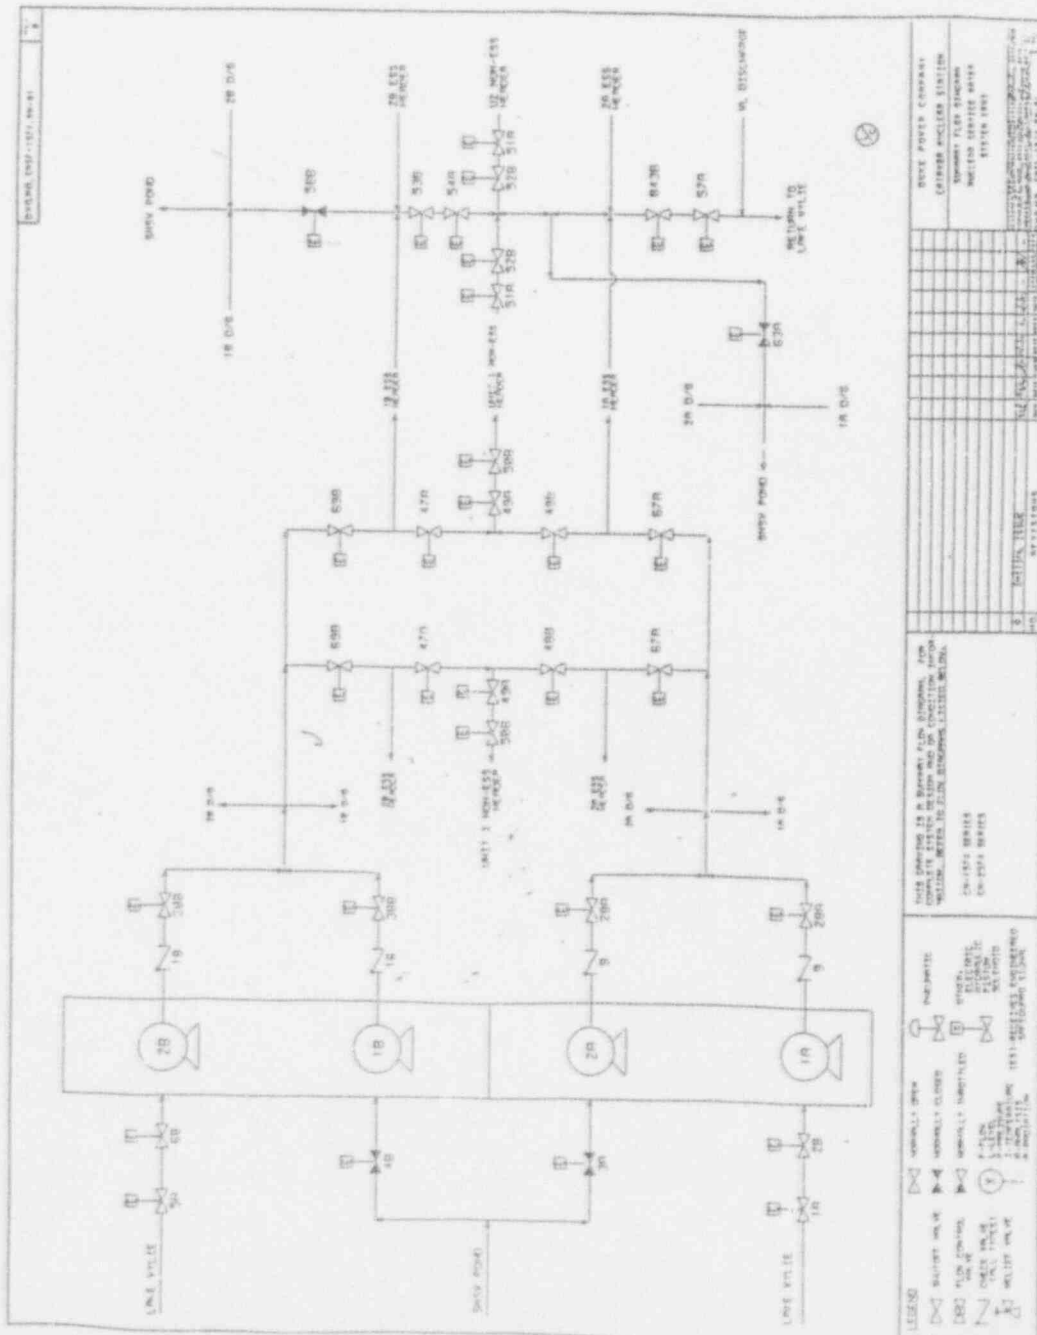
Attachment A

The discharge valves [EIS:V] that failed to open and are the subject of this report are in the Nuclear Service Water [EIS:BI] (RN) system. A simplified flow diagram of the RN system is included in the report as Attachment A. The flow diagram will help to understand the arrangement of the components discussed in this report.

To fully understand the event that occurred on February 25, 1993, the history of the torque switch settings (TSS) for the RN pump discharge valves is provided as well as a detailed event description. A diagram is included as Attachment B to aid in the understanding of the previous TSS and operability of the RN pump discharge valves. Also, a simplified flow diagram of the RN system is included in this report as Attachment A.

At 1424 hours, RN pump 1B was shutdown upon completion of the IWP test. RN pump 2B was then started to perform its IWP test. Upon starting RN pump 2B, discharge valve (2RN38B) failed to open. The header downstream of the valve was depressurized, so this valve was trying to open against maximum different pressure.

At 1426 hours, RN pump 2B was shutdown and RN pump 1B was restarted to verify that its discharge valve would open. The discharge valve (1RN38B) for 1B RN pump also failed to open with the header downstream of the valve depressurized.

At 1430 hours, Operations opened the RN crossover valve, which pressurized the "B" train header and allowed valve 1RN38B to open. RN pump 1B was shutdown. Operations contacted Engineering to ask for assistance in resolving the failure of RN discharge valves to open. Operations also initiated work orders to investigate why the "B" train RN pump discharge valves did not open during RN pump start.

At 1730 hours, after reviewing Engineering information and the results of the inspection of the RN pump discharge valves. Engineering concluded that the failure of the "B" train valves was due to higher than expected torque to open the valves with the header downstream of the valves depressurized. Engineering also determined that the "A" train RN pump discharge valves had a similar setup and therefore potentially had a similar problem. Based on the conclusion, Engineering recommended that both trains of RN on Unit 1 be declared inoperable. Engineering also advised Operations of an immediate corrective action which was to open the RN pump discharge valves and then remove power. Once the RN pump discharge valves were declared inoperable, Station Management continued to discuss potential reportability requirements.

Failure of the Unit 1 discharge valves 1RN28A and 1RN38B to open has been attributed to sizing variables that are possibly inadequate for a reason unique to these specific applications and/or a potentially degraded valve subcomponent. Corrective actions included setting the Unit 1 discharge valves to 20 degrees open, setting Unit 2 valves to maximum TSS (3.0), evaluating BIF motor operated valves in other applications, reviewing of the manufacturing sizing

- 3) Evaluated BIF motor operated valves in other applications.
- 4) Reviewed the manufacturers sizing calculations for the RN pump discharge valves.
- 5) Valve 2RN38B was removed on March 20, 1993 and replaced with a valve designed by a different manufacturer per work order 93020922-01. The valve was tested per work order 93020922-02 and the valve tested successfully. Engineering reviewed test data and found the results to be acceptable.

- 1) Engineering is continuing to analyze the data from diagnostic testing and to conduct additional testing to identify causes of higher than expected torque requirements.
- 2) Compliance will prepare a TS Interpretation concerning TS Surveillance requirements of TS 4.8.1.1.1a when TS 3.0.3 is entered.
- 3) Training will be provided on the TS Interpretation.
