Carolina Power & Light Company

BRUNSWICK STEAM ELECTRIC PLANT UNIT 2
DOCKET NO. 50-324
LICENSE NO. DPR-62
LICENSEE EVENT REPORT 2-93-005

REACTOR COOLANT CHLORIDE LEVELS COULD NOT BE RESTORED BELOW THE LIMITS WITHIN 48 HOURS

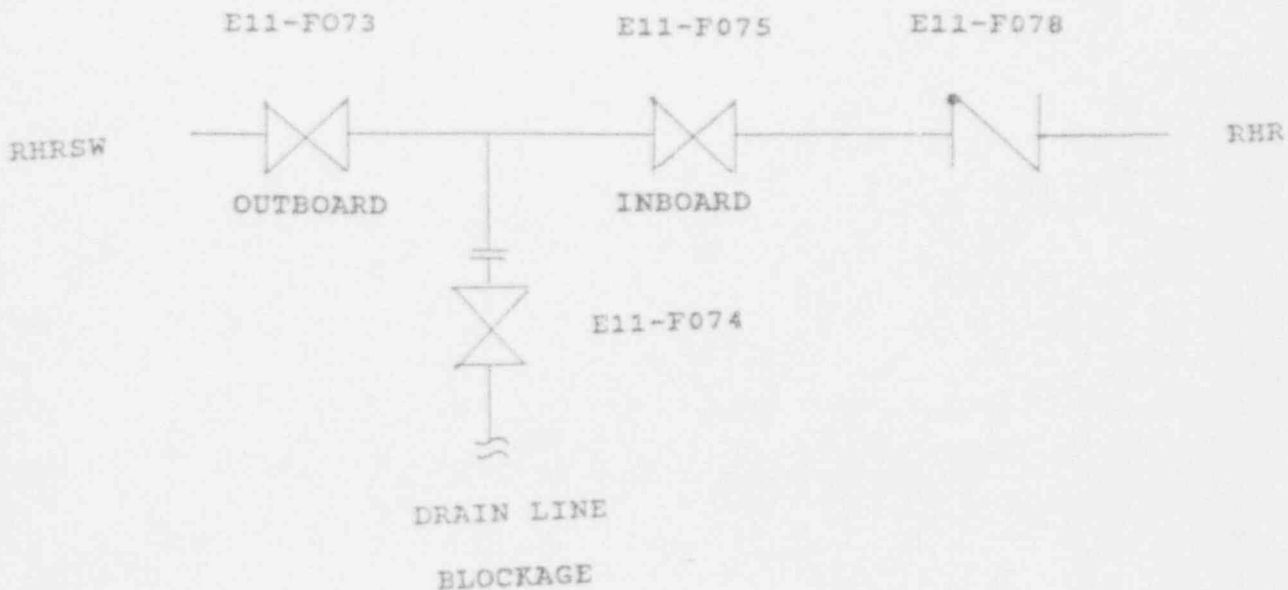
ATTACHMENT 1

Unit 2 was in Cold Shutdown to support the outage started April 21, 1992. On March 11, 1993, maintenance was performed on the inboard and outboard Residual Heat Removal Service Water (RHRSW) to Residual Heat Removal (RHR) injection valves (see attachment 1). During these repairs, a Work Request/Job Order (WR/JO) 93-AJEZ1 was written documenting the RHRSW to RHR Cross-Tie Drain line as being clogged. Upon completion of the repairs to the injection valves, full flow pump testing of the B RHR loop was performed which directed water through the Torus and the B RHR heat exchanger. At 0400, on March 16, 1993, the B loop RHR was aligned to the reactor vessel for Shutdown Cooling (SDC).

The source of the chlorides was determined to be the RHRSW to RHR System cross-tie. The clogged drain line trapped service water (brackish water) that had leaked past the outboard RHRSW injection valve, until the inboard RHRSW injection valve packing adjustment required cycling the valve for run currents, prior to and after adjusting the valve packing. Later, when a partial performance of Periodic Test (PT) 08.1.5 was used for post-maintenance testing the valve was again cycled. These valve cycles allowed the trapped service water to pass and resulted in a chloride source with only a check valve between it and the rest of the B RHR loop. At this point, minor perturbations (i.e. swapping to SDC, stopping pumps, etc.) and time were all that was needed to put chlorides in either the Reactor Coolant system or the Torus.

- 1) The outboard RHRSW to RHR System cross-tie valve was leaking by its seat.
- 2) The drain line between the RHRSW to RHR Cross-Tie valves was clogged and trapped the service water until the inboard valve was cycled. While a WR/JO was written, the immediate consequence of this deficiency was not put in the context of the on-going maintenance that required cycling the inboard RHRSW to RHR cross-tie injection valve.
- 3) The inboard RHRSW to RHR System cross-tie valve had a packing leak that required it to be cycled as part of the packing adjustment.
- 4) Loss of Off-site Power delayed the recovery.

The clogged drain line has been cleared (WR/JO 93-AJEZ1) with additional supports being installed to maintain the proper slope needed to minimize corrosion on the drain piping (WR/JO 93-AKXT1).

The inboard (WR/JO 93-AJAJ1) and outboard (WR/JO 93-AJAB1) RHRSW to RHR Cross-Tie valves were repaired.
