WOLF CREEK

Subject: Docket No. 50-482: Licensee Event Report 93-004-00

FACILITY NAME (1) Wolf Creek Generating Station										DOCKET NUMBER (2) 0 5 0 0 0 4 8 2 1										PAGE (3) 1 OF 1 4			
TITLE (4) Grid-To-Rod Fretting Results In Broken Fuel Rod																							
EVENT DATE (5)			LER NUMBER (6)				REPORT DATE (7)			OTHER FACILITIES INVOLVED (8)													
MONTH	DAY	YEAR	YEAR	SEQUENTIAL NUMBER	REVISION NUMBER	MONTH	DAY	YEAR	FACILITY NAMES				DOCKET NUMBER(S)										
0	3	1	6	9	3	9	3	0	0	4	0	0	0	4	1	5	9	3	0	5	0	0	0
OPERATING MODE (9) 6		THIS REPORT IS SUBMITTED PURSUANT TO THE REQUIREMENTS OF 10 CFR 5. (Check one or more of the following) (11)																					
POWER LEVEL (10) 10		20.402(b)				20.405(c)				50.73(a)(2)(iv)				73.71(b)

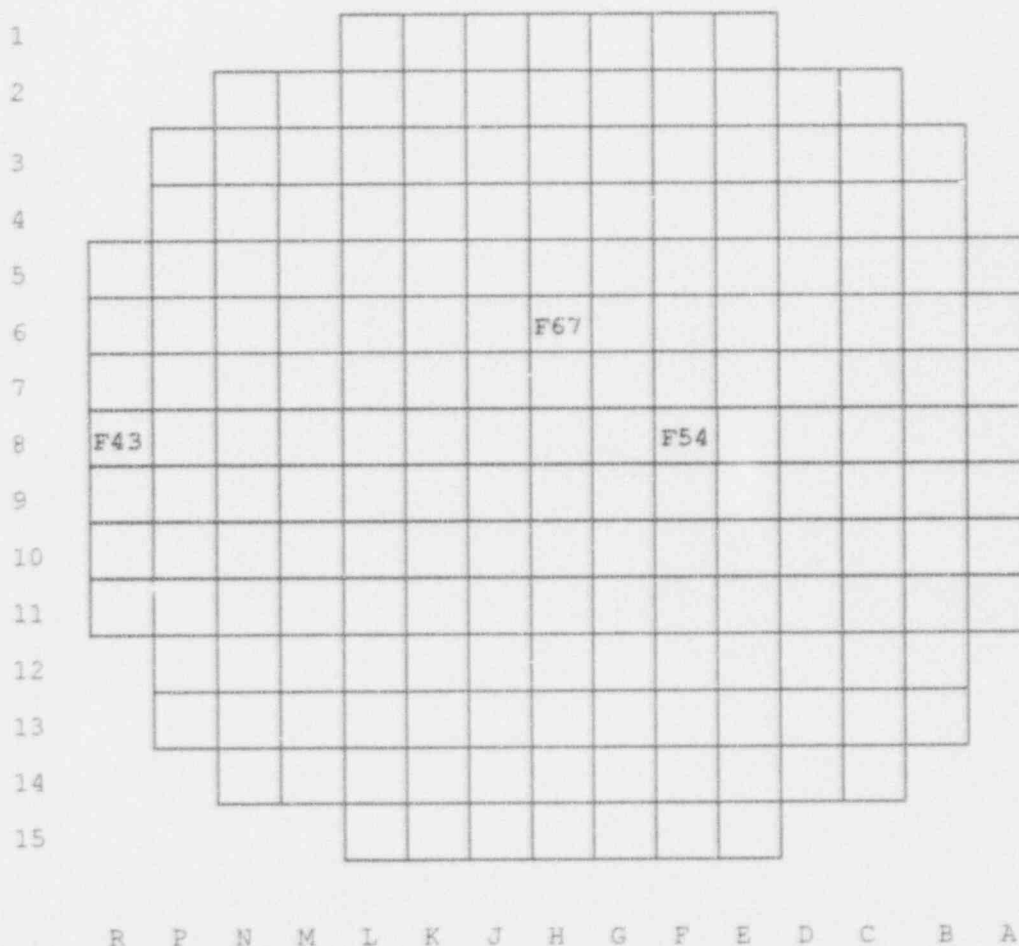
FIGURE 1
FUEL LOCATIONS

During and following completion of the core off-load to the Fuel Building (ND), all fuel assemblies were inspected utilizing a through transmission ultrasonic technique and visual inspection using a remote underwater video camera. These inspection activities resulted in the discovery of additional defective fuel rods (leakers) in fuel assemblies F43 and F54, as well as in defective fuel assembly F67 with the broken fuel rod. Figure 1, "Fuel Locations," provides a diagram of the operating Cycle 6 core loading, including the locations of the three fuel assemblies with defective fuel rods.

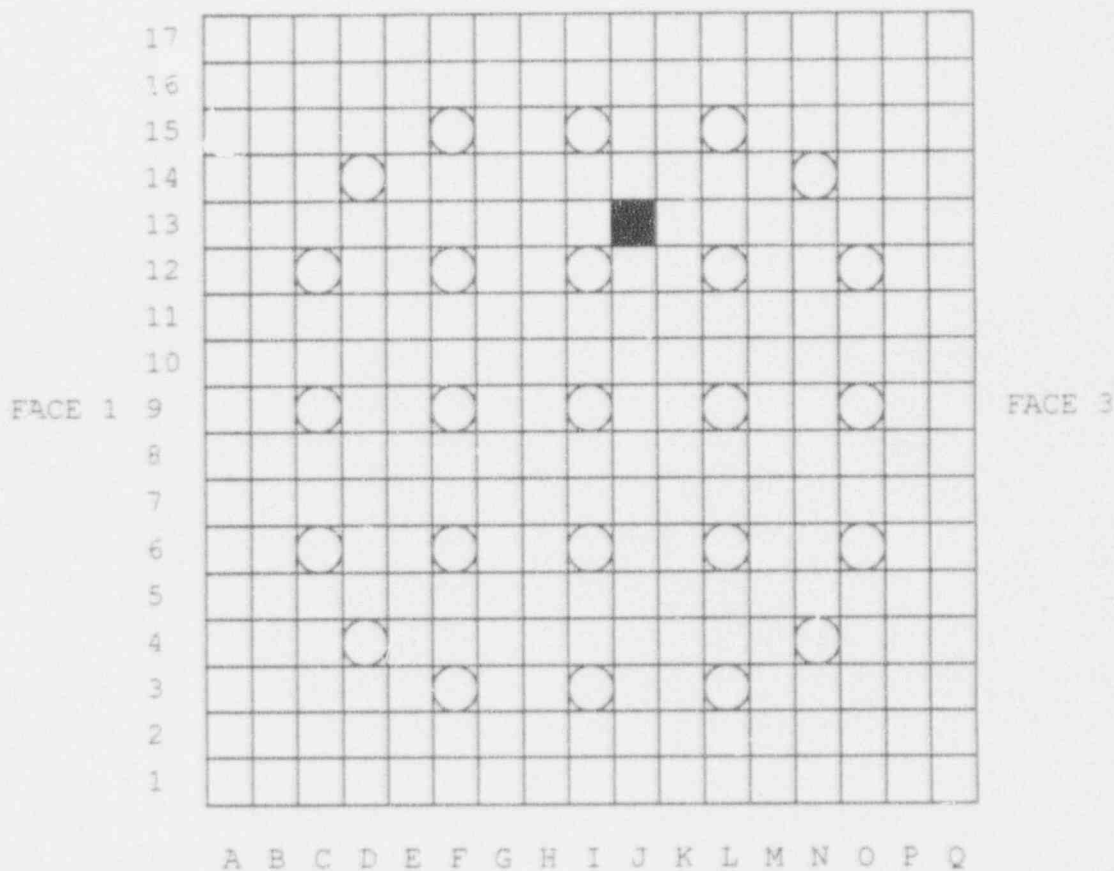
FIGURE 2
FUEL ASSEMBLY F43

On March 14, 1993, fuel assembly F43 was ultrasonically examined. The results of the examination indicated one failed fuel rod. The location of the failed fuel rod within the assembly is position J13 (Reference Figure 2 for location of the F43 defective fuel rod). This is an interior rod; therefore, no visual inspection was possible.

DEFECTIVE ROD POSITION J13

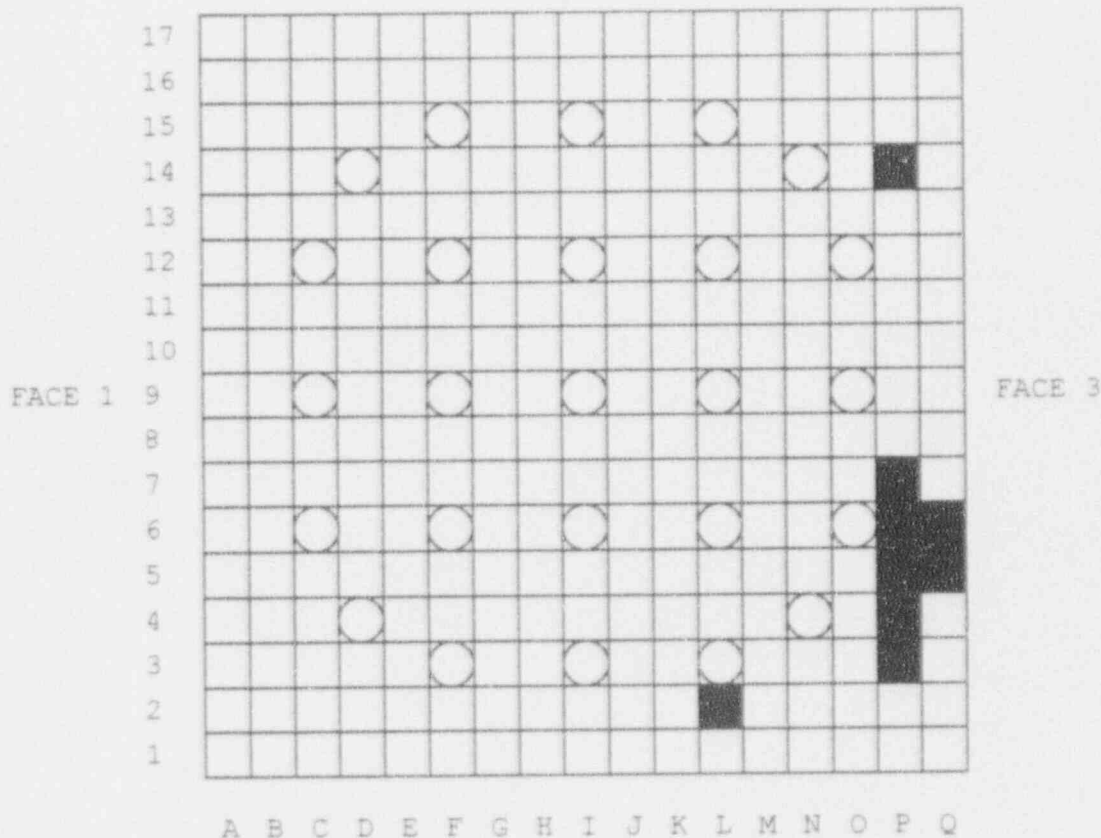
FIGURE 3
FUEL ASSEMBLY F54

On March 14, 1993, fuel assembly F54 was ultrasonically examined. The results of this examination indicated nine failed fuel rods (Reference Figure 3 for location of the F54 defective fuel rods). These rods could be divided into three groups. The largest group contains seven rods on Face 3. Two rods (at positions Q5, Q6) are located on the fuel assembly periphery and five rods (at positions P3, P4, P5, P6, P7) are located on the second row behind the other two rods. The second and third groups contain a single rod each on the second and fourteenth rows respectively. Rod P14 is near Face 3 and rod L2 is near Face 4. From the visual inspections, there was extensive evidence that the cladding on these fuel rods had failed. Hydride blisters were present in the middle spans and rod Q5 was noticeably loose in the bottom grid.

DEFECTIVE ROD POSITION L2, P3, P4
P5, P6, P7, P14, Q5, and Q6

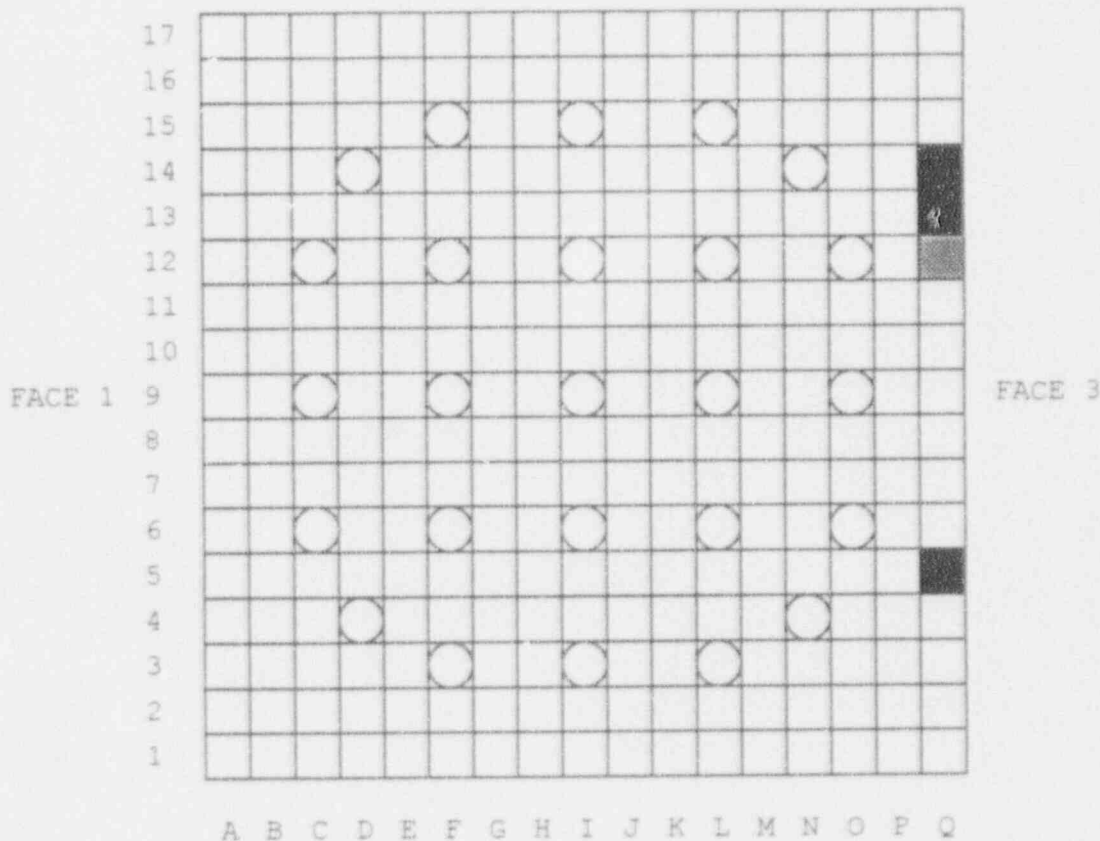
FIGURE 4
FUEL ASSEMBLY F67

On March 17, 1993, fuel assembly F67, which contained the broken fuel rod, was removed from the reactor core and ultrasonically examined. The results of this examination determined that there were four failed rods (Reference Figure 4 for location of the F67 defective fuel rods). These rods were located on Face 3 in positions Q5, Q12 (broken fuel rod), Q13, and Q14. A full length visual inspection of Face 3 was conducted. The

review of that inspection confirmed the identified rod failures. Hydride blisters were found on all of the failed fuel rods. Furthermore, rod Q12 had approximately 11-12 inches of the rod missing above grid 5 and rod Q13 was fractured below grid 6. Rods Q5 and Q14 were observed to be loose in grid 1.

- DEFECTIVE ROD POSITION Q5, Q13, and Q14
- BROKEN FUEL ROD Q12
- GUIDE TUBE
