Subject: Quad Cities Nuclear Power Station Unit 2  
Request for NRC Approval of a Non-Code Repair  
for a Recirculation System Pipe Flaw  
NRC Docket No. 50-265

## **QUAD CITIES STATION RECIRCULATION SYSTEM PIPE FLAW PROPOSED REPAIR METHOD**

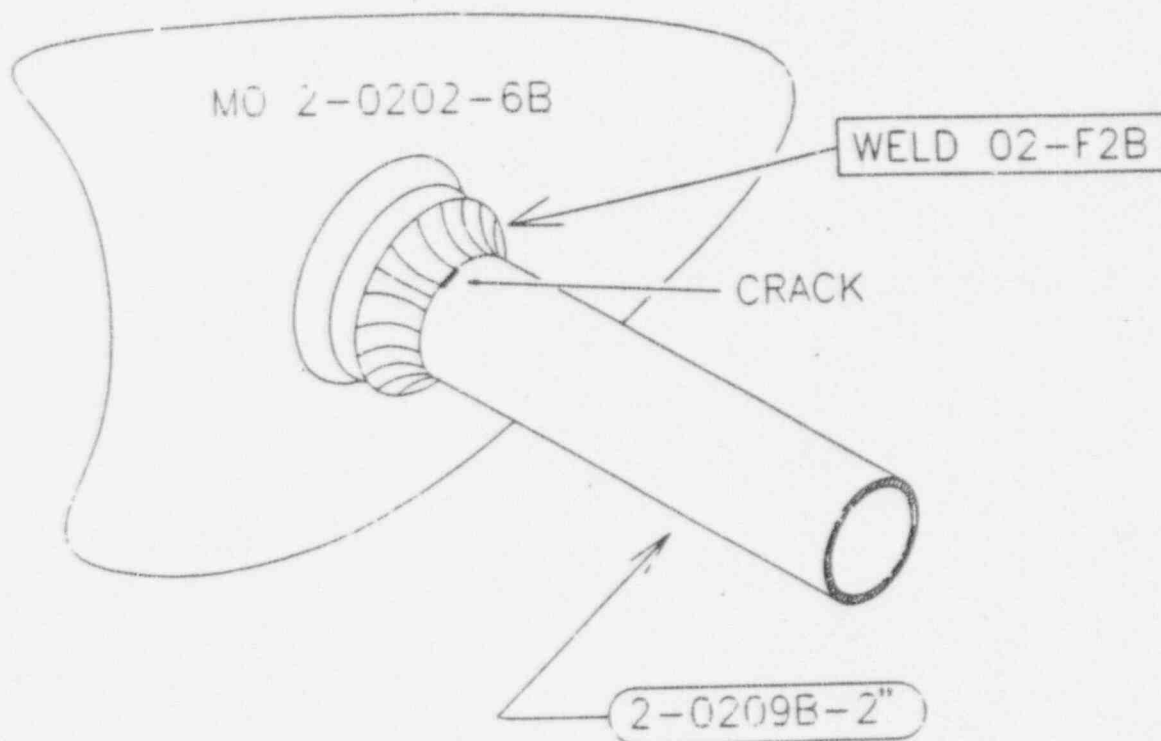
FIGURE 1

Weld 02-F2B is a fillet weld joining line 2-0209B-2" (2" NPS schedule 80 [0.218" thick]) to valve body MO 2-0202-6B (22" NPS) in a socket-type weldment (See Figure 1). Line 2-0209B-2" provides bypass circulation around valve MO 2-0202-6B. This line and valve are made from ASTM A-312, Type 304 and A-351, Grade CF8M stainless steels, respectively.

During the Quad Cities Unit 2 1993 outage (Q2R12), health physics surveys performed near this weld detected high levels of beta radiation usually associated with primary piping system leakage. Further investigation lead to a liquid penetrant examination of this weld and the discovery of a 3/32" to 5/32" long through-wall flaw as shown in Figure 2. This flaw is difficult to observe visually, but is slowly weeping under hydrostatic conditions.

Weld O2-F2B

Pipe/Valve Configuration and Flaw Location

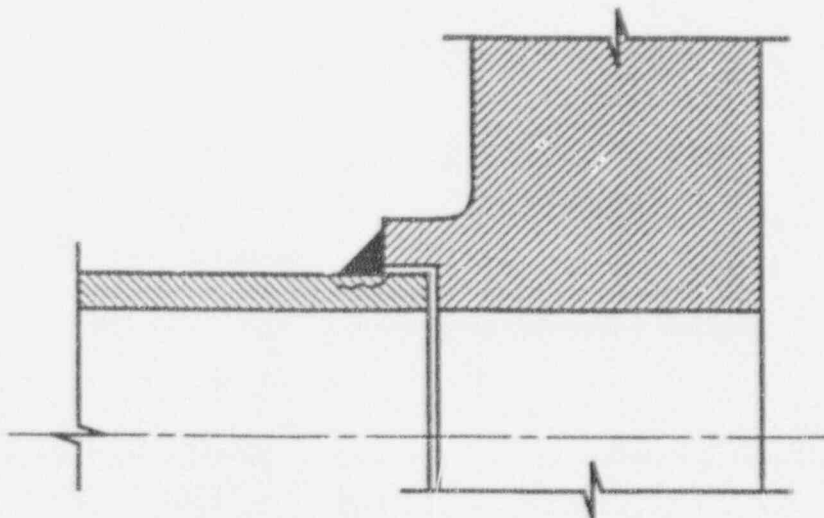
FIGURE 2

As shown in Figure 2, a crevice also exists in weld 02-F2B. It was believed that this crevice could be the initiation site for a defect starting at the heel of the fillet weld and propagating by means of IGSCC through the HAZ under the fillet weld due to the residual stress condition.

Based upon the UT results which did not detect any reflectors in the pipe wall under the fillet weld, the flaw appears to propagate in the direction parallel to the pipe surface/pipe axis, along the fillet weld to the pipe fusion zone.

Given the UT results, and the previous experiences with cracked socket joints, CECo believes that the most likely cause of the flaw initiation is a weld defect, propagated by service induced stresses.

Weld O2-F2B

Crevice and Flaw Configuration
