## LICENSEE EVENT REPORT (LER)

Waterford Steam Electric Station Unit 3

Rx Trip Caused by Age-Related Loss of Inverter and Protection System Power Supply

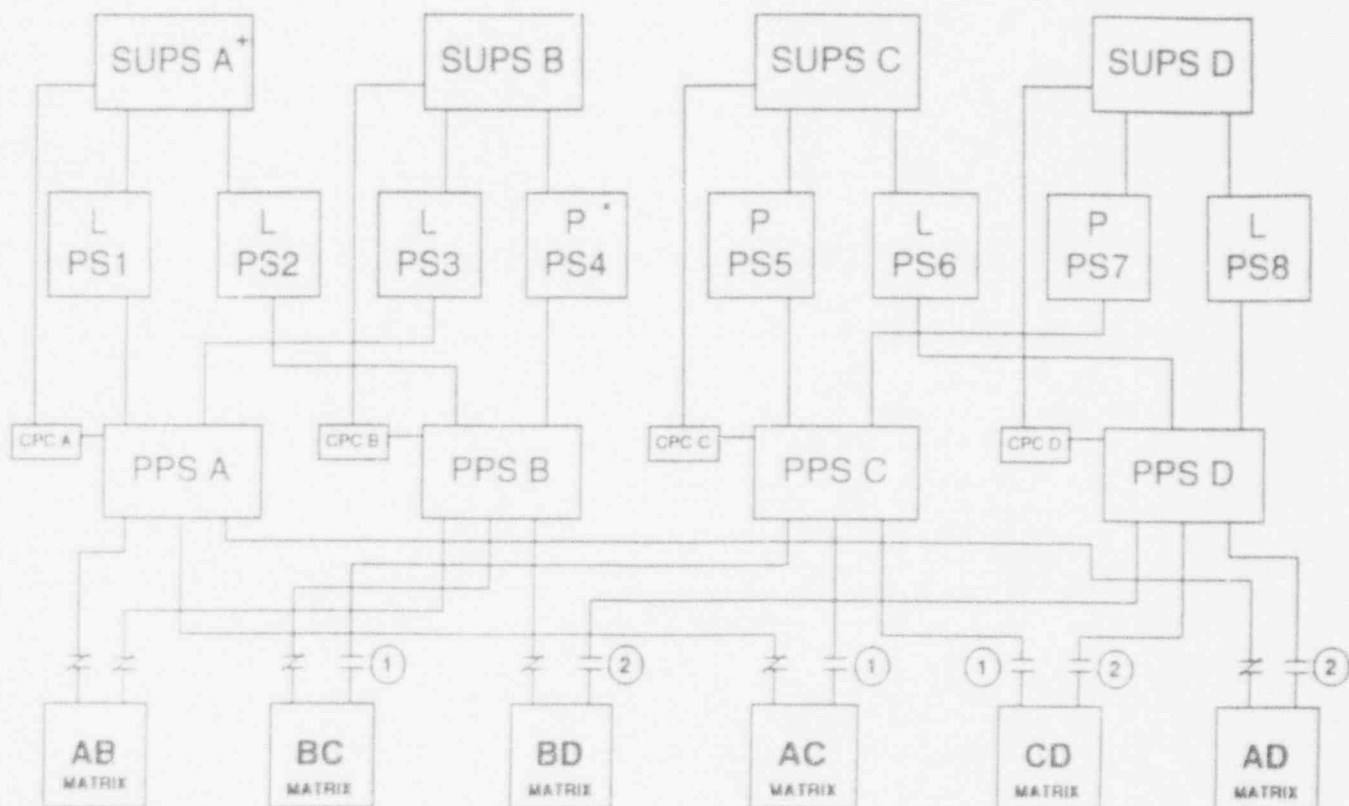
Plant Protection System Electrical Schematic

On March 4, 1993 at 2045, Waterford 3 was operating in Mode 1 at 100% power when a frequency detection card failed in SUPS 'C' causing the SUPS to trip. The loss of SUPS 'C' removed power from the associated Core Protection Calculator (CPC 'C') and caused it to trip as expected on loss of input power. One CPC is provided for each of the four PPS channels to calculate the departure from nucleate boiling ratio (DNBR) and the local power density (LPD); when either of these parameters exceeds a preset value, a low DNBR or high LPD trip signal is provided to the PPS. As expected, the loss of CPC 'C' resulted in low DNBR and high LPD trips on PPS channel 'C.' With PPS channel 'C' in a tripped condition, a "half trip" was generated in the three (of six total) PPS logic matrices associated with channel 'C.'

The loss of SUPS 'C' also deenergized the two associated PPS power supplies, PS5 and PS6. The loss of PS5, which supplies the PPS logic unit in channel 'C,' did not affect the event because the logic unit was still energized via SUPS 'D' and PS7. The loss of PS6, on the other hand, removed one source of the auctioneered electrical power supplied to the PPS channel 'D' logic unit. In itself, this should not have been a problem because PS8, supplied from SUPS 'D,' should have continued to supply the channel 'D' logic unit.

However, during the electrical transient that followed the loss of SUPS 'C,' the supply breaker for PS8 appeared to trip open on overcurrent and deenergized the PPS channel 'D' logic unit. As expected, this generated a half trip on the three logic matrices associated with channel 'D.'

The simultaneous half trips on PPS channels 'C' and 'D' satisfied the necessary coincidence logic for the 'CD' matrix and resulted in a reactor trip on low DNBR and high LPD.
