MONTICELLO NUCLEAR GENERATING PLANT
Docket No. 50-263 License No. DPR-22

Reactor Protection System Actuation
From High Pressure Caused By Inadequate Procedure

LICENSEE EVENT REPORT (LER)

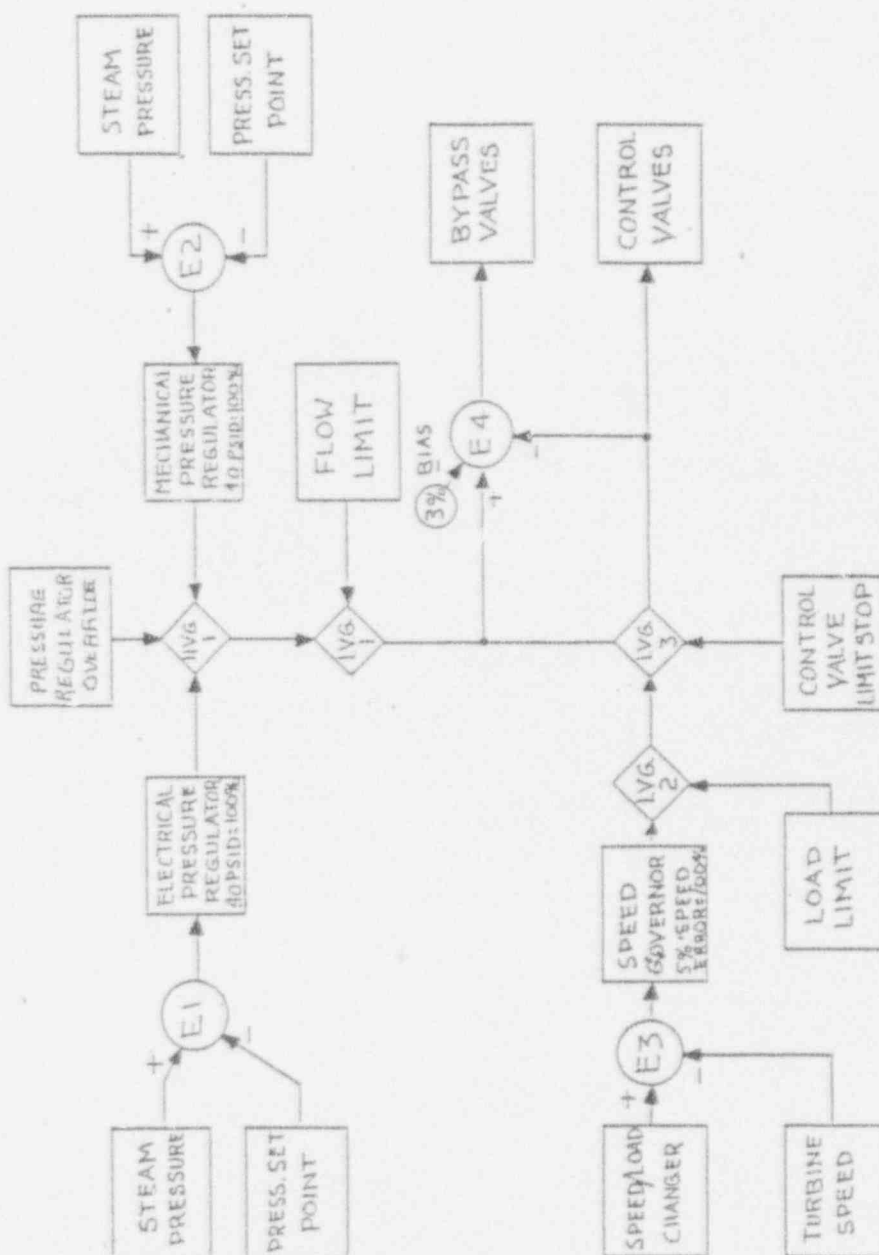
FIGURE 1

To understand the following explanation, refer to the attached Figure 1, Main Steam Pressure Control Functional Control Diagram. Stop Valve closure terminated steam flow to the turbine. This initiated a slow increase in reactor pressure and allowed the turbine to decelerate. The increase in reactor pressure resulted in a slowly increasing output from the Mechanical Pressure Regulator. The decrease in turbine speed resulted in an increasing

output from the Speed Governor. Initially, the output of low value gate 3 (LVG3 on Figure 1) was limited by the speed governor signal. The difference between the pressure signal and the output of LVG3, minus a bias of 3%, (output of E4) controlled the opening of the bypass valves. Since the output of LVG3 was increasing at about the same rate as the pressure signal, the bypass valves did not respond to the initial slow pressure increase. When the pressure signal reached the setting of the Flow Limit, the pressure signal applied to E4 was held at the limited value (100%). As the speed signal to LVG3 continued to increase, the difference signal (output of E4) decreased, and the bypass valves began to close. This caused a faster pressure increase.

The cause of the event was an inadequate procedure. The procedure was revised on March 3, 1993. During the revision process a step to place the Load Limit to 25% to limit the speed governor signal was deleted. The revised procedure was validated on the plant simulator, but subsequent investigation has determined that the simulator did not model the control system correctly. A contributing factor was inadequate knowledge by the Licensed Operators and system engineer involved in the procedure revision and incorrect simulator modeling.

1. The Turbine Stop and Control Valve Tightness Test procedure has been revised.
2. The plant simulator was revised to properly model operation of the Steam Pressure Control System.
3. The failed scram pilot solenoid valve was replaced and all installed scram pilot solenoid valves were cycled and verified to function properly.
4. All remaining solenoids of this type in stock were inspected and no other problems were found.
