LICENSEE EVENT REPORT (LER)

FACILITY NAME (1) PRAIRIE ISLAND NUCLEAR GENERATING PLANT UNIT 1						DOCKET NUMBER (2) 05000 282			PAGE (3) 1 OF 5					
TITLE (4) Auto-Start of No. 121 Cooling Water Pump on Low Header Pressure While Aligned for Safeguards Operation														
EVENT DATE (5)			LER NUMBER (6)			REPORT NUMBER (7)			OTHER FACILITIES INVOLVED (8)					
MONTH	DAY	YEAR	YEAR	SEQUENTIAL NUMBER	REVISION NUMBER	MONTH	DAY	YEAR	FACILITY NAME	DOCKET NUMBER				
03	25	93	93	006	00	04	26	93	Prairie Island Unit 2	05000 306				
									FACILITY NAME	DOCKET NUMBER				
										05000				
OPERATING MODE (9)		THIS REPORT IS SUBMITTED PURSUANT TO THE REQUIREMENTS OF 10 CFR §: (Check one or more) (11)												
N		20.402(b)			20.405(c)			50.73(a)(2)(iv)			73.71(b)			
POWER LEVEL (10)		20.405(a)(1)(i)			50.36(c)(1)			50.73(a)(2)(v)			73.71(c)			
100		20.405(a)(1)(ii)			50.36(c)(2)			50.73(a)(2)(vi)			<input checked="" type="checkbox"/> OTHER

FACILITY NAME (1)	DOCKET NUMBER (2)	LER NUMBER (6)			PAGE (3)
Prairie Island Nuc Generating Plt Unit 1	05000 282	YEAR	SEQUENTIAL NUMBER	REVISION NUMBER	2 OF 5
		93	- 006 -	00

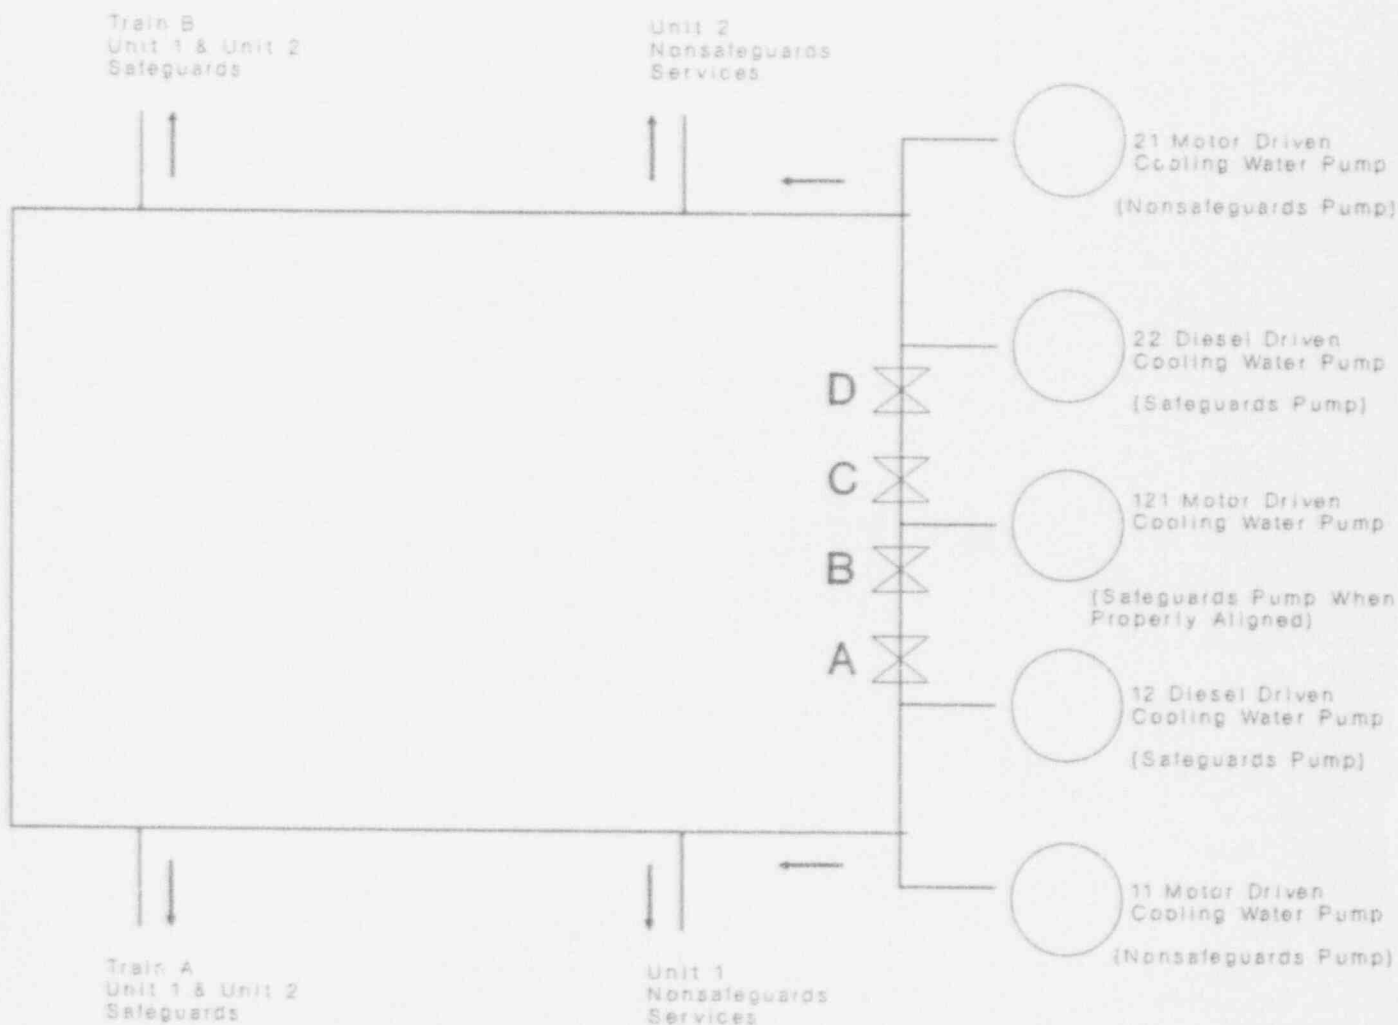
FIGURE ONE

See Figure One, attached.

The Work Request was sent to the control room, and on March 25, 1993, No. 121 Pump was aligned for safeguards operation and No. 22 Pump was logged out of service. The safeguards alignment of No. 121 Pump calls for cooling water header valves A and B to be closed. Nos. 11 and 21 Motor-driven Cooling Water Pumps were operating at the time.

when No. 22 Pump was stopped, the loss of flow caused a low pressure spike on the cooling water header and an unplanned auto-start of No. 121 Pump. The control room operators observed the auto-start on the annunciator board and on the process computer.

During the pump test, the operator did not open the A and B header valves. If those valves had been opened before No. 22 Pump was stopped, No. 11 Motor-driven Cooling Water Pump would have supplied enough flow to maintain adequate cooling water header pressure to prevent the auto-start of No. 121 Pump. Instructions in the procedure were not clear regarding disposition of the header valves.

The surveillance procedures for testing diesel-driven cooling water pumps will be revised to clarify the instructions for disposition of the header valves.
