Re: Docket No. 50-275, OL-DPR-80
Docket No. 50-323, OL-DPR-82
Diablo Canyon Units 1 and 2
Licensee Event Report 1-93-005-00
Medium Voltage Cable Failures

LICENSEE EVENT REPORT (LER)

FACILITY NAME (1) DIABLO CANYON UNIT 1										DOCKET NUMBER (2) 0 5 0 0 0 2 7 5					PAGE (3) 1 OF 14		
TITLE (4) MEDIUM VOLTAGE CABLE FAILURES																	
EVENT DATE (5)			LER NUMBER (6)				REPORT DATE (7)			OTHER FACILITIES INVOLVED (8)							
MON	DAY	YR	YR	SEQUENTIAL NUMBER		REVISION NUMBER		MON	DAY	YR	FACILITY NAMES				DOCKET NUMBER (8)		
											DIABLO CANYON UNIT 2				0 5 0 0 0 3 2 3		
10	29	89	93	-	0 0 5	-	0 0	04	23	93					0 5 0 0 0		
OPERATING MODE (9) 1			THIS REPORT IS SUBMITTED PURSUANT TO THE REQUIREMENTS OF 10 CFR: (11)														
POWER LEVEL (10) 1 0 0			<input checked="" type="checkbox"/> 10 CFR <u>VOLUNTARY</u> <input type="checkbox"/> OTHER _____ (Specify in Abstract below and in text, NRC Form 366A)														
LICENSEE CONTACT FOR THIS LER (12)																	
DAVID P. SISK, SENIOR REGULATORY COMPLIANCE ENGINEER										TELEPHONE NUMBER AREA CODE 805 545-4420

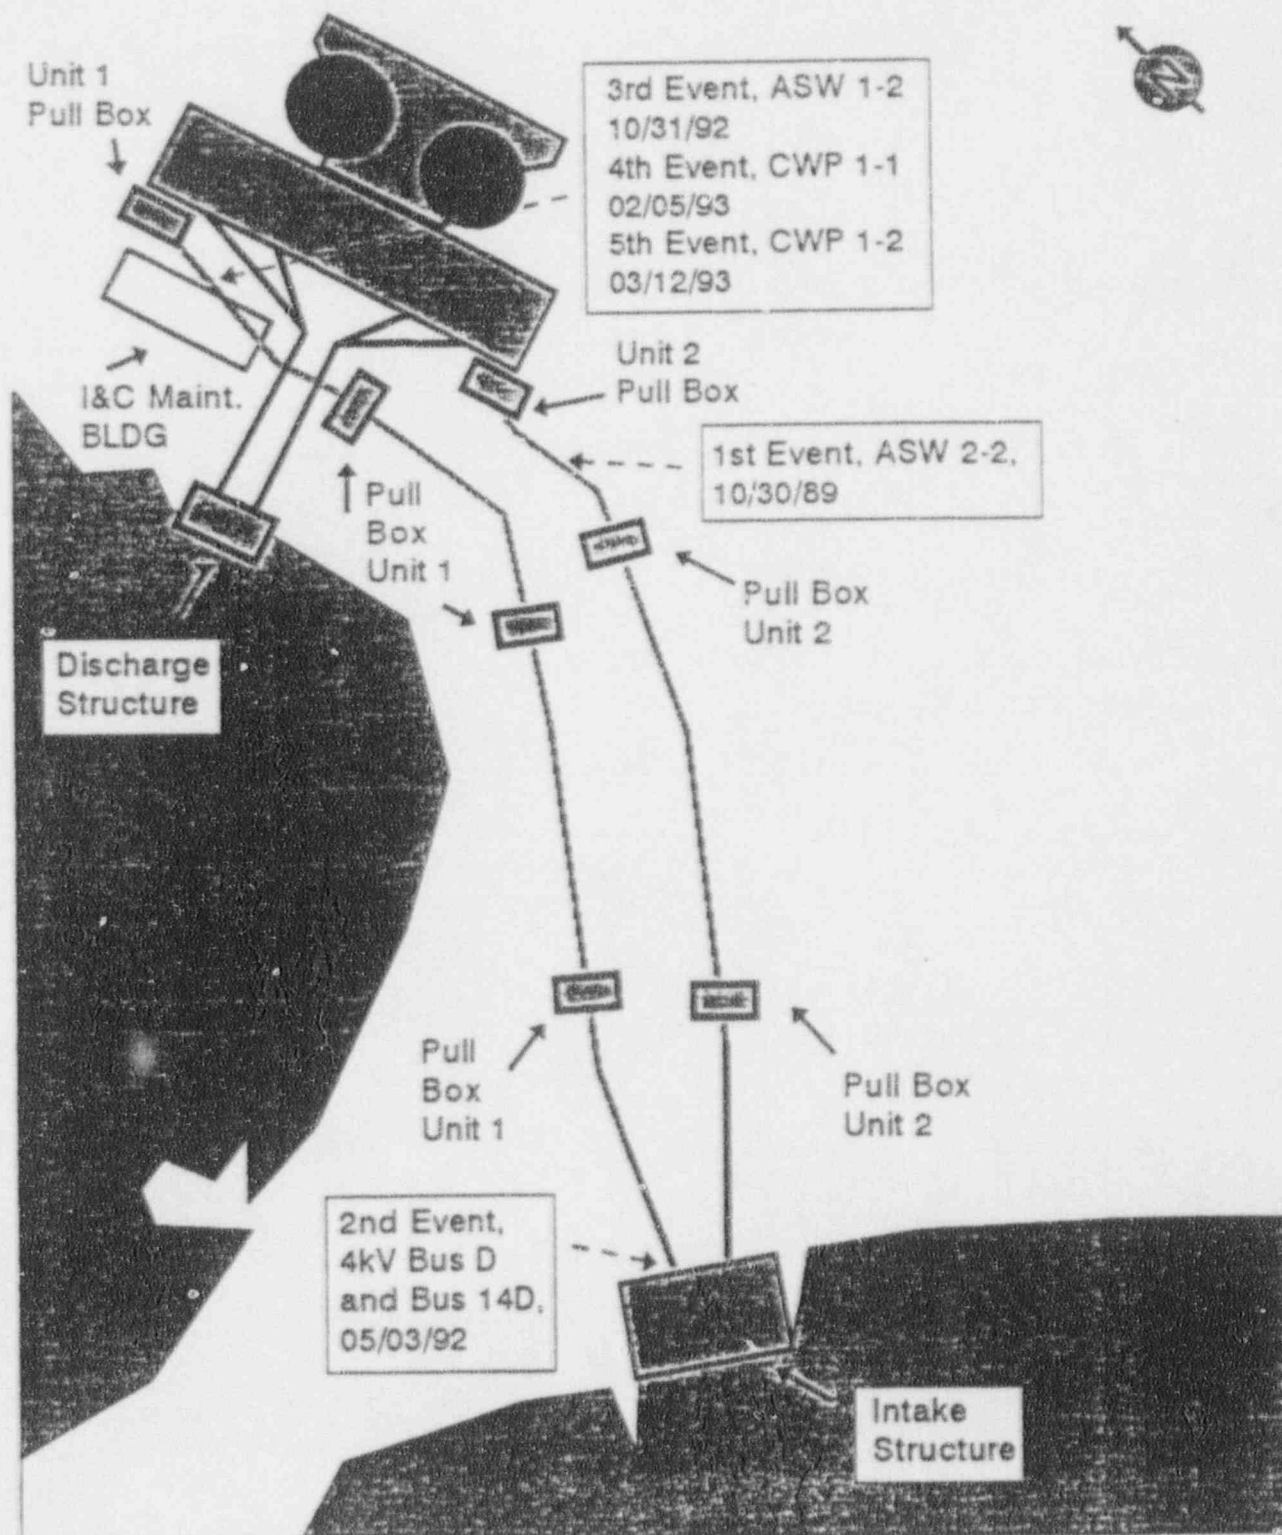
Figure 1: Site Overview of Conduit Trench for Units 1 & 2

The subject cables are routed in two separate sets of duct bank conduits, one for each unit, between the turbine building and the intake structure. Concrete vaults are located at various intervals to serve as pull boxes for the circuits. These duct bank conduits are directly buried in sand and are covered for their entire length by a six-inch thick concrete cap. The duct bank conduits include 12kV, 4kV, and 480V (CBL4) power cables, 120V ac control cables (EF)(CBL3), 125V dc control cables (EJ)(CBL3), and instrument cables (EF)(CBL1).

The Unit 1 and Unit 2 trenches are similar, except that the Unit 1 duct bank rises to cross over the circulating water discharge tunnel and then slopes downhill towards the intake structure. This design makes the Unit 1 section of cable conduits near the turbine building susceptible to submergence if the pull box sump pumps are not functional and if the water within the pull boxes rises above the conduit openings.

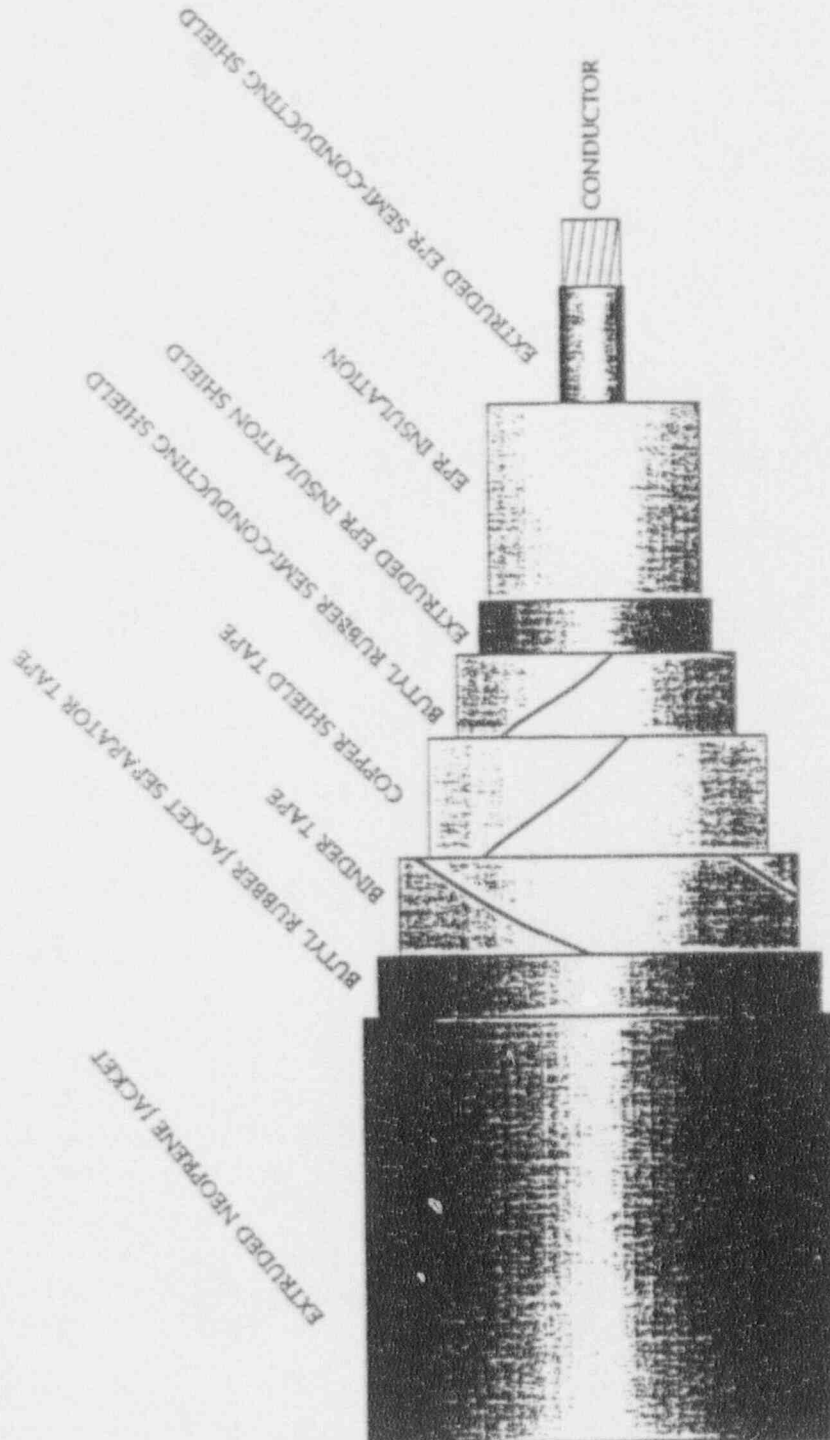
FIGURE 2 : DESIGN OF 4KV AND 12KV OKONITE CABLES

The cable construction is similar for both the 4kV and 12kV cables. The cables are a shielded single-conductor cable design and are constructed in concentric layers (see Figure 2). There are four cable layers of interest for this LER: (1) the insulation (EA)(CBL)(INS) layer, which is approximately 115 mils of black EPR for the 4kV cables and approximately 220 mils of black EPR for the 12kV cables; (2) the tinned copper shield tape, which acts to equalize the electrical stress; (3) the wax coated synthetic binder tape, which holds the copper shield against the cable, thereby allowing the outer jacket to be extruded over the cable during manufacture; and (4) the outside layer, which is a neoprene jacket. The function of the outer neoprene jacket is to protect the cable during installation (impact and abrasion resistance) and to act as a physical barrier between the

outside environment and the shield once the cable is installed. The cable jackets are not bonded to the cable shield or insulation layers.
