CHEMICAL TREATMENT SYSTEM EVALUATION FOR THE
SALT WATER COOLING SYSTEM
AT CALVERT CLIFFS NUCLEAR POWER PLANT
(XX-dddd)

Final Report, March 31, 1993

Betz Laboratories
1 Quality Way
Trevose, Pa 19053

Electric Power Research Institute
3412 Hillview Avenue
Palo Alto, California 94304

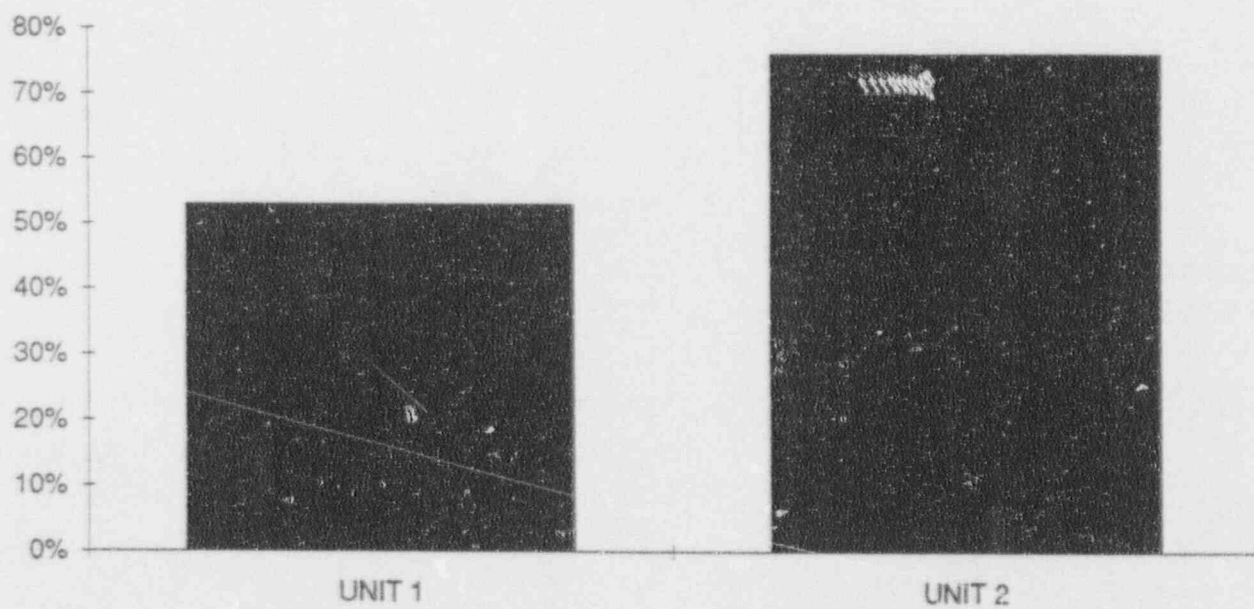
FIGURE 4-1

One important parameter that underlies the basic results of this test program is difference in frequency of treatment between the heat exchangers in Unit 1 and Unit 2. The number of treatments applied during the course of the study are contained in Figure 4-1. The differences in treatment effectiveness between the heat exchangers is largely attributable to the greater number of applied treatments in the Unit 2 heat exchanger versus the Unit 1 heat exchanger. Following is a discussion of the results obtained.

PERCENTAGE OF TREATMENT DURING TEST PERIOD
UNIT 1 VS UNIT 2

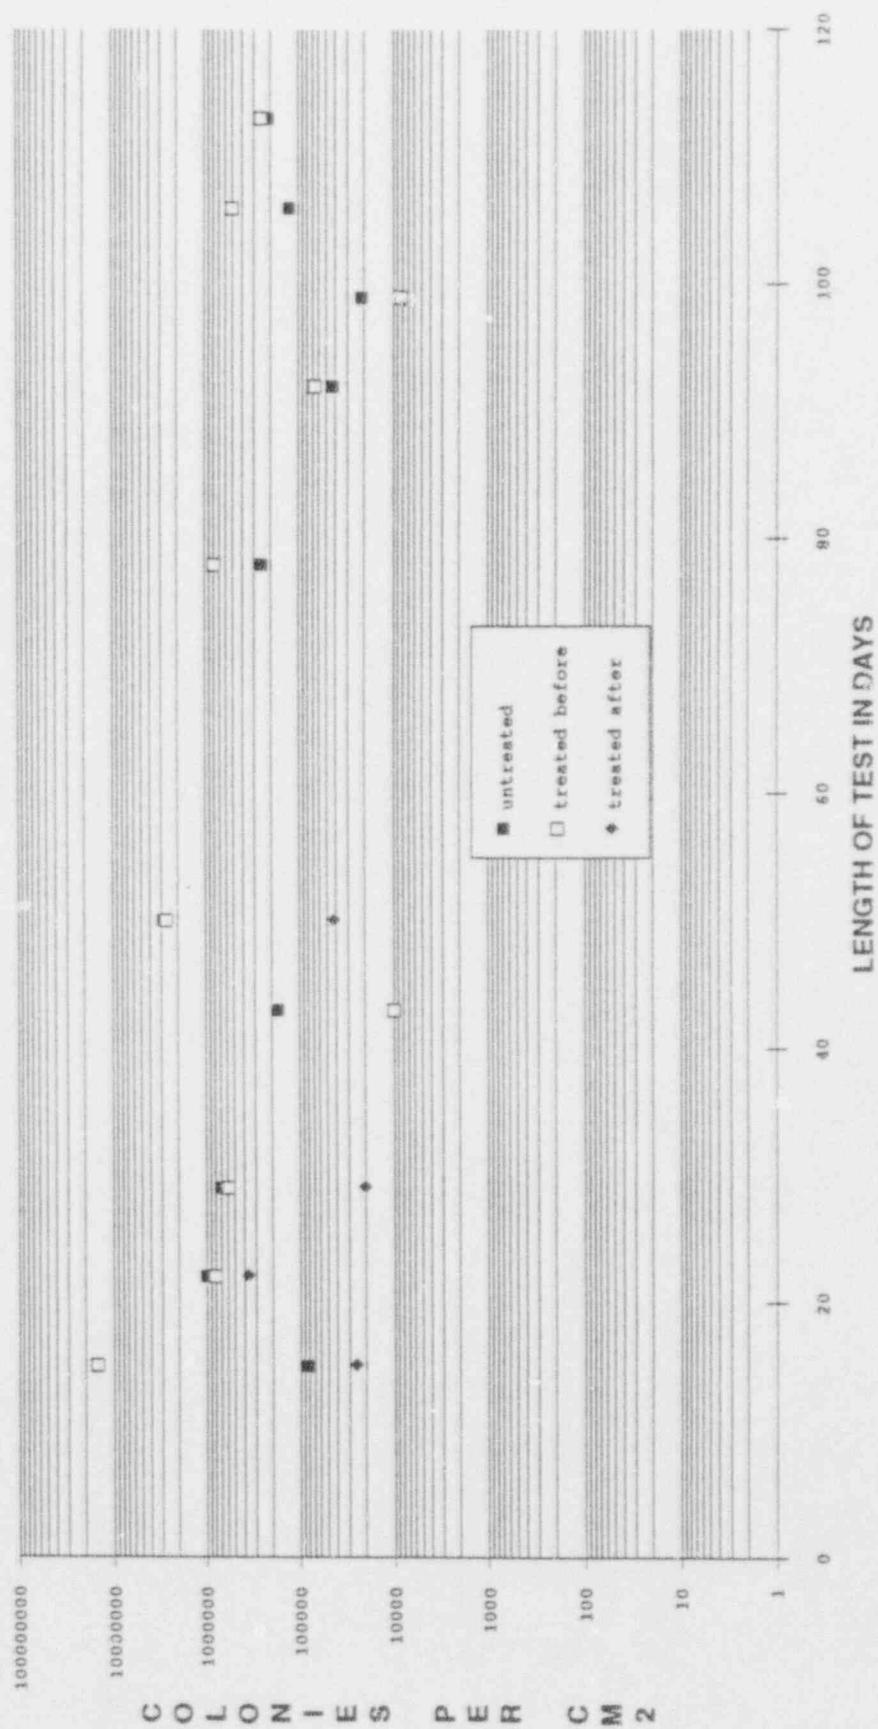
FIGURE 4-2

Comparisons of the treated and untreated heat exchangers are shown in Figures 4-2 thru 4-5. Both aerobic and anaerobic (sulfate reducing) bacteria are compared. During the course of the study, screen coupons were removed at alternate intervals to ascertain the concentration of sessile organisms in the two systems. The initial weeks of the study focused on the immediate impact of the treatment on MB levels. Therefore, two coupons were removed each week in the treated systems to determine the before and after bacterial levels. These are designated "treated before" and "treated after" in the legend of Figures 4-2 thru 4-5.

UNIT 1 AEROBIC BACTERIA LEVELS IN TREATED AND UNTREATED SYSTEMS

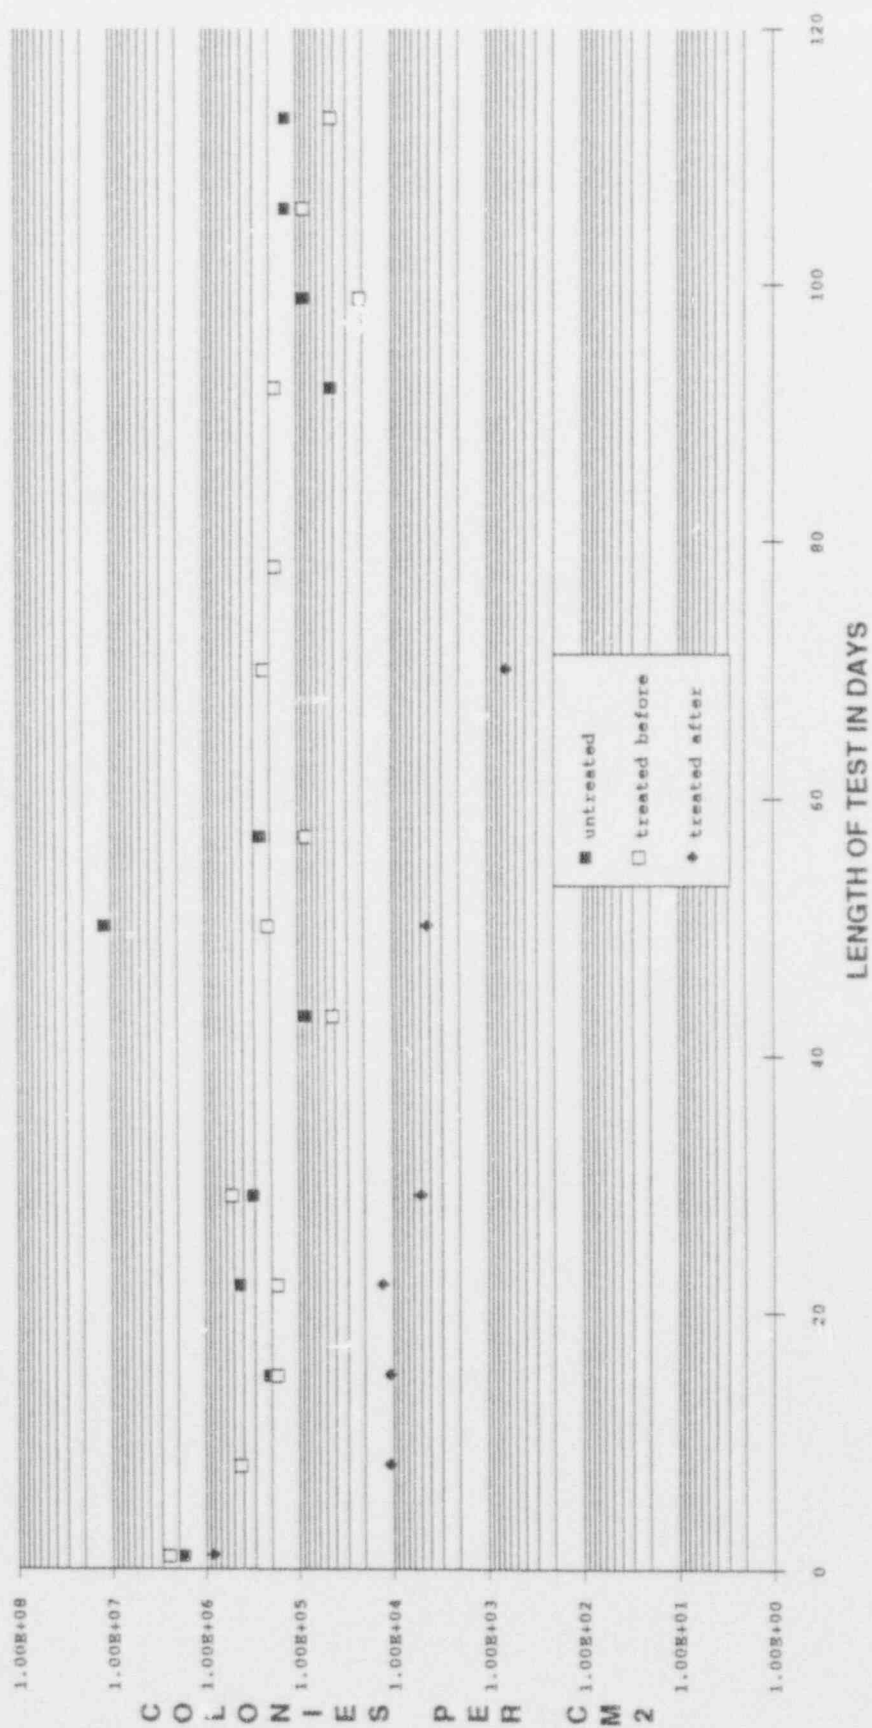
FIGURE 4-3

did exist, but the spread in the data narrowed from roughly a two order magnitude difference, to somewhat less than one order of magnitude for aerobic bacteria in Unit 2, but still remained two orders of magnitude lower with respect to sulfate reducing bacteria. In the case of Unit 1, the longer term trends are inconsistent, largely due to the inconsistent chemical application schedule.

UNIT 2 AEROBIC BACTERIA LEVELS IN TREATED AND UNTREATED SYSTEMS

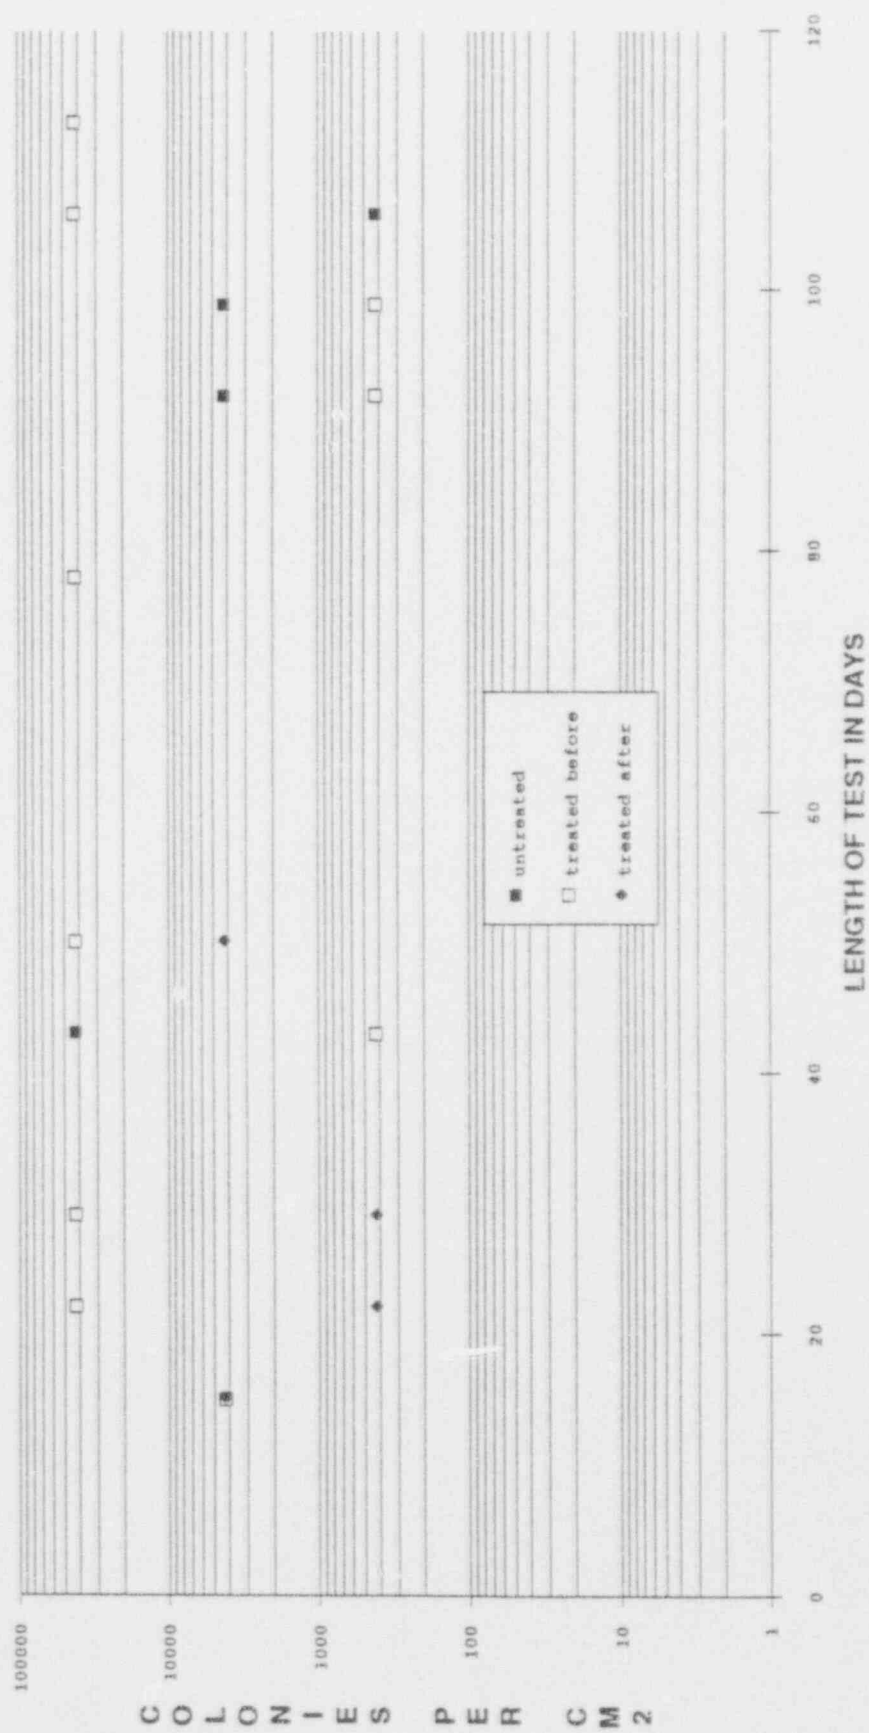
FIGURE 4-4

UNIT 1 SULFATE BACTERIA LEVELS IN TREATED AND UNTREATED SYSTEMS

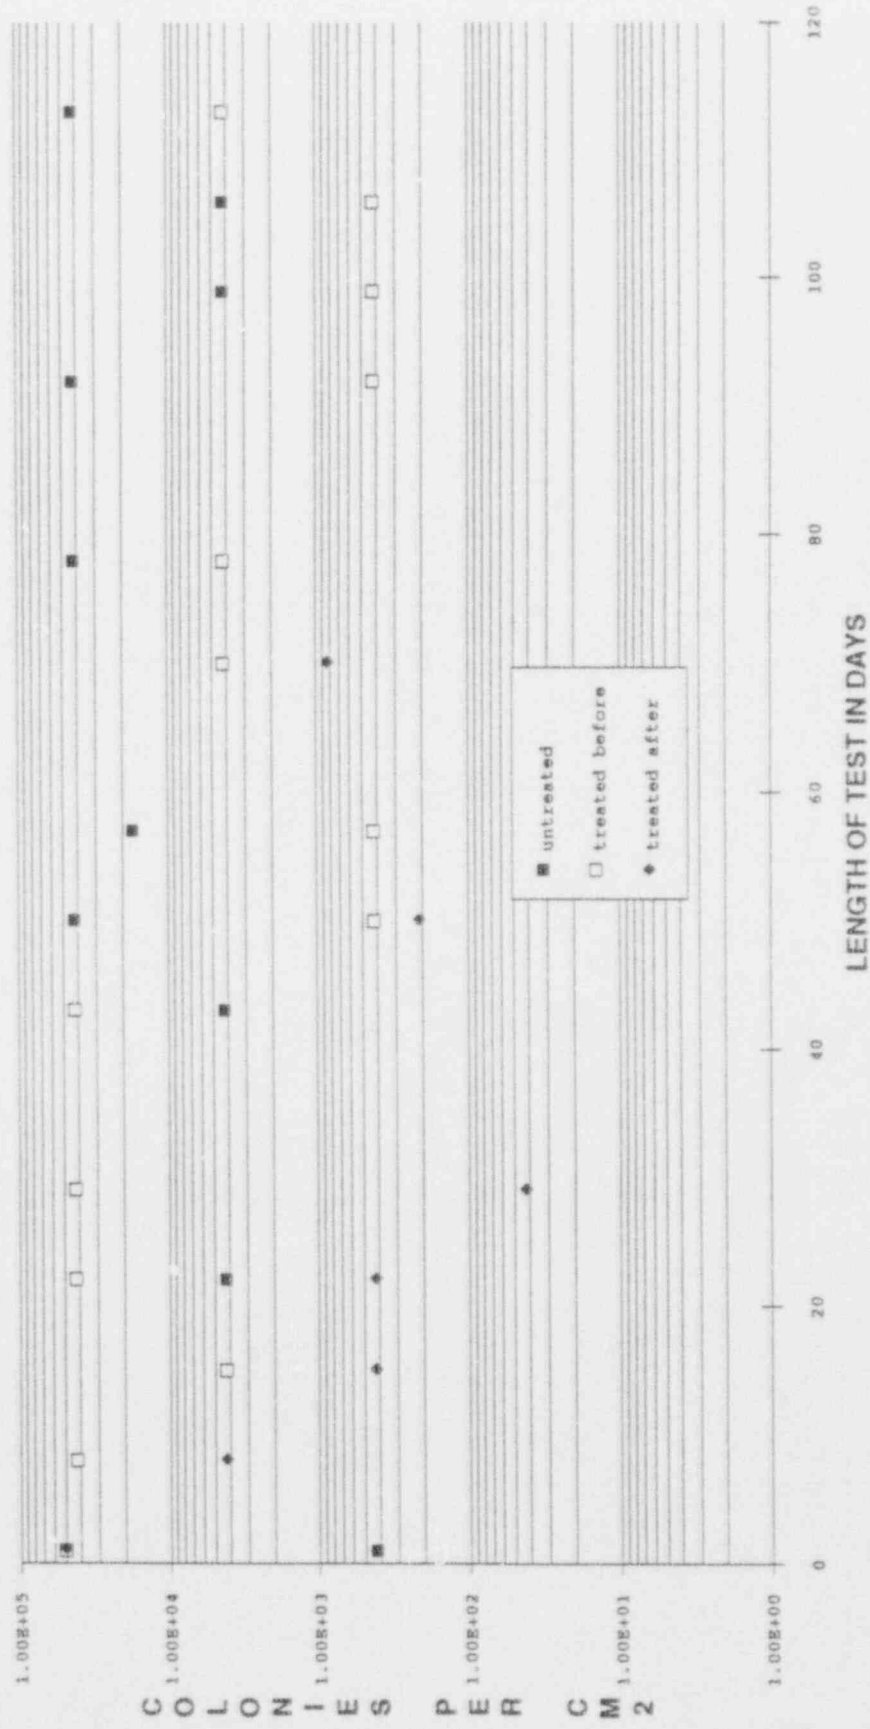
FIGURE 4-5

UNIT 2 SULFATE BACTERIA LEVELS IN TREATED AND UNTREATED SYSTEMS

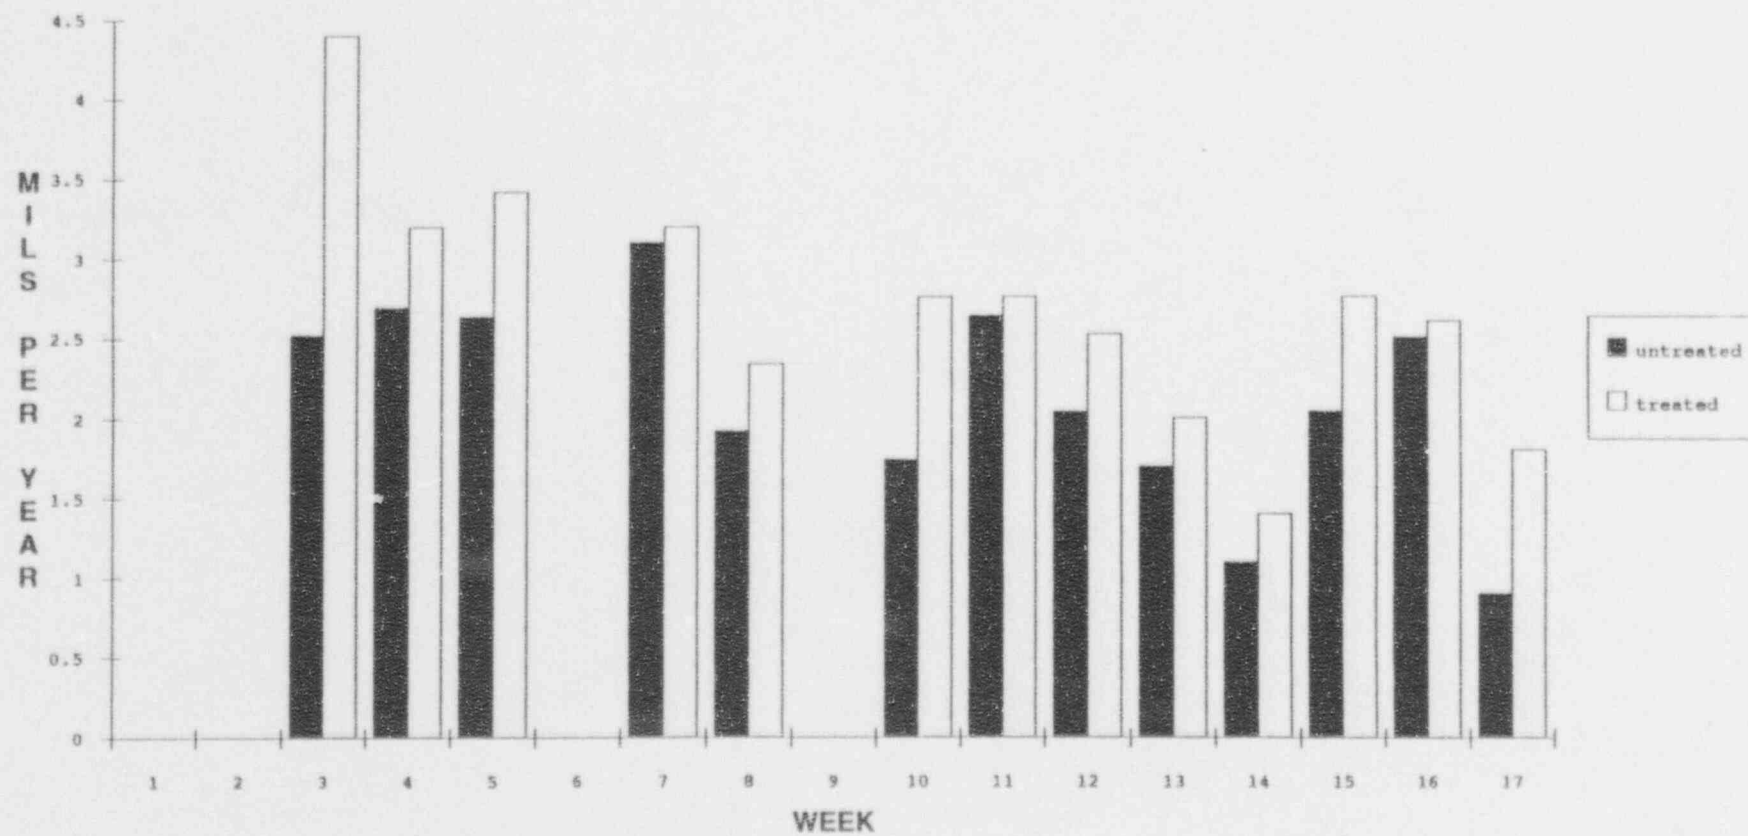
FIGURE 4-6

Results from the instantaneous probes with 90/10 copper nickel metallurgy are displayed in Figures 4-6 thru 4-13. Readings were obtained both before and during the treatment. With the exception of the last few weeks of the Unit 1 test, and week 7 of Unit 1, the imbalance readings were less than the general corrosion readings, indicating that pitting was not active. With respect to general corrosion comparisons of the treated and untreated headers revealed a slightly higher initial rate for the treated systems, averaging approximately 1.0 to 2.0 mils per year higher on the copper/nickel in these systems. This phenomenon was also seen on the coupons removed after the test and shown in Figures 4-14 and 4-15.

A disadvantage of simply analyzing corrosion coupons is that they provide a time-averaged corrosion rate. Additional insight is provided from the instantaneous general corrosion readings in Figures 4-6 and 4-10. These figures indicate that the highest absolute corrosion rates and highest rate differences between the treated and untreated systems occurred during the initial weeks of the test. In later weeks, the differences between system corrosion rates became progressively smaller, and were essentially consistent beginning in approximately Week 7 of the program in Unit 2. This data suggests that the largest portion of the corrosion occurred during the initial weeks of the study, and slowly reduced over time. This conclusion is consistent with laboratory and field studies that demonstrate higher initial corrosion rates occur on new, clean metal surfaces until the surface is passivated by a corrosion product film.

UNIT 1 GENERAL CORROSION RATES FOR COPPER/NICKEL (TREATED VS. UNTREATED)

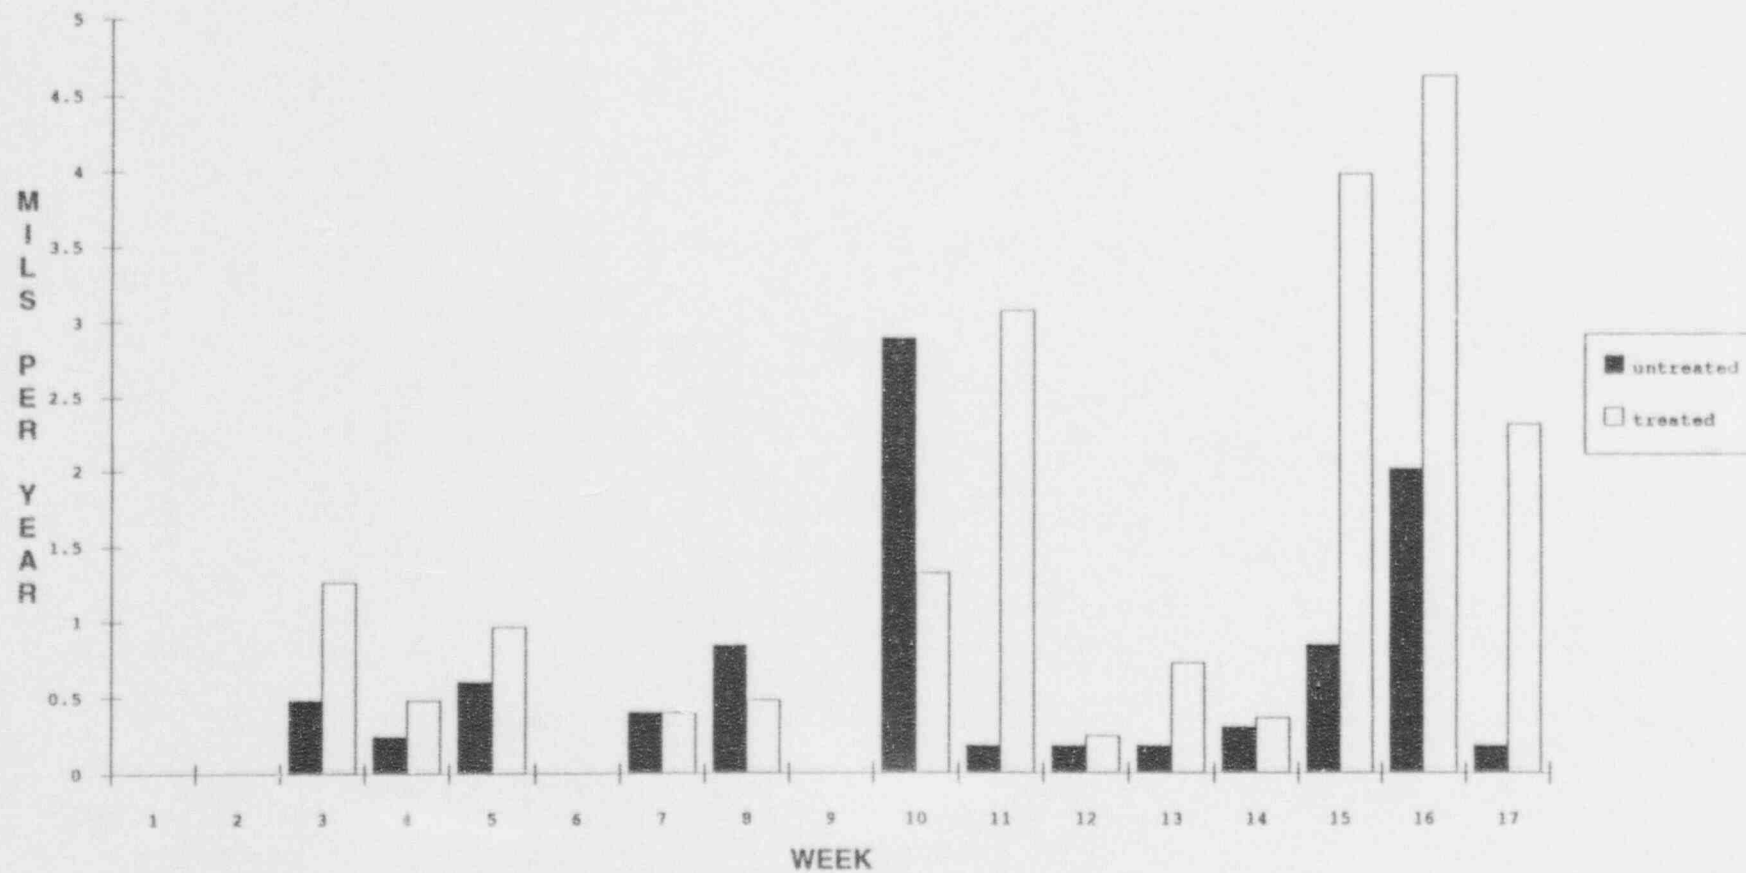
FIGURE 4-7

UNIT 1 IMBALANCE READINGS FOR COPPER/NICKEL (TREATED VS. UNTREATED)

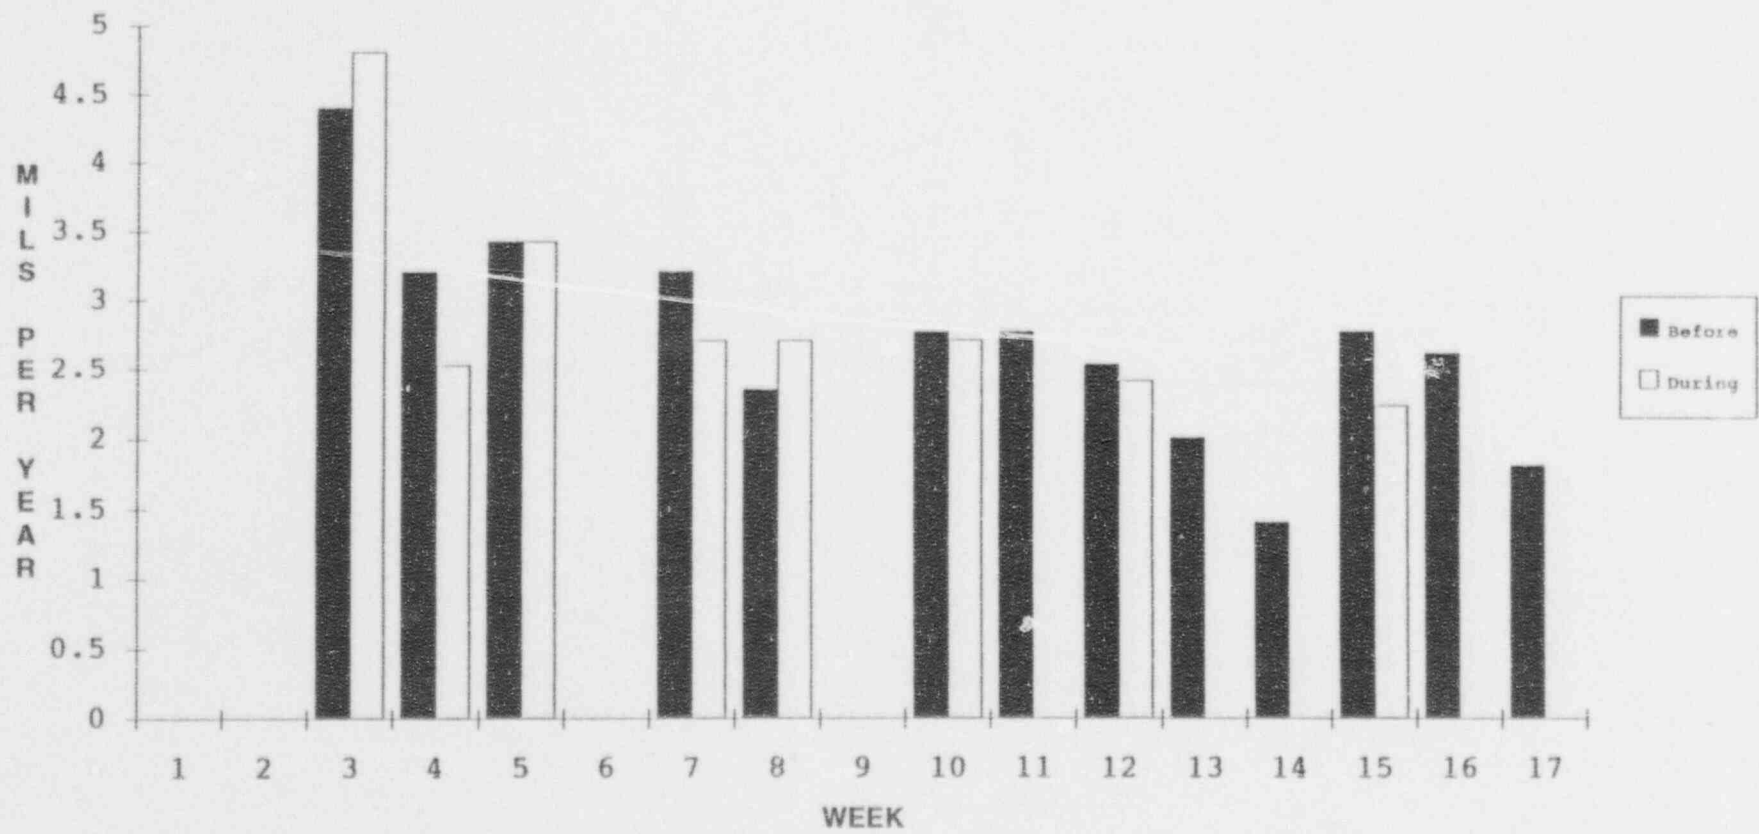
FIGURE 4-8

UNIT 1 GENERAL/COPPER NICKEL CORROSION RATES BEFORE AND DURING TREATMENT

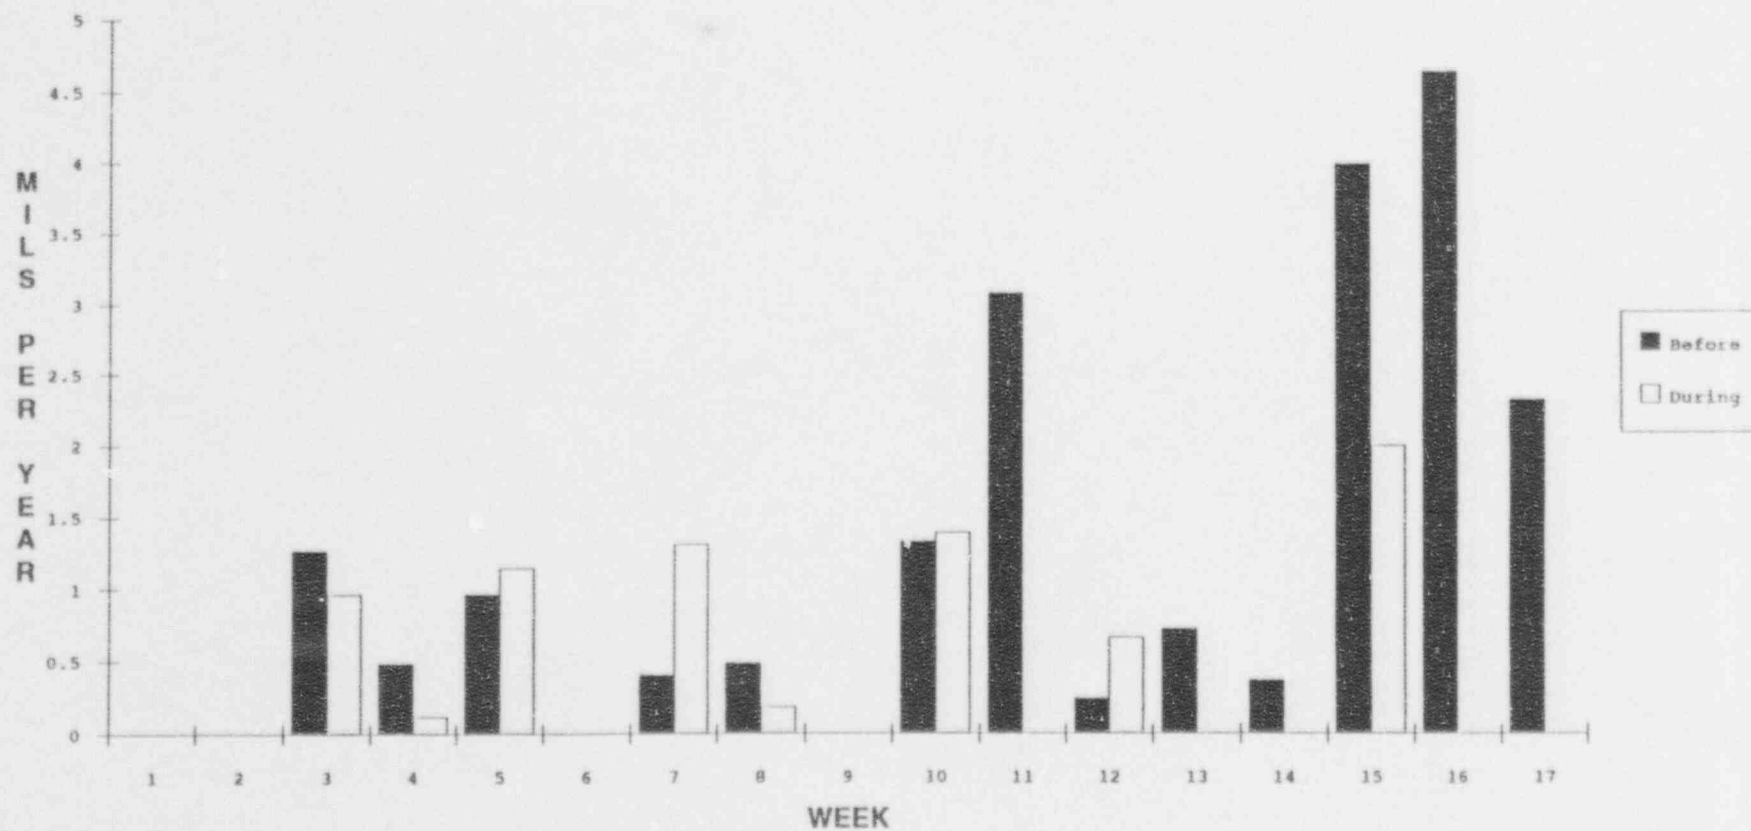
FIGURE 4-9

UNIT 1 IMBALANCE READINGS FOR COPPER/NICKEL BEFORE AND DURING TREATMENT

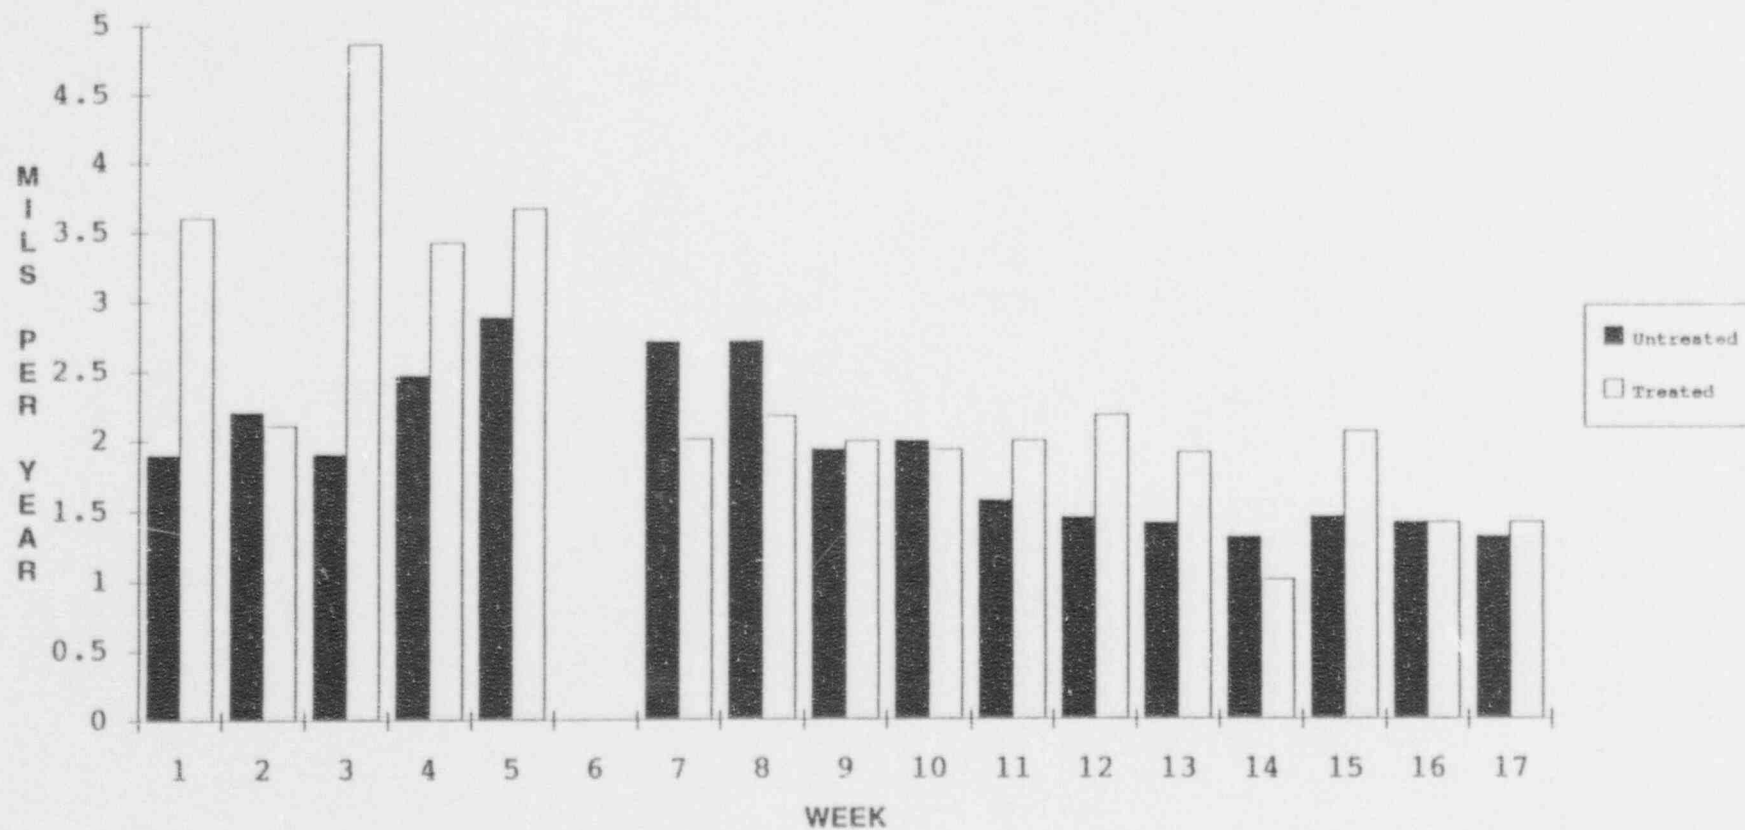
FIGURE 4-10

UNIT 2 GENERAL CORROSION RATE FOR COPPER/NICKEL (TREATED VS. UNTREATED)

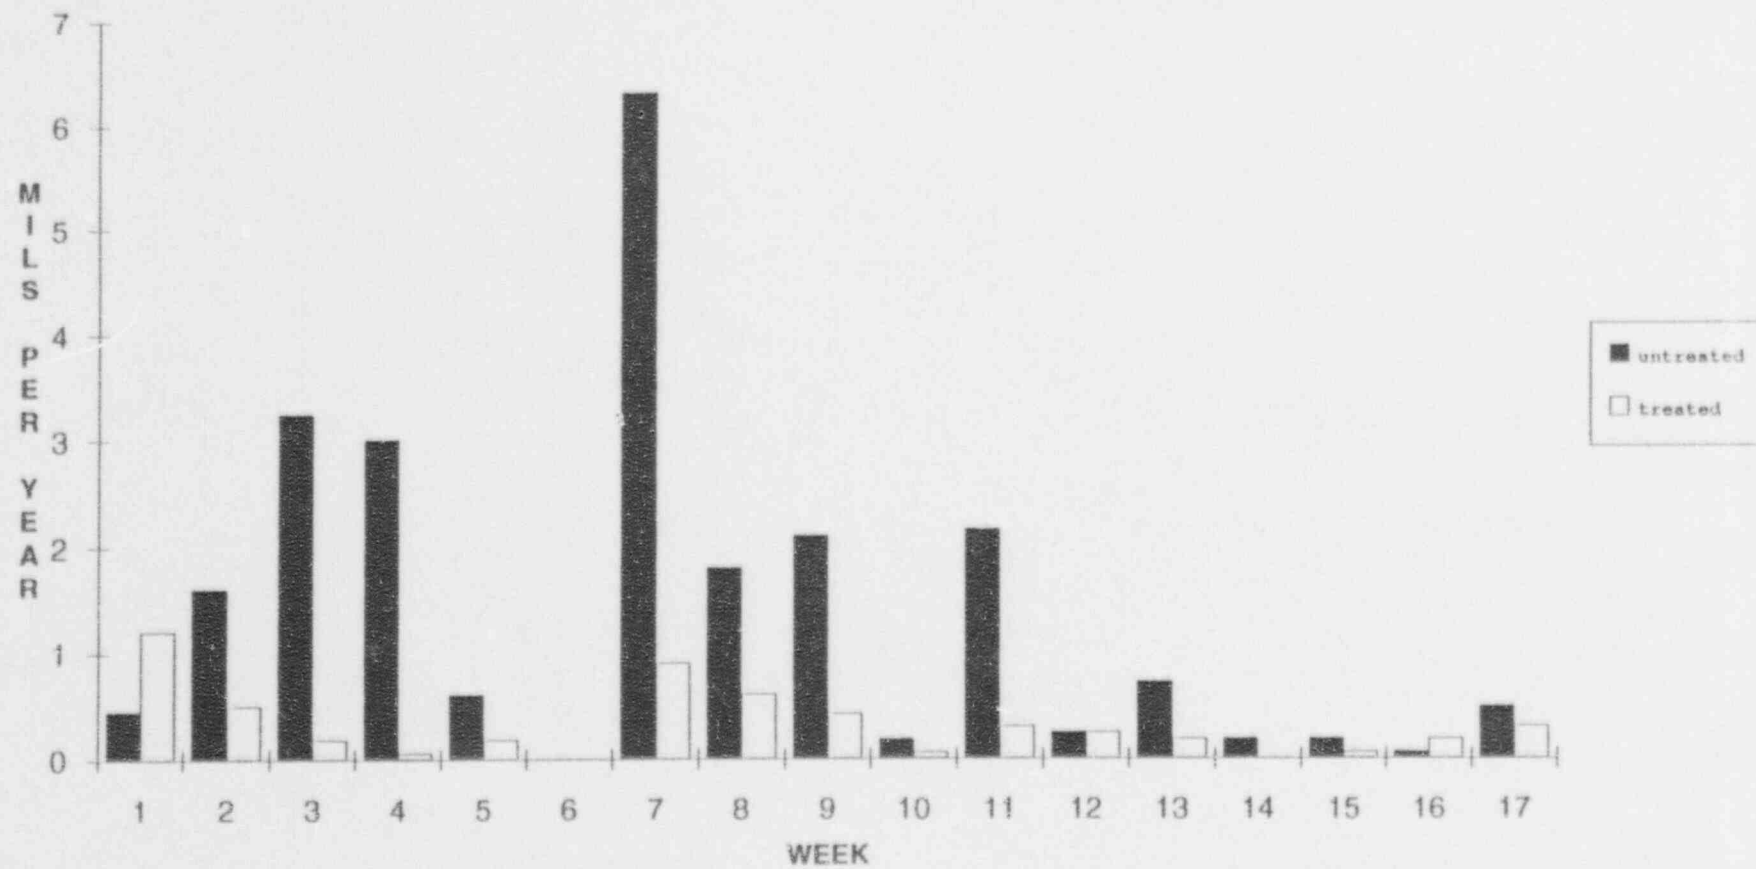
FIGURE 4-11

UNIT 2 IMBALANCE READINGS FOR COPPER/NICKEL (TREATED VS. UNTREATED)

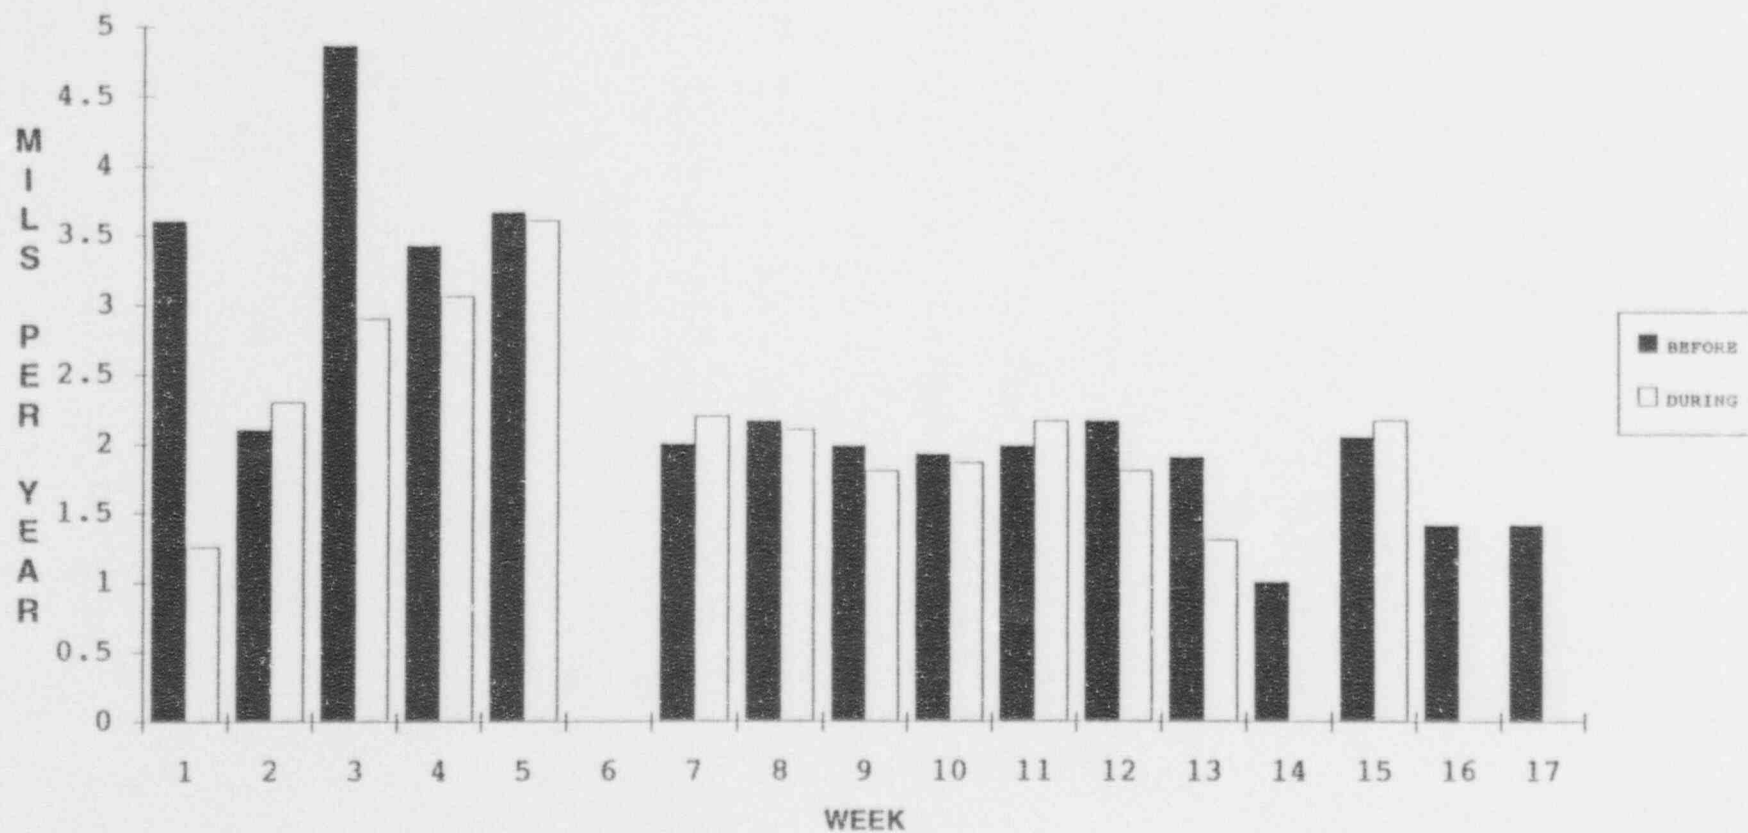
FIGURE 4-12

UNIT 2 GENERAL COPPER/NICKEL CORROSION RATES BEFORE AND DURING TREATMENT

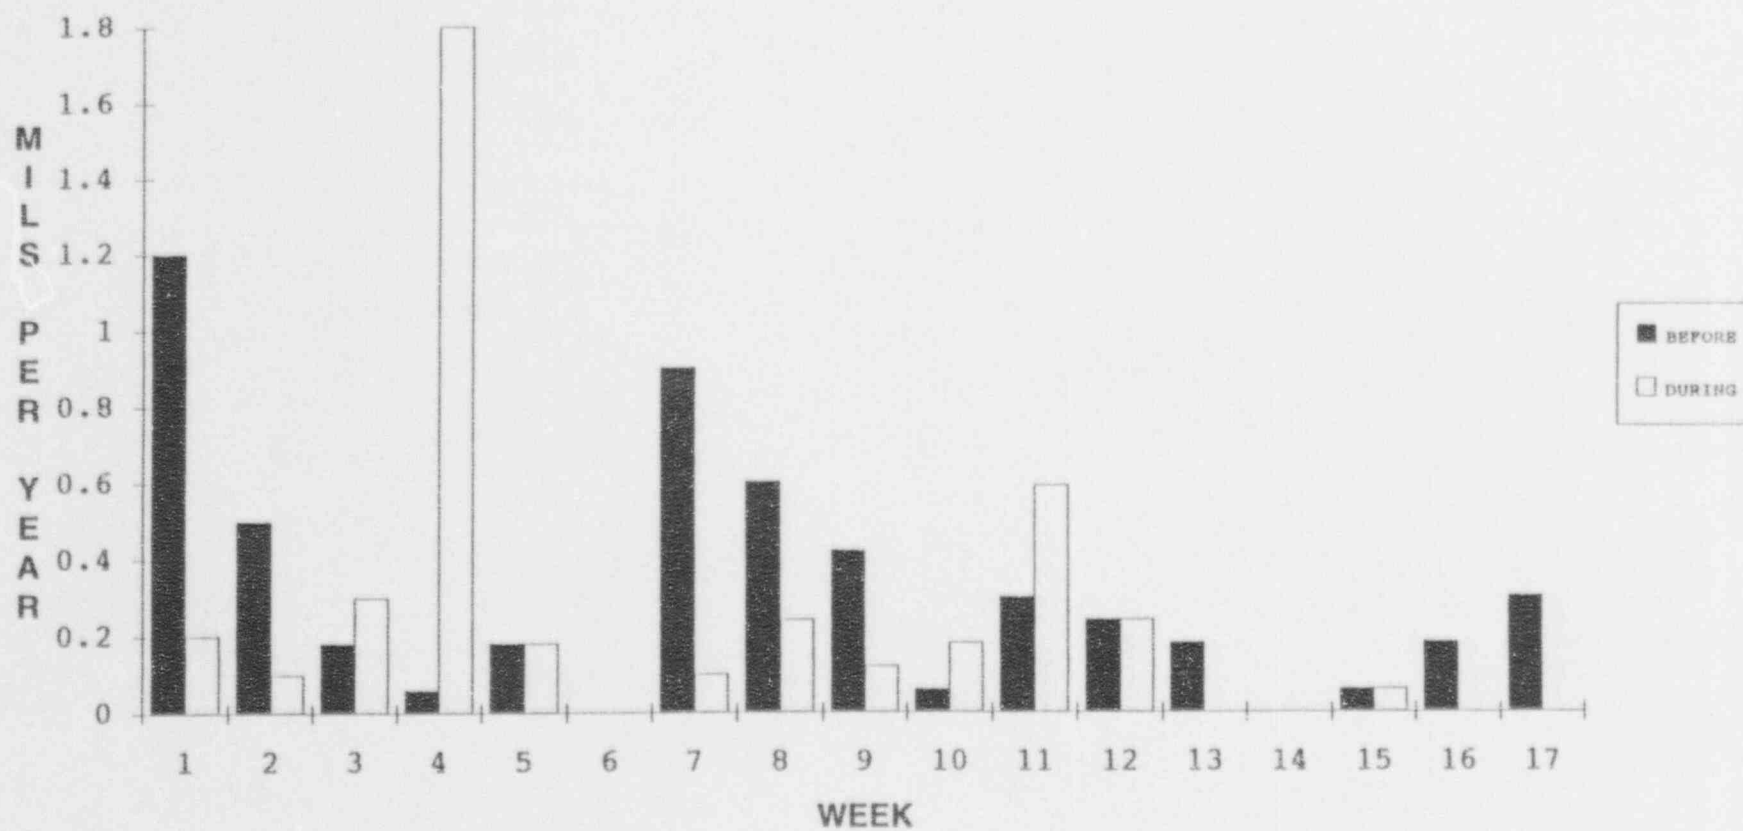
FIGURE 4-13

UNIT 2 IMBALANCE READINGS FOR COPPER/NICKEL BEFORE AND DURING TREATMENT

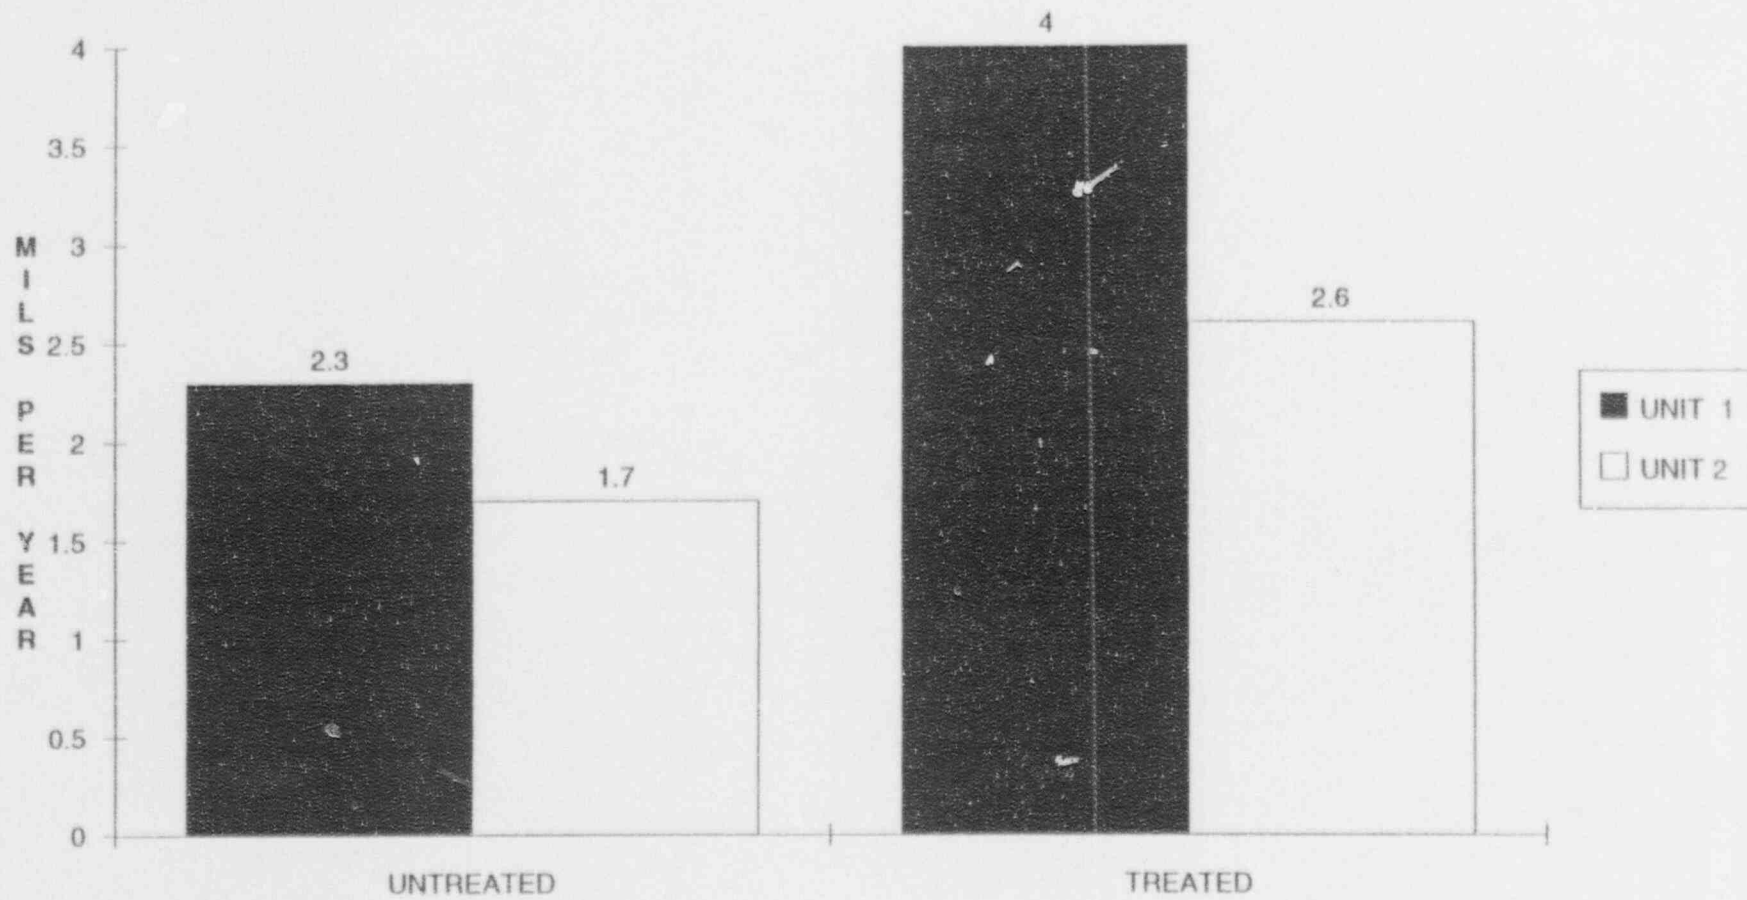
FIGURE 4-14

From analyzing these factors and the data obtained from this study, the differences in corrosion rates are believed to be related to differences in microfouling and deposition between the treated and untreated systems. The MB data clearly indicate that the surfaces are left in a cleaner condition after treatment, thus promoting more efficient heat transfer. A cleaner surface also permits the base metal to be re-exposed to the naturally aggressive system water, while the untreated, fouled surface is insulated from the environment to a greater degree by the biofilm. The result is that the treated systems would have an initially higher corrosion rate, but would more quickly reach equilibrium than the untreated system. It would be expected that if the coupons were left in service for a longer period of time, there would be essentially no difference between the treated and untreated system corrosion rates.

COPPER NICKEL CORROSION RATES FOR UNITS 1 AND 2 (TREATED VS. UNTREATED)
