CHEMICAL TREATMENT SYSTEM EVALUATION FOR THE
SALT WATER COOLING SYSTEM
AT CALVERT CLIFFS NUCLEAR POWER PLANT
(XX-dddd)

Final Report, March 31, 1993

Betz Laboratories
1 Quality Way
Trevose, Pa 19053

Electric Power Research Institute
3412 Hillview Avenue
Palo Alto, California 94304

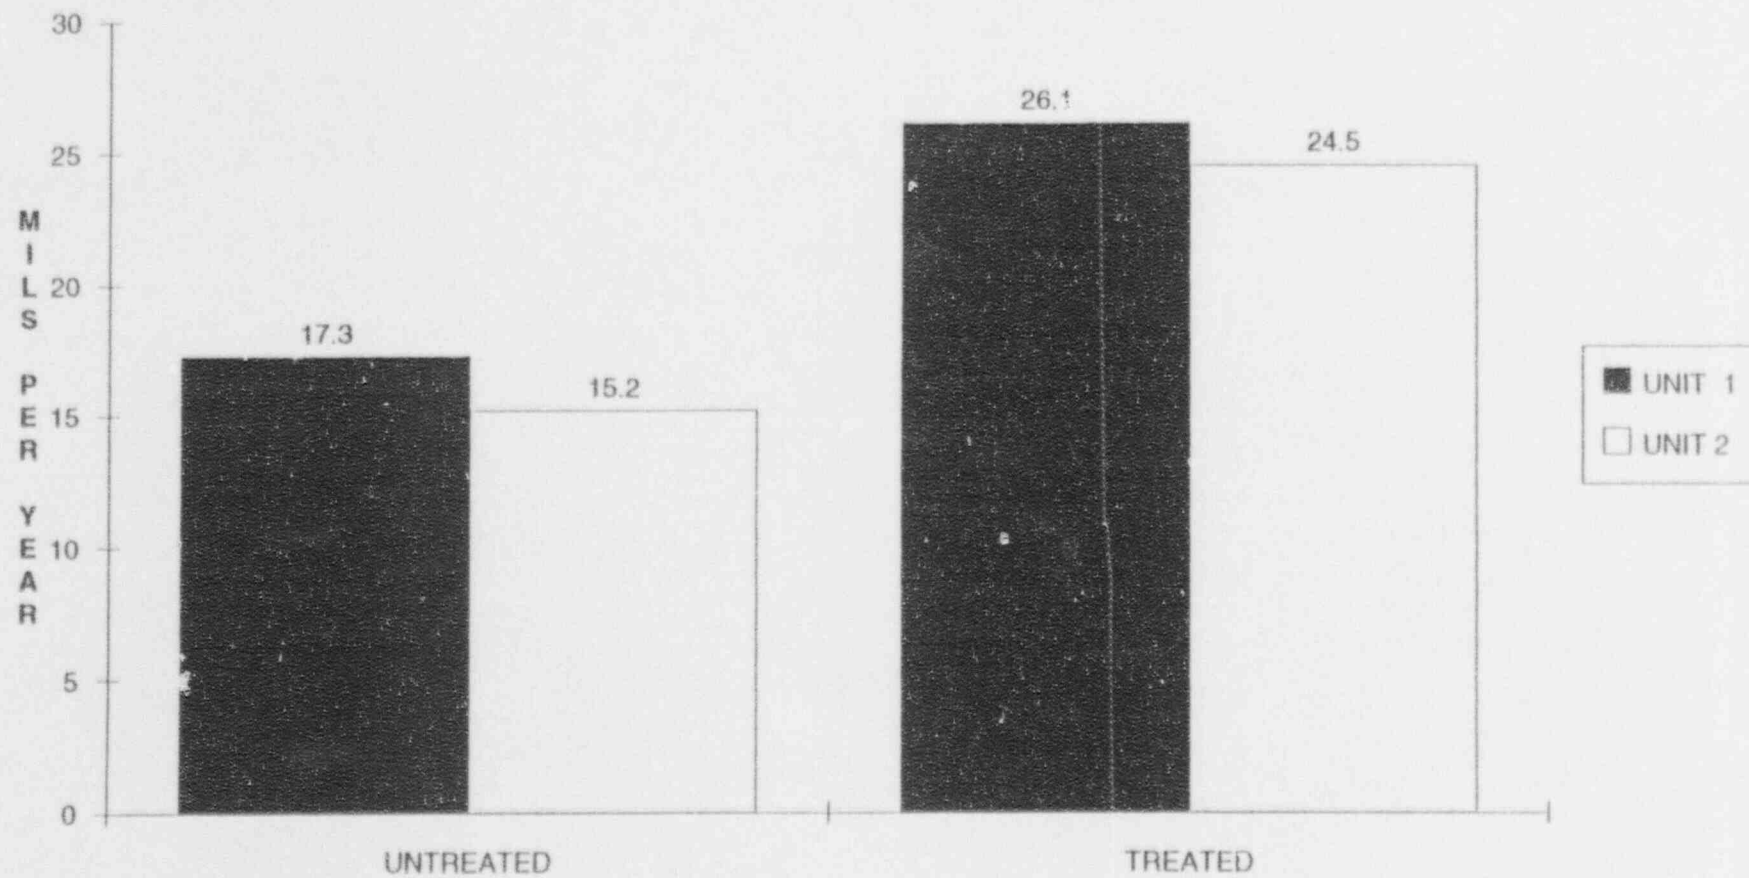
FIGURE 4-15

Results from the instantaneous probes with 90/10 copper nickel metallurgy are displayed in Figures 4-6 thru 4-13. Readings were obtained both before and during the treatment. With the exception of the last few weeks of the Unit 1 test, and week 7 of Unit 1, the imbalance readings were less than the general corrosion readings, indicating that pitting was not active. With respect to general corrosion comparisons of the treated and untreated headers revealed a slightly higher initial rate for the treated systems, averaging approximately 1.0 to 2.0 mils per year higher on the copper/nickel in these systems. This phenomenon was also seen on the coupons removed after the test and shown in Figures 4-14 and 4-15.

This explanation is also valid for the differences in mild steel corrosion rates. However, there are several other mitigating factors regarding the SW system that should also be considered for this material. For instance, the carbon steel piping is concrete or rubber lined, insulating the steel from the naturally aggressive system water environment. Therefore, the mild steel corrosion rates observed do not pose a risk to the long term operation of the SW system.

MILD STEEL CORROSION RATES FOR UNITS 1 AND 2 (TREATED VS. UNTREATED)

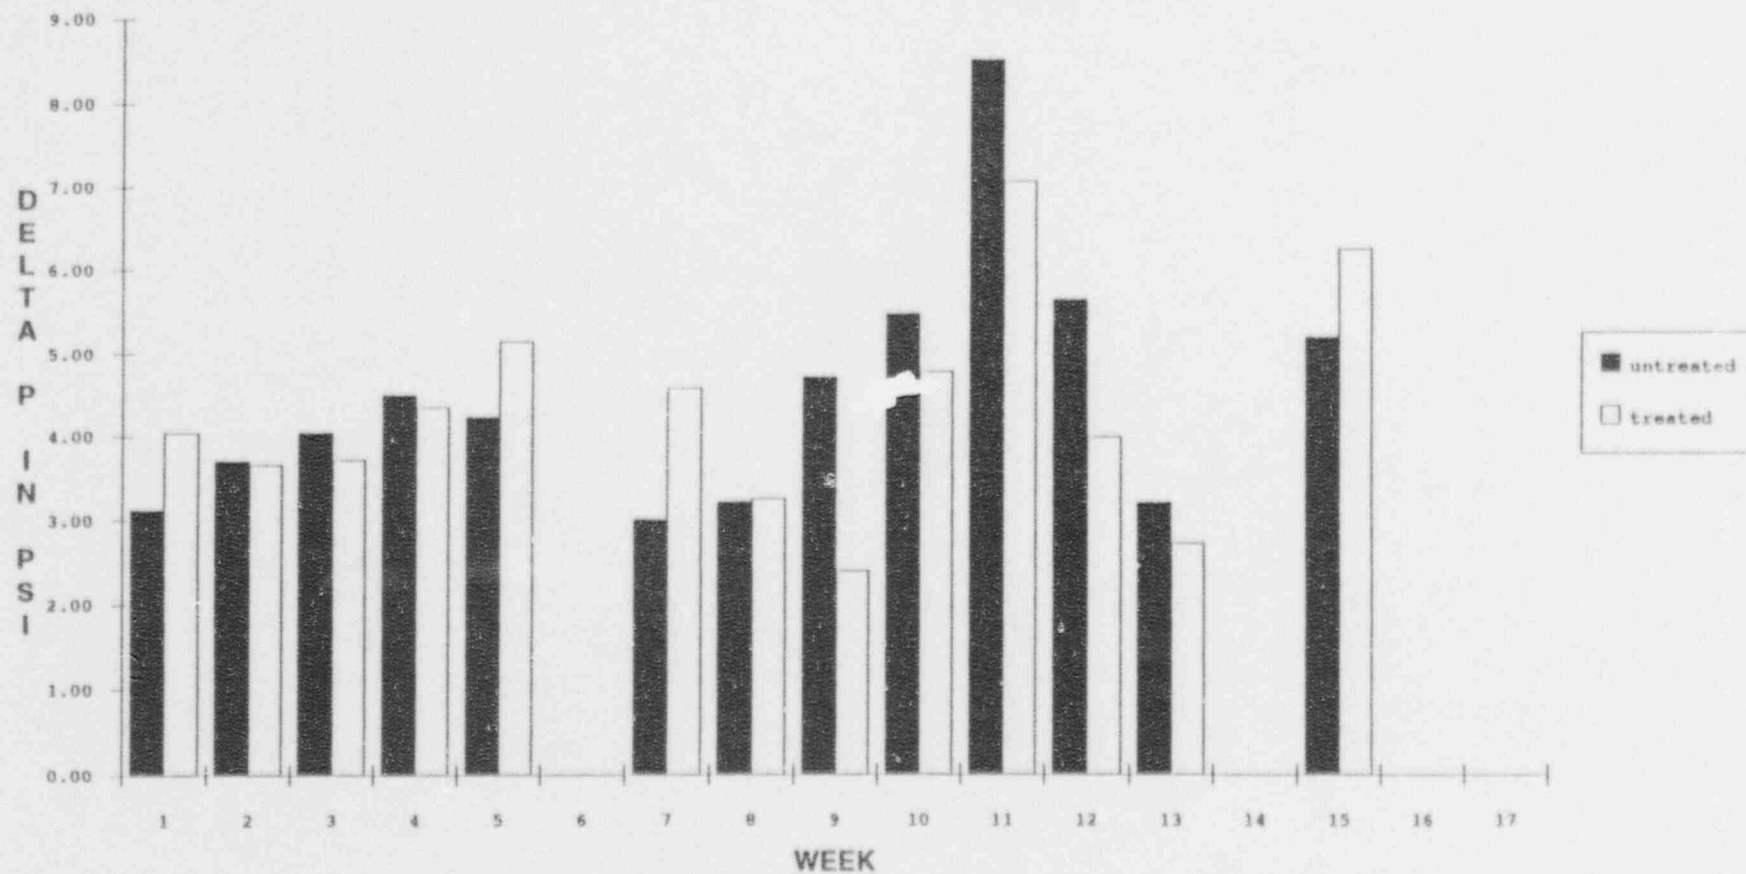
FIGURE 4-16

applicable to each train of this system to permit ready comparison of the data. This data is displayed in Figures 4-16 thru 4-19.

However, a generally favorable trend exists in the more consistently treated Unit 2 heat exchanger, with the treated system exhibiting relatively smaller pressure drops than the untreated system. Also, slight delta P improvements were typically seen after treatment, as indicated in Figure 4-17. With respect to Unit 1, however, no similar benefit is seen. This is believed to be attributable to the inconsistent application of CT-1 on this Unit. Further data correlation is needed in this area if delta P is determined to be an important trending parameter.

UNIT 2 NORMALIZED PRESSURE DIFFERENTIAL (TREATED VS. UNTREATED)

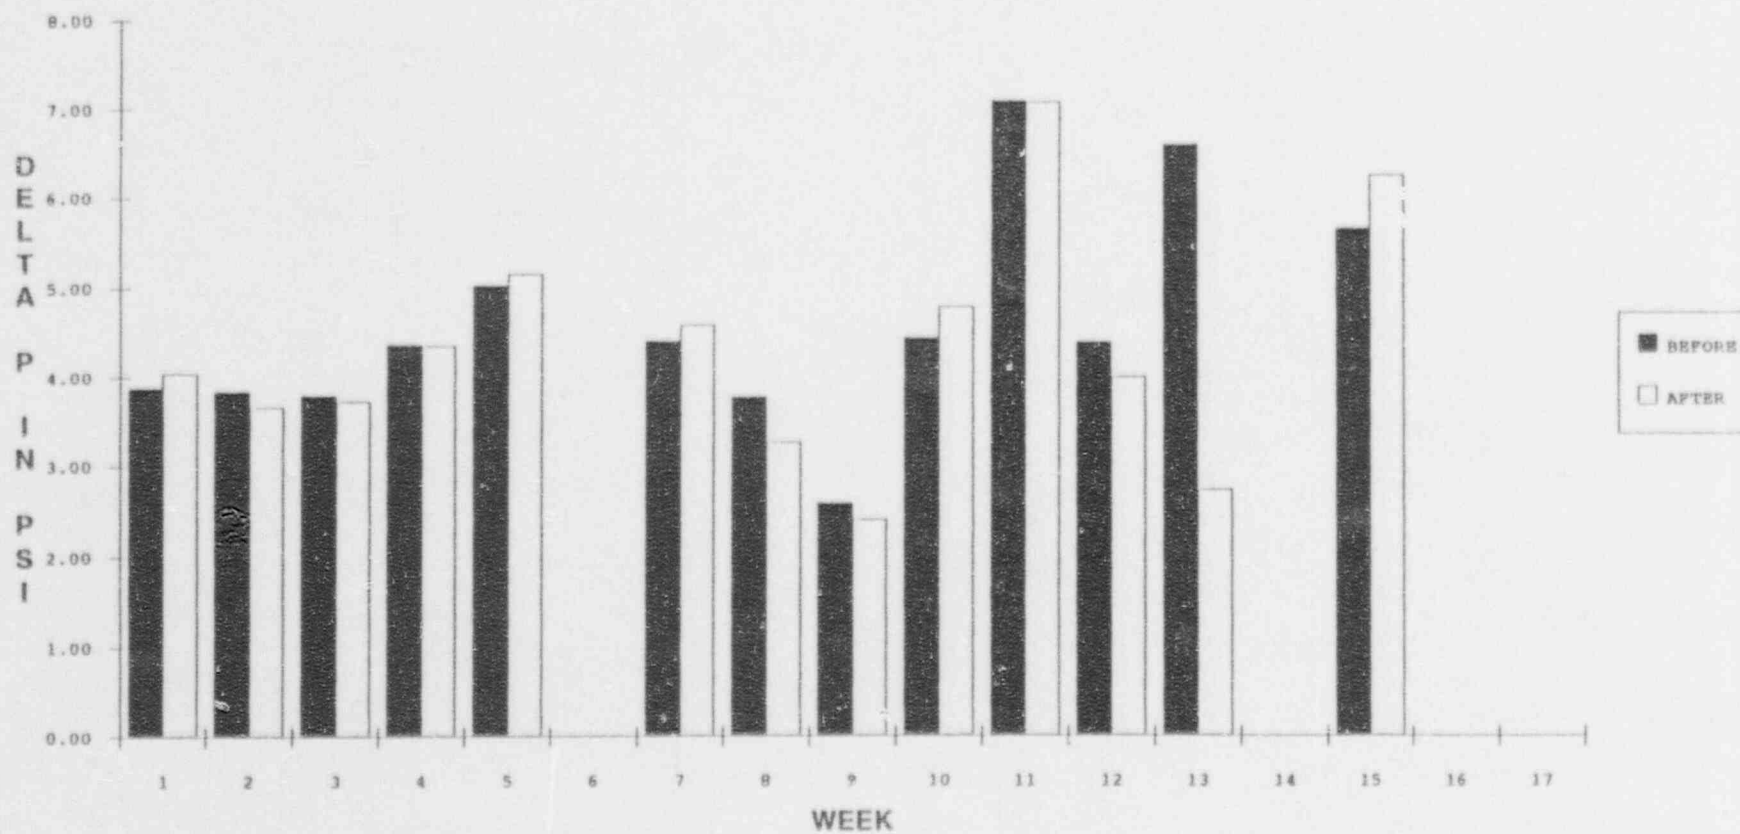
FIGURE 4-17

UNIT 2 TREATED SYSTEM BEFORE AND AFTER NORMALIZED PRESSURE DIFFERENTIAL

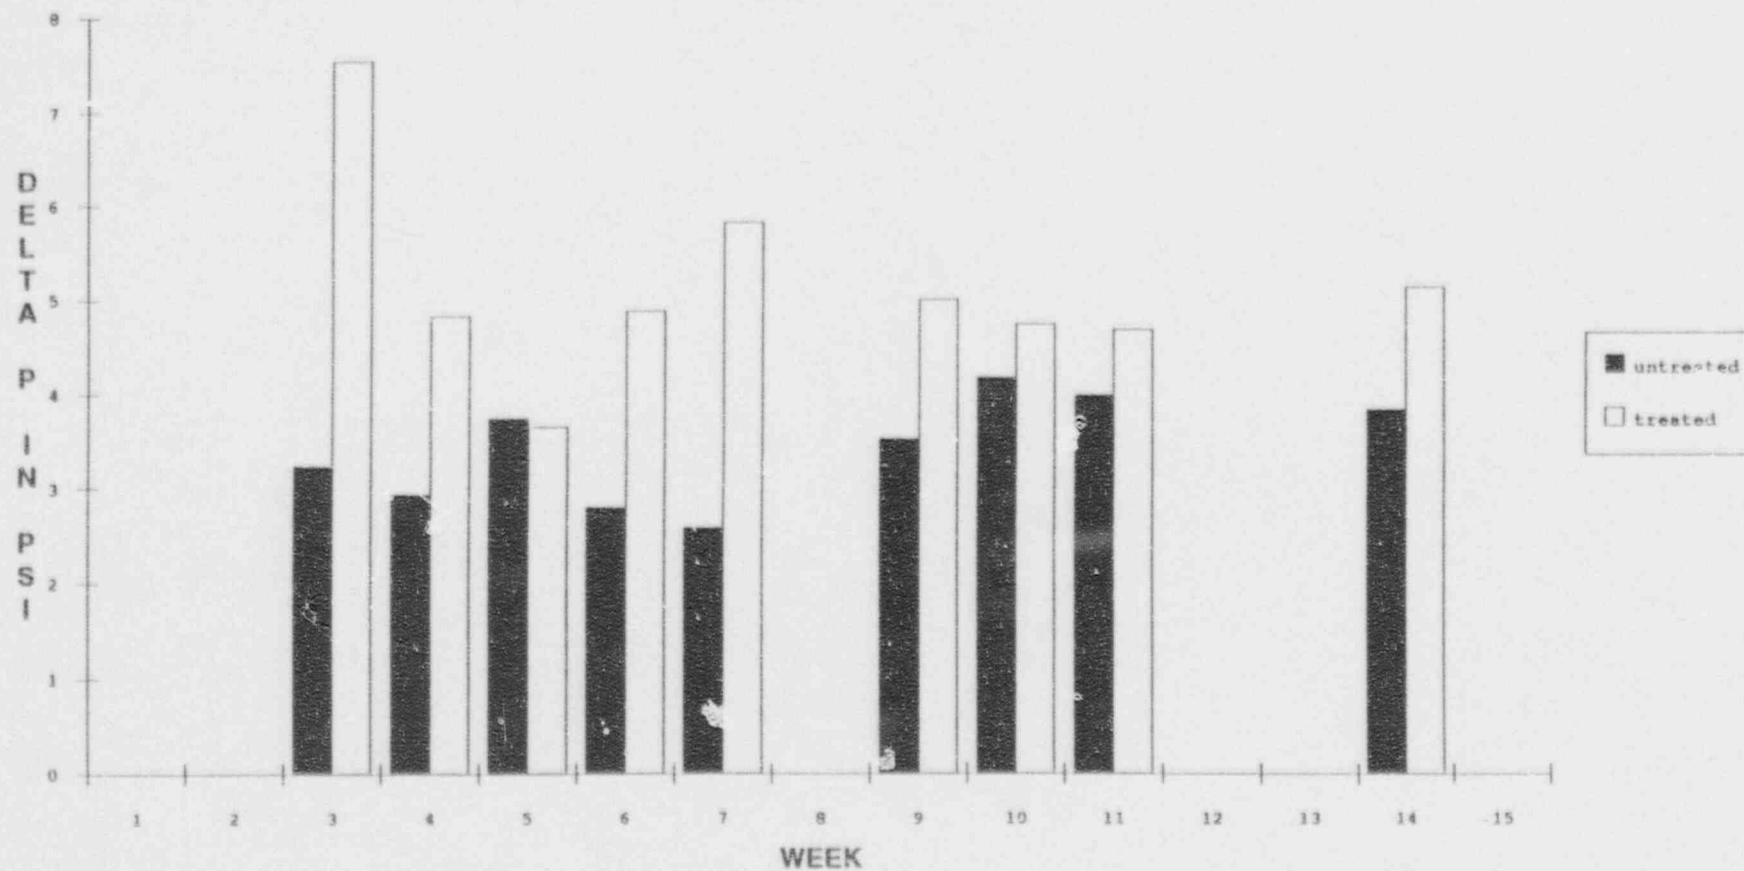
FIGURE 4-18

Two factors contributed to changing the pressure differential across the heat exchangers. These factors are addressed in the Introduction of this report. These heat exchangers suffer both macrofouling (clams, oysters, crabs, etc.) and microfouling. Both of these phenomena contribute to higher pressure drops, with periodic casual cleanings performed as needed to address macrofouling, and quarterly bullettings to address microfouling. Casual cleanings particularly can greatly reduce the observed pressure drop for week to week and therefore add complexity to interpretation of the data. Increased heat exchanger performance can be seen after each cleaning bulletting. As a result, it is more difficult to determine the true difference between a treated and untreated heat exchanger from reviewing this data.

UNIT 1 NORMALIZED PRESSURE DIFFERENTIAL (TREATED VS. UNTREATED)

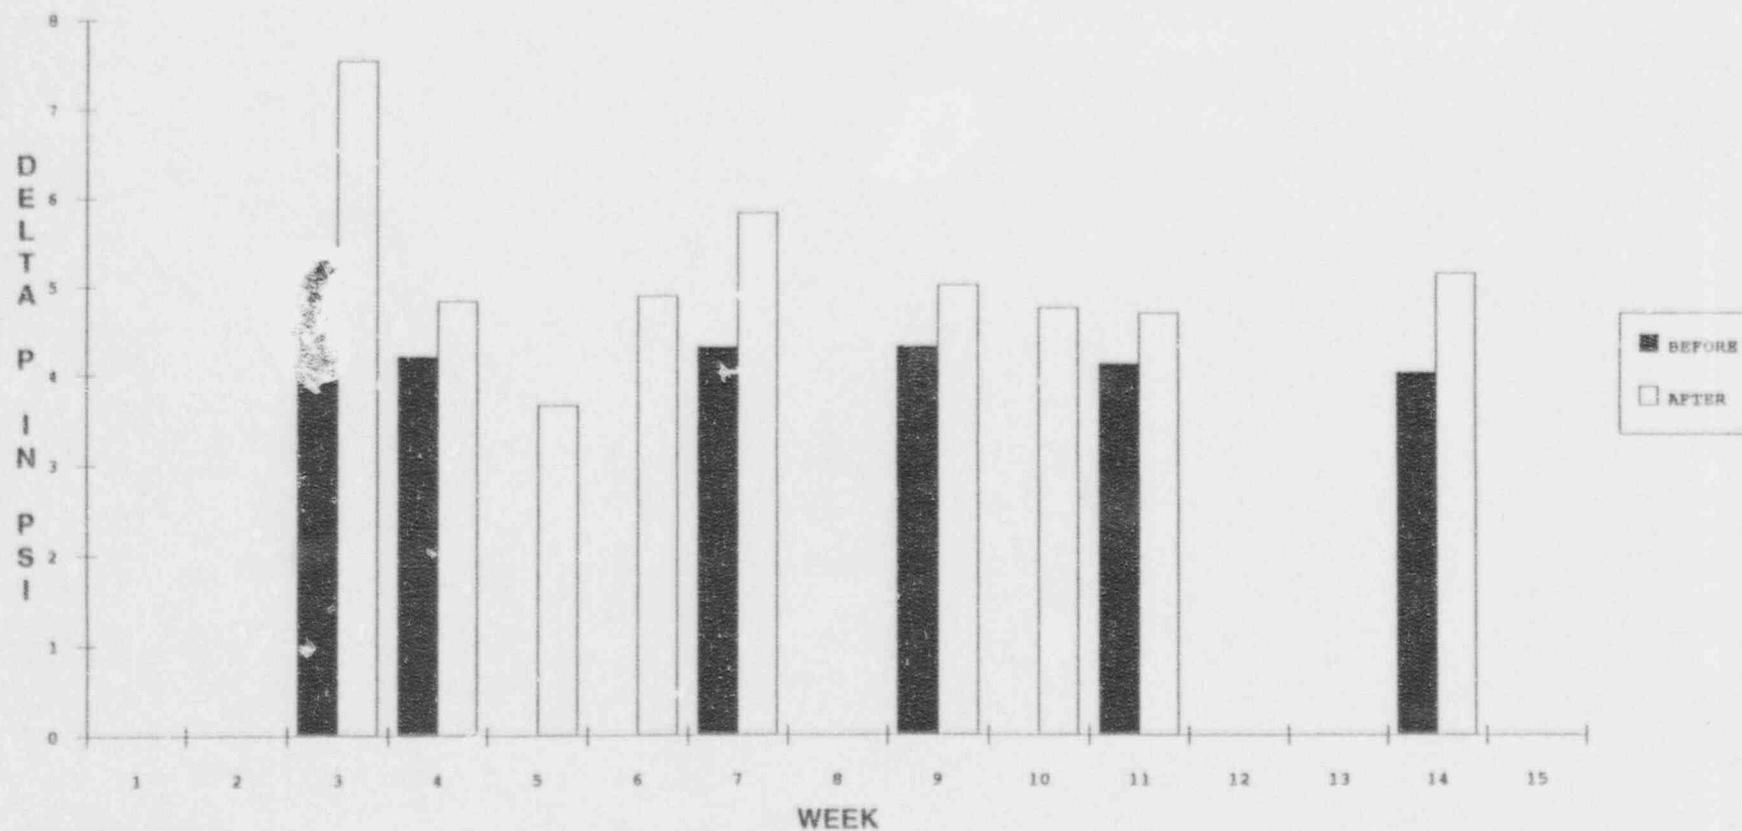
FIGURE 4-19

UNIT 1 TREATED SYSTEM BEFORE AND AFTER NORMALIZED PRESSURE DIFFERENTIAL

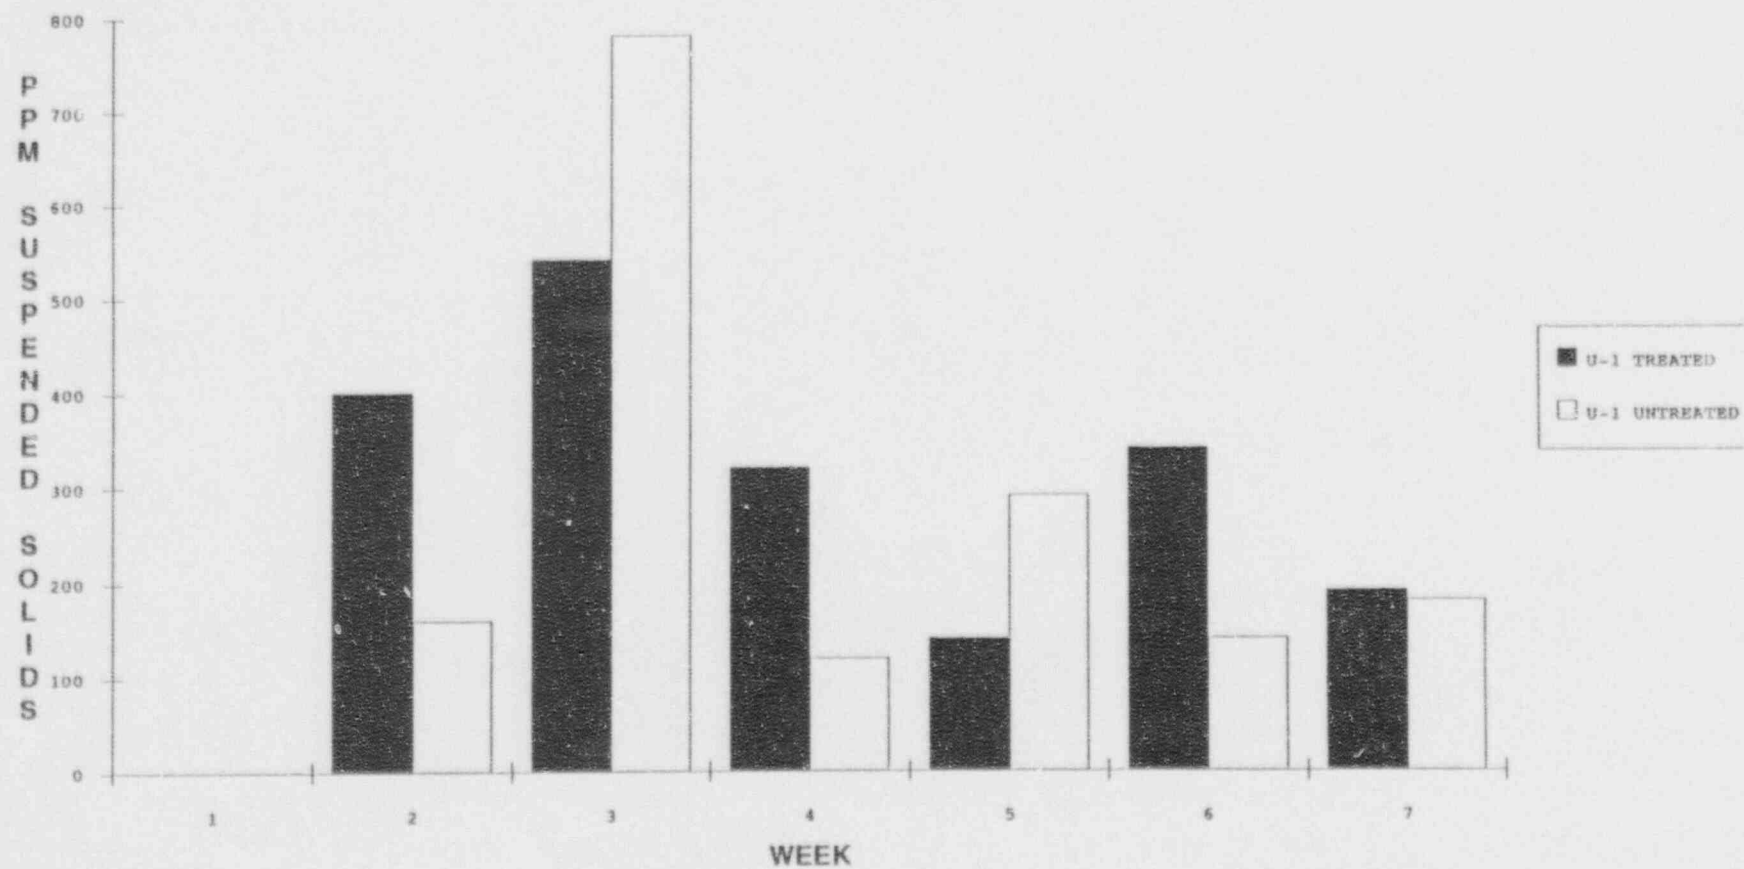
FIGURE 4-20

However, visual differences in growth occurring on the treated and untreated MB coupons could however be readily observed. The amount of suspended solids present in the sample water containing the coupons could be readily measured and compared between treated and untreated heat exchangers. This alternate method was used as an indication of accumulated biofilm present in the heat exchangers and was initiated approximately mid-way through the 17 week test period. The results from this analytical work are displayed in Figures 4-20 and 4-21.

UNIT 1 SUSPENDED SOLIDS FROM BACTERIA MONITORING COUPONS

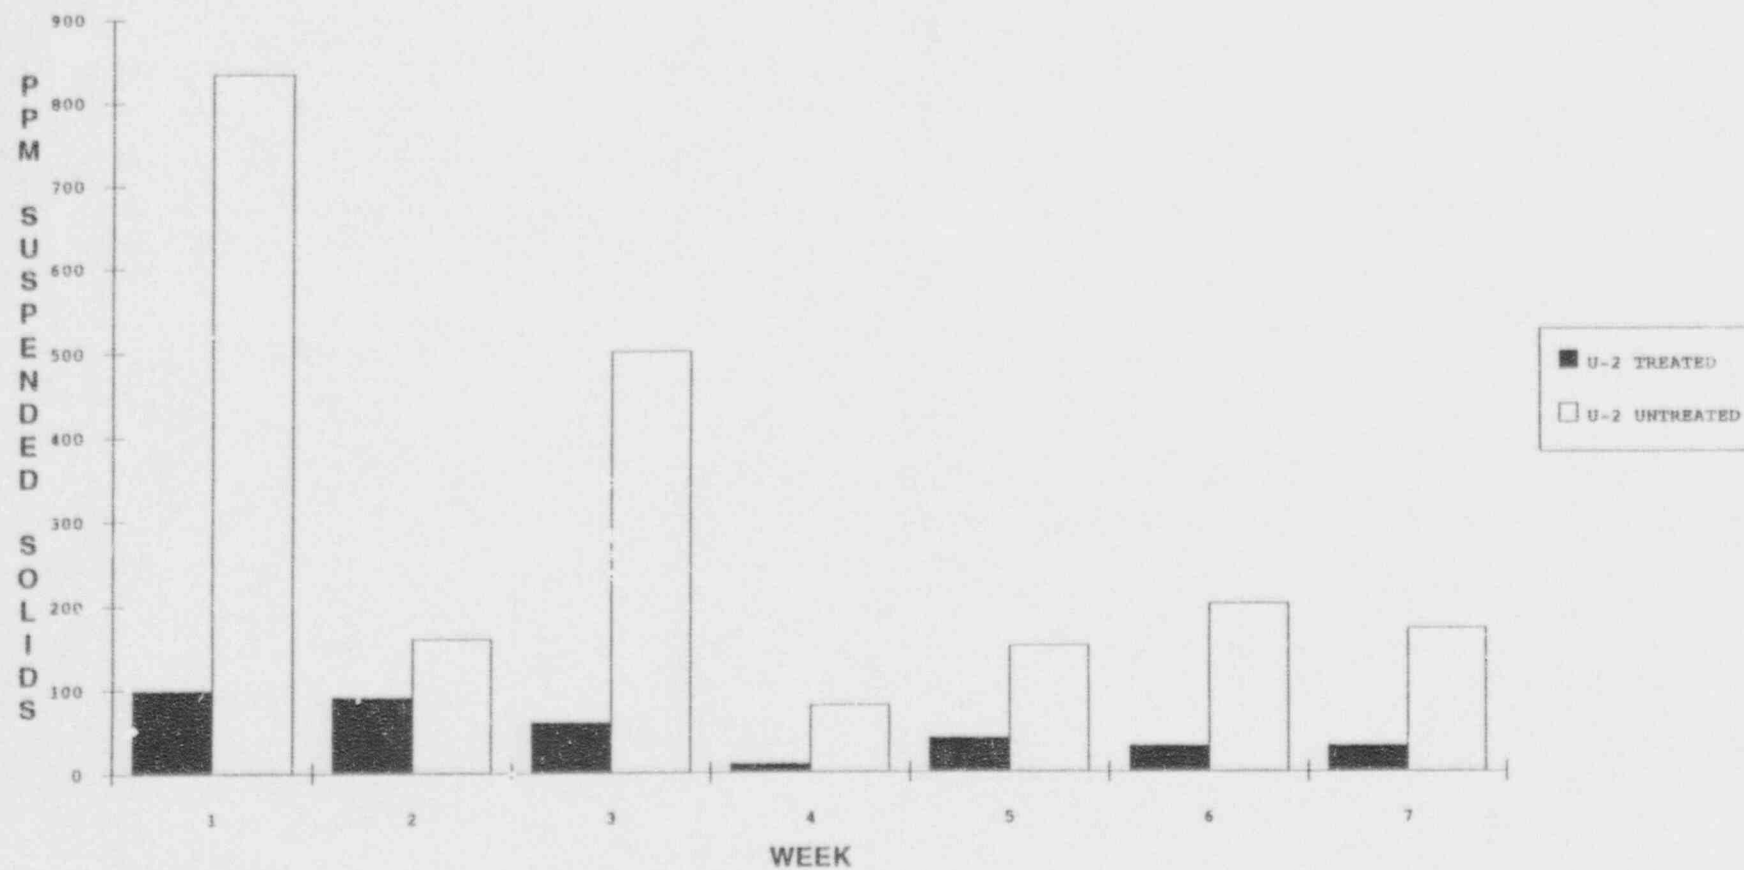
FIGURE 4-21

Where the treatment program was consistently implemented (Unit 2), a dramatic difference in the amount of material removed from the coupon is seen in examining Figure 4-21. Anywhere from one-half to a full order of magnitude difference existed between the treated and untreated systems. This is again consistent with the quantities of material removed during the bulletting operations in the Unit 2 heat exchangers, demonstrating biofilm and hence microfouling control. For Unit 1, no consistent trend again due to the inconsistent application of the treatment.

UNIT 2 SUSPENDED SOLIDS FROM BACTERIA MONITORING COUPONS

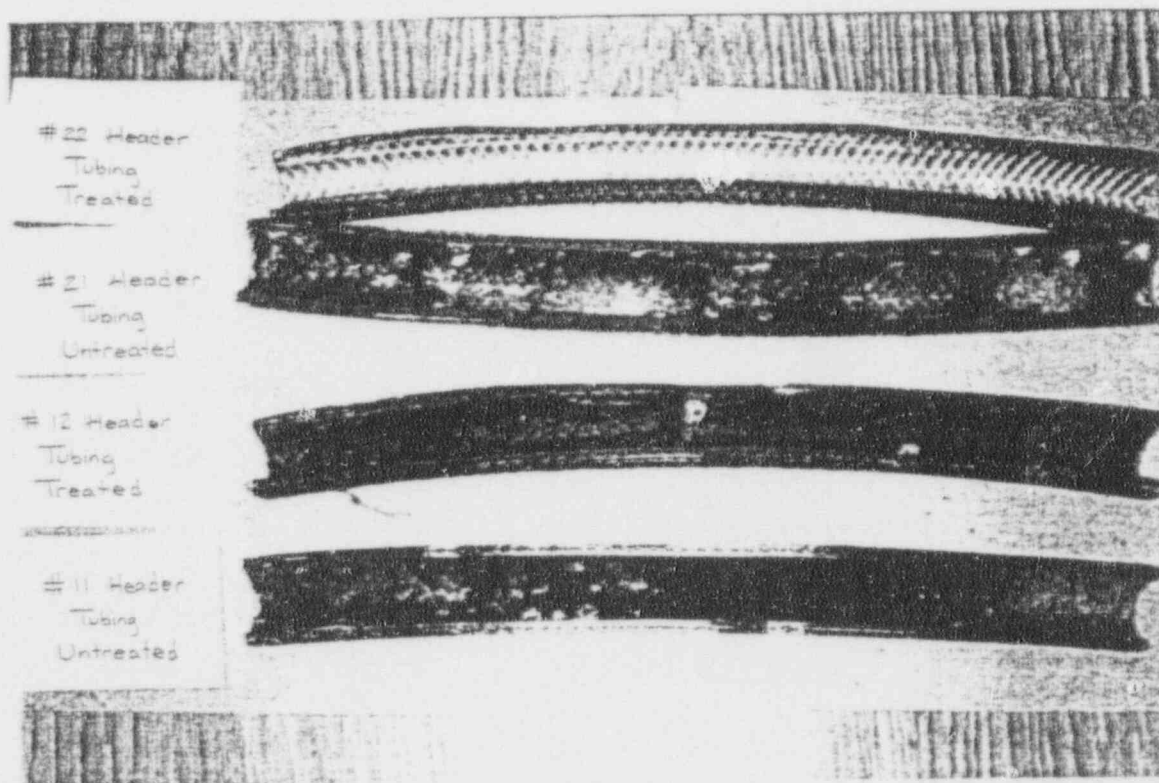
Finally, upon conclusion of the test, the side stream corrosion racks were dismantled. Sections of the discharge hose running to the floor drains were obtained, cut longitudinally, and analyzed. The floor drain sections selected offer the greatest degree of flow and geometric consistency between the hose sections. Relative comparisons between the treated and untreated headers were made and are summarized in the Table 4-1. Photographs were also obtained and are included in Figure 4-22. Dramatic differences exist in the treated and untreated systems, particularly with respect to Unit 2. Some degree of macrofouling control (namely on barnacles) can even be seen in the Unit 1 treated system.

Area Assessed	#11 Heat Exchanger (Untreated)	#12 Heat Exchanger (Treated)	#21 Heat Exchanger (Untreated)	#22 Heat Exchanger (Treated)
Connection fitting diameter reduction	Reduced approx. 50% due to barnacles, slime, sea grapes, and hydrozoan.	Reduced approx. 30% with similar organisms as in the #11 heat exchanger.	Reduced approx. 25%-30% with similar organisms as in the #11 and #12 heat exchangers.	Barnacles and slime present, but to much lesser degree than in the other heat exchangers. Minor (5%) diameter reduction.
Barnacles in 3 foot section of discharge hose	72 barnacles, mostly medium to large in size.	28 barnacles of medium to small size.	154 barnacles of varying sizes. Many barnacle clusters present.	16 barnacles of small to medium size. Most barnacles were small.
Discharge hose condition and growth.	Continuous slime growth on I.D. surface.	Areas of heavy and light slime growth on I.D. surface.	Intermittent slime and growth on ID hose surface.	Very minor growth on ID surface. Most of hose length remained translucent in color.

FIGURE 4-22
Photograph of Corrosion Rack Drain Hoses From Treated and Untreated Systems At End of
Evaluation
