WOLF CREEK

Subject: Docket No. 50-482: Licensee Event Report 93-008-00

TITLE (4)
Flux Doubling circuit required for Modes 3, 4, and 5 was "blocked" for several days.

Wolf Creek Generating Station
LER 93-008-00

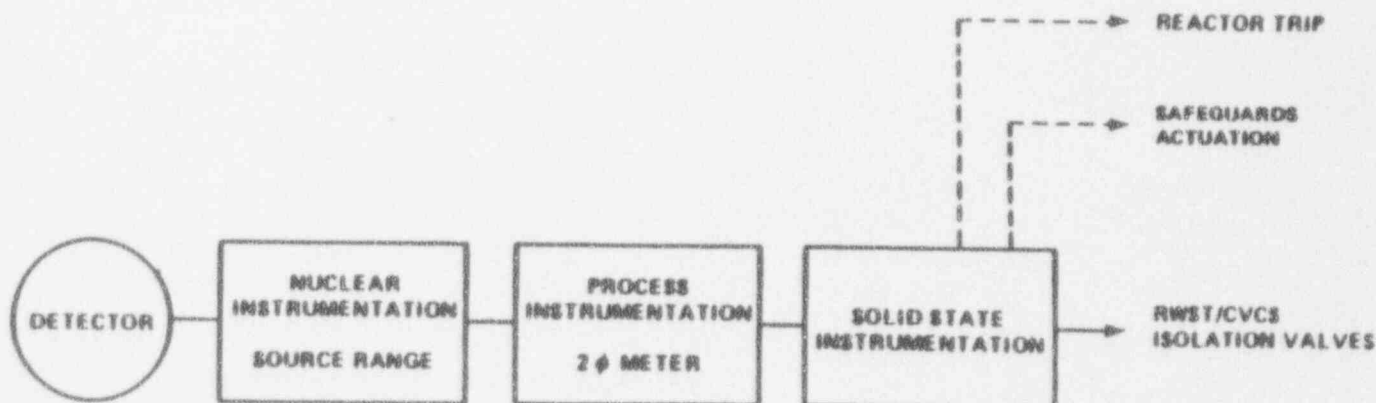
Figure 1

Instrumentation is provided to mitigate the consequences of an inadvertent addition of unborated, primary grade water into the RCS. The attached figure (Figure 1) is a simplified block diagram of the boron dilution control system at WCGS taken from USAR Figure 7.6-6. This figure shows the Flux Doubling detection system and the protection system output for the associated isolation valve actuations of RWST/CVCS.

INSTRUMENTATION FOR PROTECTION
AGAINST INADVERTENT BORON DILUTION
