# Duquesne Light Company

**Subject: Beaver Valley Power Station, Unit No. 2  
Docket No. 50-412, License No. NPF-73  
Request for Relief for a Non-Code  
Repair on 2-SWS-EJM-237A and 2-SWS-EJM-237B**

DUQUESNE LIGHT COMPANY  
Nuclear Power Division  
Beaver Valley Power Station, Unit 2

Request for Relief for Non-Code  
Repairs on 2-SWS-EJM-237A and 2-SWS-EJM-237B

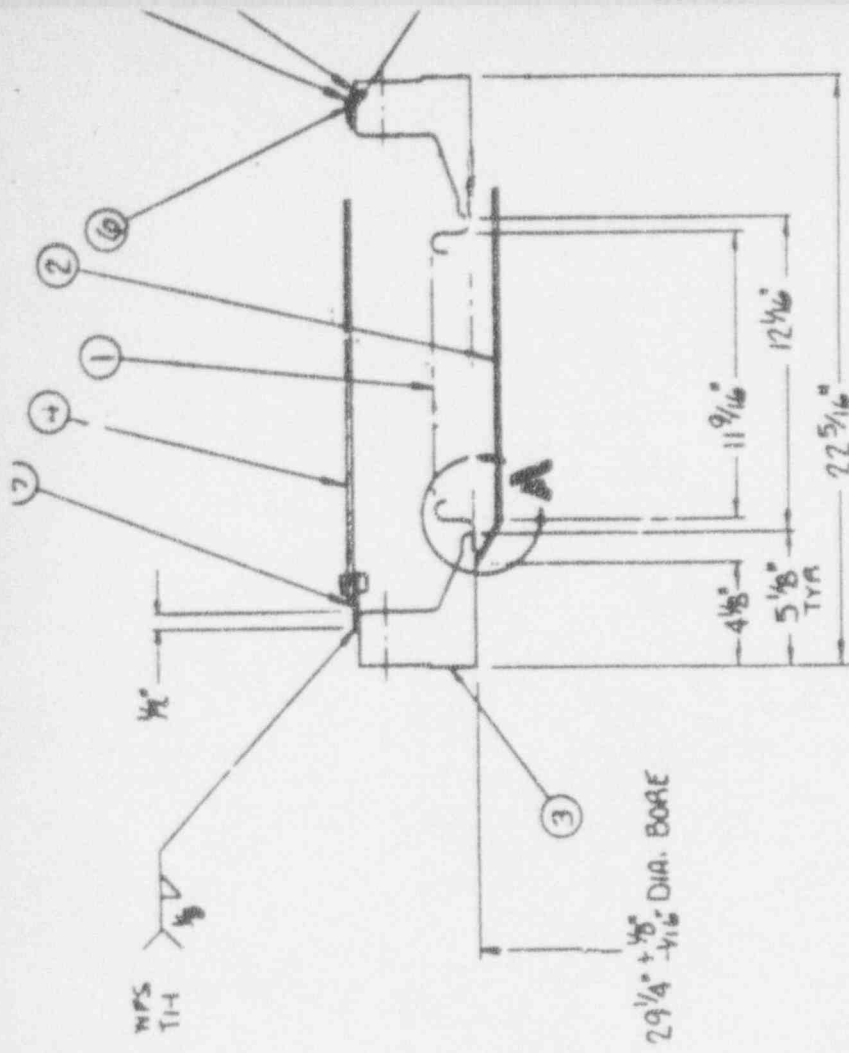
FIGURE 1

The leakage on both the leaking MEJ and the weeping MEJ is on the downstream weld between the stainless steel bellows and the carbon steel flange (see Figure 1). The leakage is suspected to be caused by erosion and/or corrosion/pitting in the region of the weld joint which is a dissimilar weld between a stainless steel bellows and carbon steel flange (a stainless steel weld filler material was used). Both of the MEJs will be inspected following their removal for repair or replacement in the next scheduled outage exceeding 30 days. A failure analysis will also be performed to determine the failure mechanism.

The leakage on both of the MEJs is on the downstream weld between the stainless steel bellows and the carbon steel flange. The configuration of the joint (see Figure 1) does not permit the flaw to be evaluated by either the "Through-Wall Flaw" or "Wall Thinning" approaches provided by Enclosure 1 to Generic Letter 90-05. Therefore, the following alternative evaluation is provided for NRC staff review and approval.

1. Weld joint design is incompatible with conventional ASME Code techniques. The weld joint illustrated in Pathway Bellows Drawing D-3-3213 Rev A-1 (Figure 1) is essentially a dissimilar metal seal weld set within a counterbore in the carbon steel flange surface.
2. The taper angle and flat surface of the 150# weld neck flange creates geometrical limitations with regard to examination beam angles and examination surface access.
3. There are no reference standards or readily available mockups available to allow development of UT techniques and/or reference sensitivity determination.

1. A fiberglass reinforced epoxy resin material wrapped completely around the joint between the bellows and the flange. This material is pressure rated and will seal the joint and prevent gross leakage or water spray.
2. In order to prevent the possibility of the bellows from disengaging from the flange, six (6) dogs (see Figures 2 and 3) will be bolted to the flange joint. These dogs will hold the first bellows convolution in place. In the unlikely event of a complete weld failure, this modification will hold the bellows inside of the flange joint. This modification will not prevent the bellows from performing its normal function.

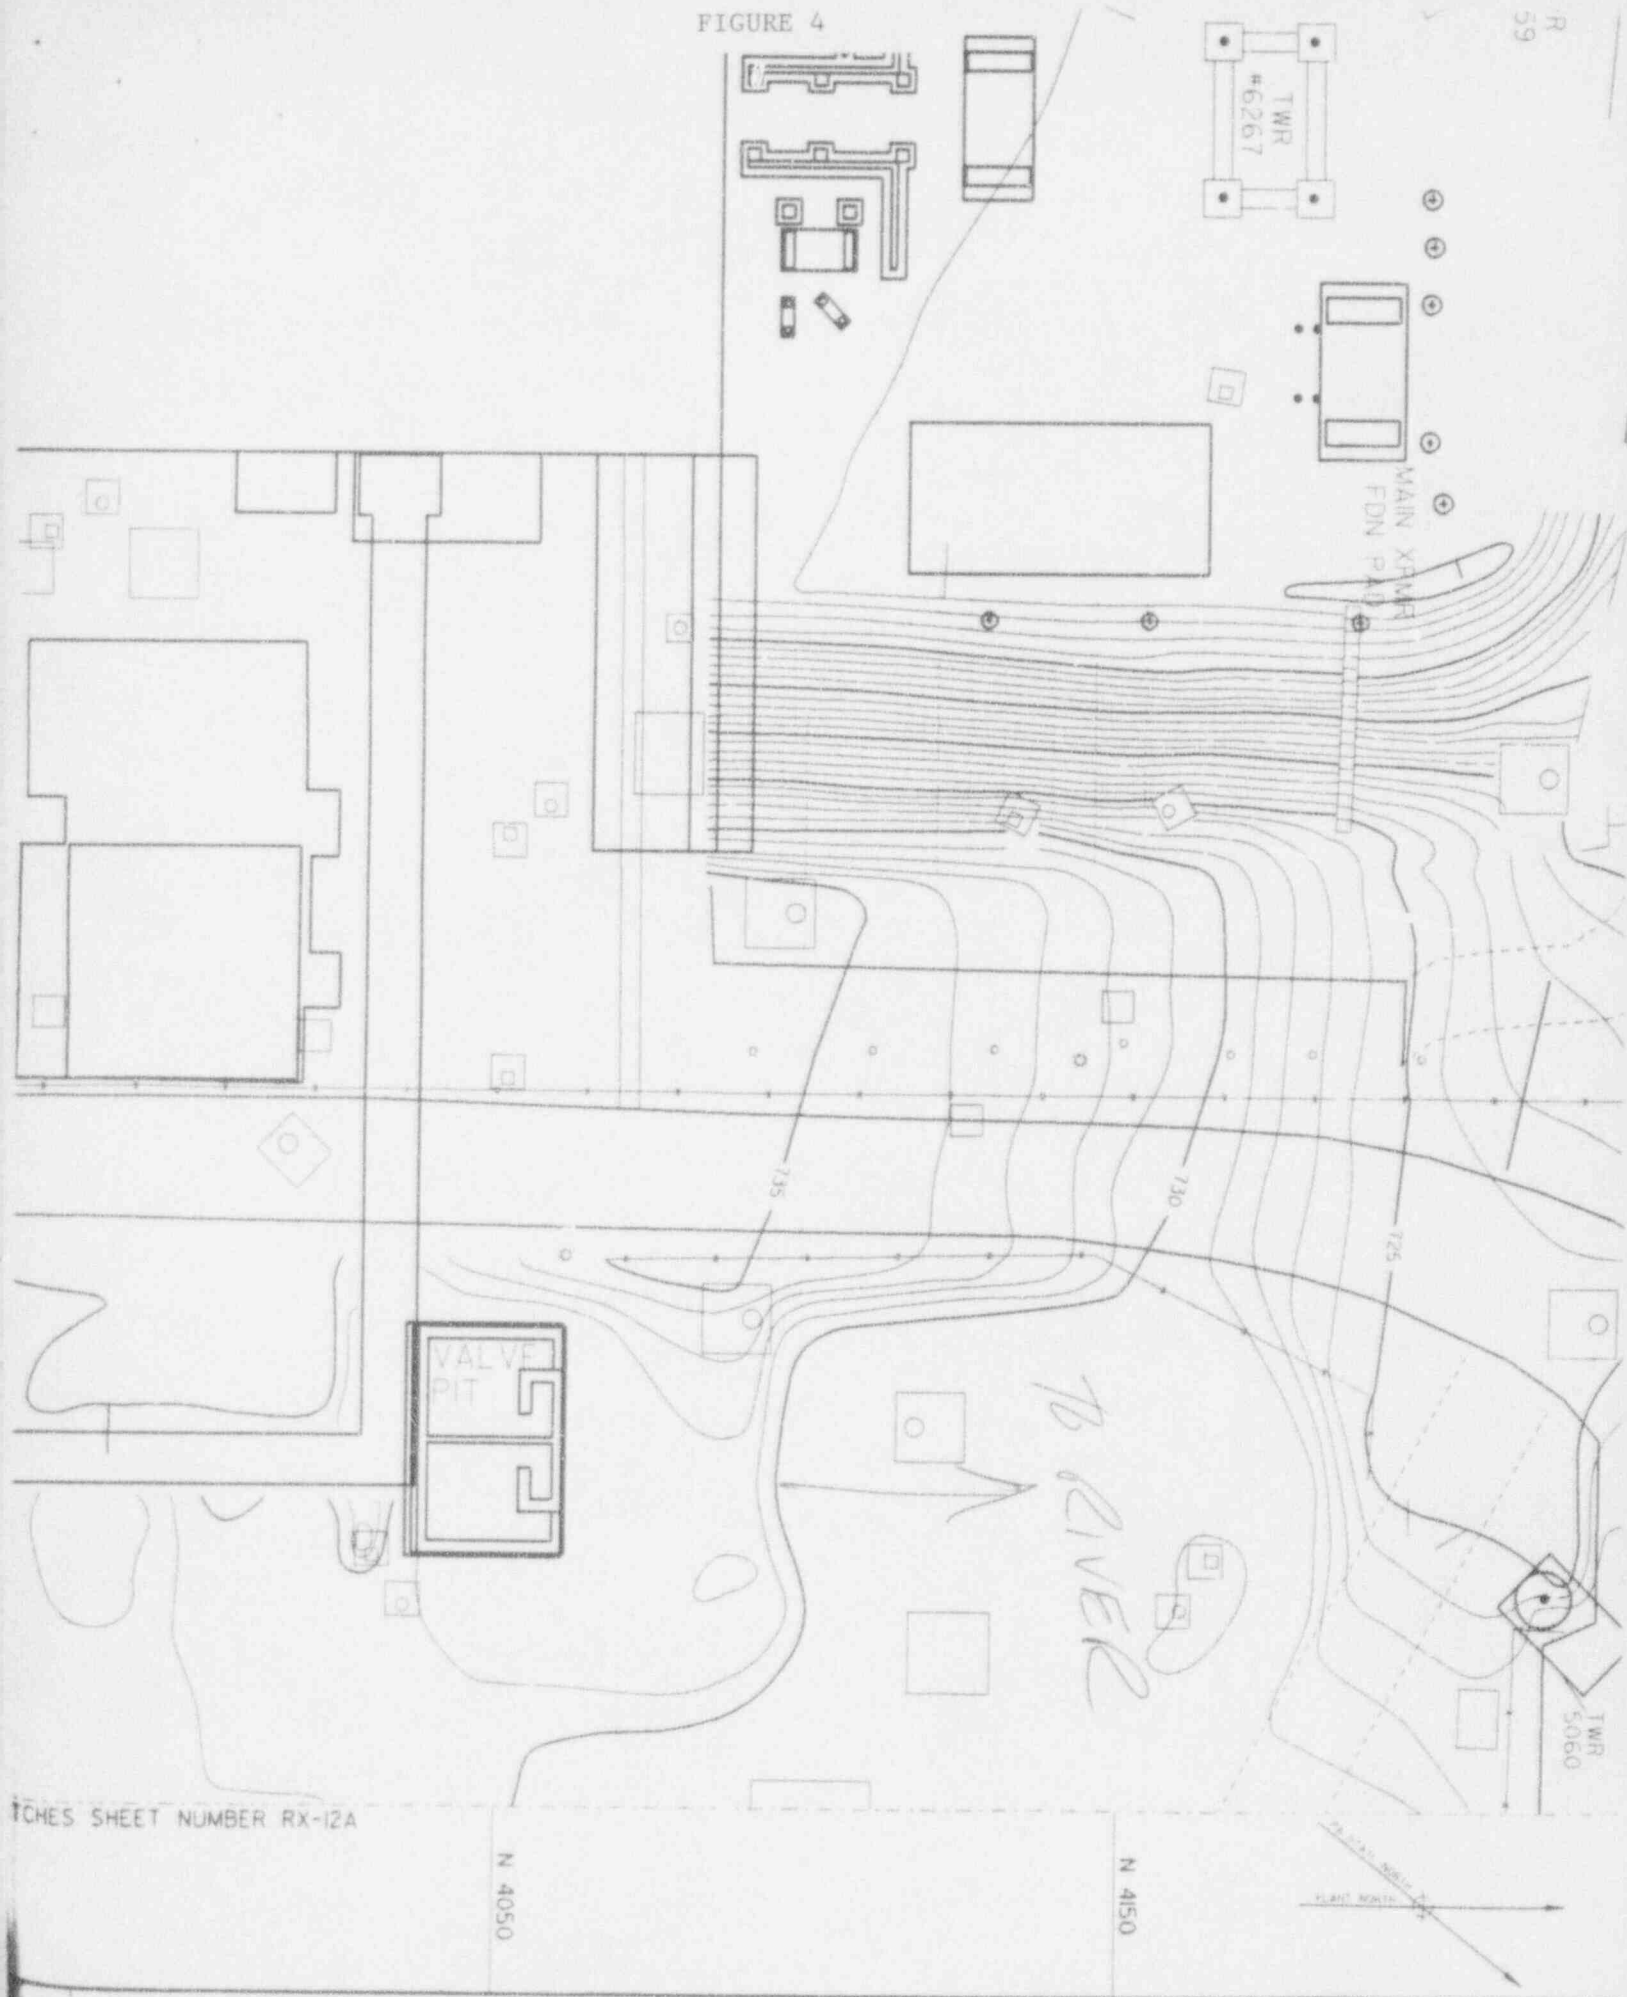
FIGURE 4

Flooding: Each MEJ is located in the side of the service water valve pit associated with its respective train and is physically separated from the opposite train's side. This buried valve pit is located in the yard area and is separate from any other structure (see Figure 4). Any leakage from a complete weld failure will be minimal due to design of non-code repair. However, any leakage from an MEJ will be collected in one of the two valve pit sumps. Each sump has a high level alarm (at 9" level) in the control room and is equipped with an automatic sump pump rated at 28 gpm. The alarm response procedure, will be revised to provide specific operator action to check the affected MEJ leakage rate and initiate further actions if required. However, in the event of catastrophic failure of an MEJ, only the equipment located in that valve pit would be affected, the other service water train will be unaffected. Loss of a complete service water train has been previously analyzed in UFSAR Section 9.2. Therefore, this failure would not create an unanalyzed condition.

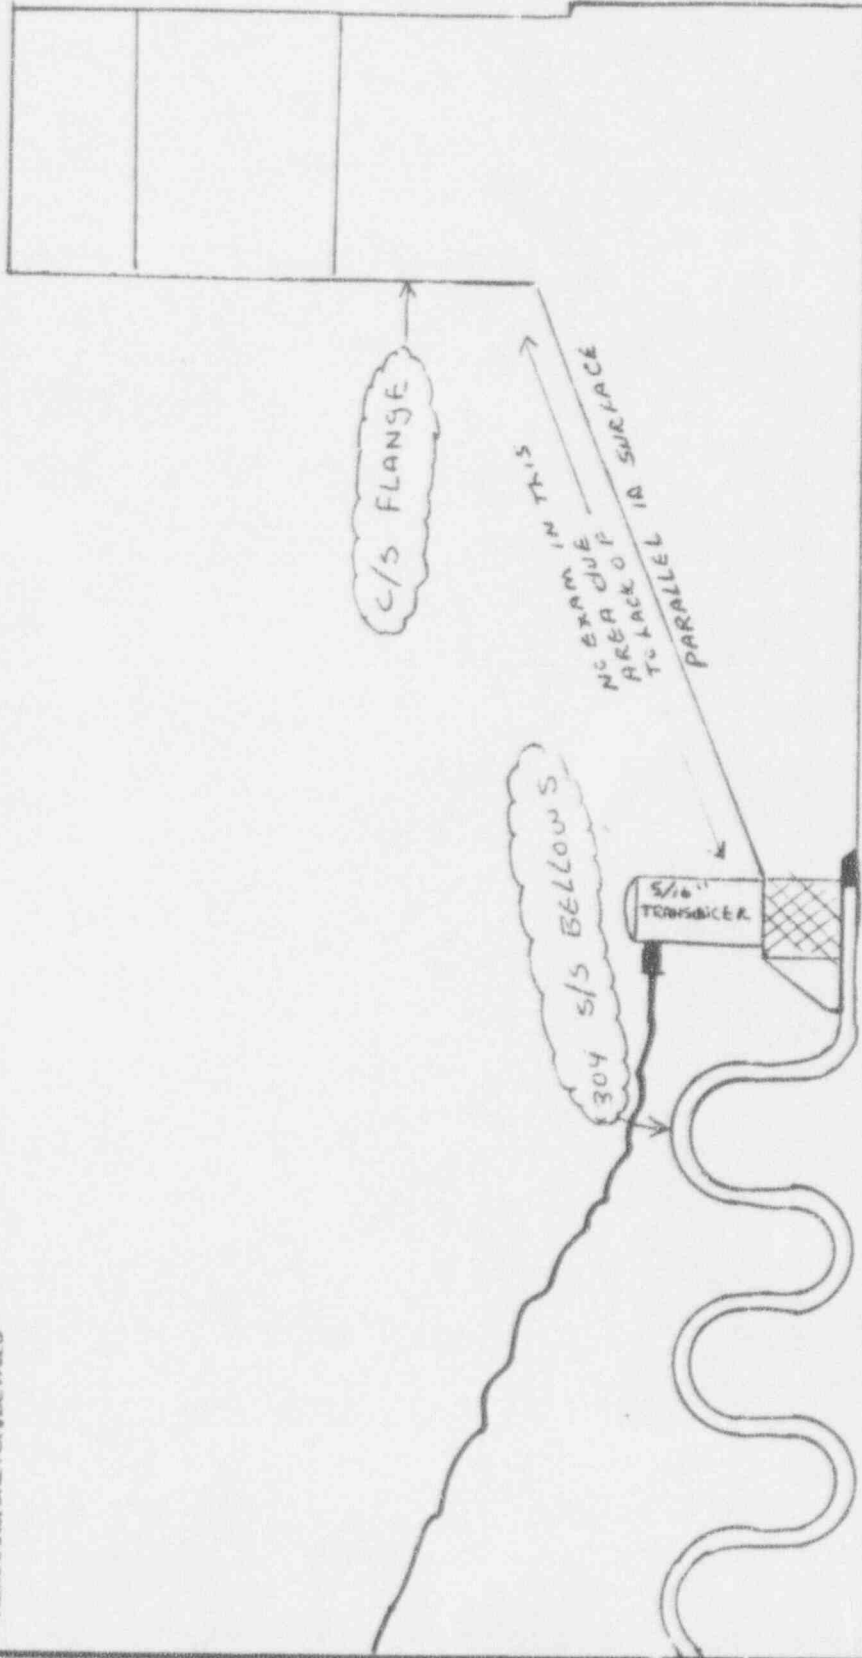
REMARKS/SKETCH/DETAILS

BOTH FLANGES ON BOTH EXPANSION JOINTS EXAMINED  
360° FOR THICKNESS AS ILLUSTRATED ON PAGE #2.

<u>2-SWS-EJM-237A</u>	<u>2-SWS-EJM-237B</u>
<u>INLET</u> <u>OUTLET</u>	<u>INLET</u> <u>OUTLET</u>
<i>.275"-.285"</i> <i>.275"-.285"</i>	<i>.260"-.280"</i> <i>.275"-.295"</i>

MEASUREMENTS LIMITED IN SOME AREAS ON 237A DUE TO HEAVY RUST  
AND ON 237B DUE TO A NARROWER CONTACT AREA (~3/16" wide).  
BACKREFLECTION MAINTAINED IN AREAS WITH GOOD CONTACT SURFACE -  
THICKNESS VARIATIONS APPEAR TO BE DUE TO FABRICATION MACHINING.
