MP-93-447

LICENSEE EVENT REPORT (LER)

FACILITY NAME (1)						Millstone Nuclear Power Station Unit 2									DOCKET NUMBER (2)							PAGE (3)																	
						0 5 0 0 0 3 3 6 1									OF 0 5																								
TITLE (4) Reactor Trips on Steam Generator Low Water Level																																							
EVENT DATE (5)						LER NUMBER (6)						REPORT DATE (7)						OTHER FACILITIES INVOLVED (8)																					
MONTH			DAY			YEAR			YEAR			SEQUENTIAL NUMBER			REVISION NUMBER			MONTH			DAY			YEAR			FACILITY NAMES												
																											0 5 0 0 0												
0 2 2			9 3			9 3			-			0 0 4			-			0 1			0 6			0 4			9 3			0 5 0 0 0									
OPERATING MODE (9)						THIS REPORT IS BEING SUBMITTED PURSUANT TO THE REQUIREMENTS OF 10 CFR § (Check one or more of the following) (11)																																	
1						20.402(b)						20.402(c)						<input checked="" type="checkbox"/> 50.73(a)(2)(iv)						73.71(b)

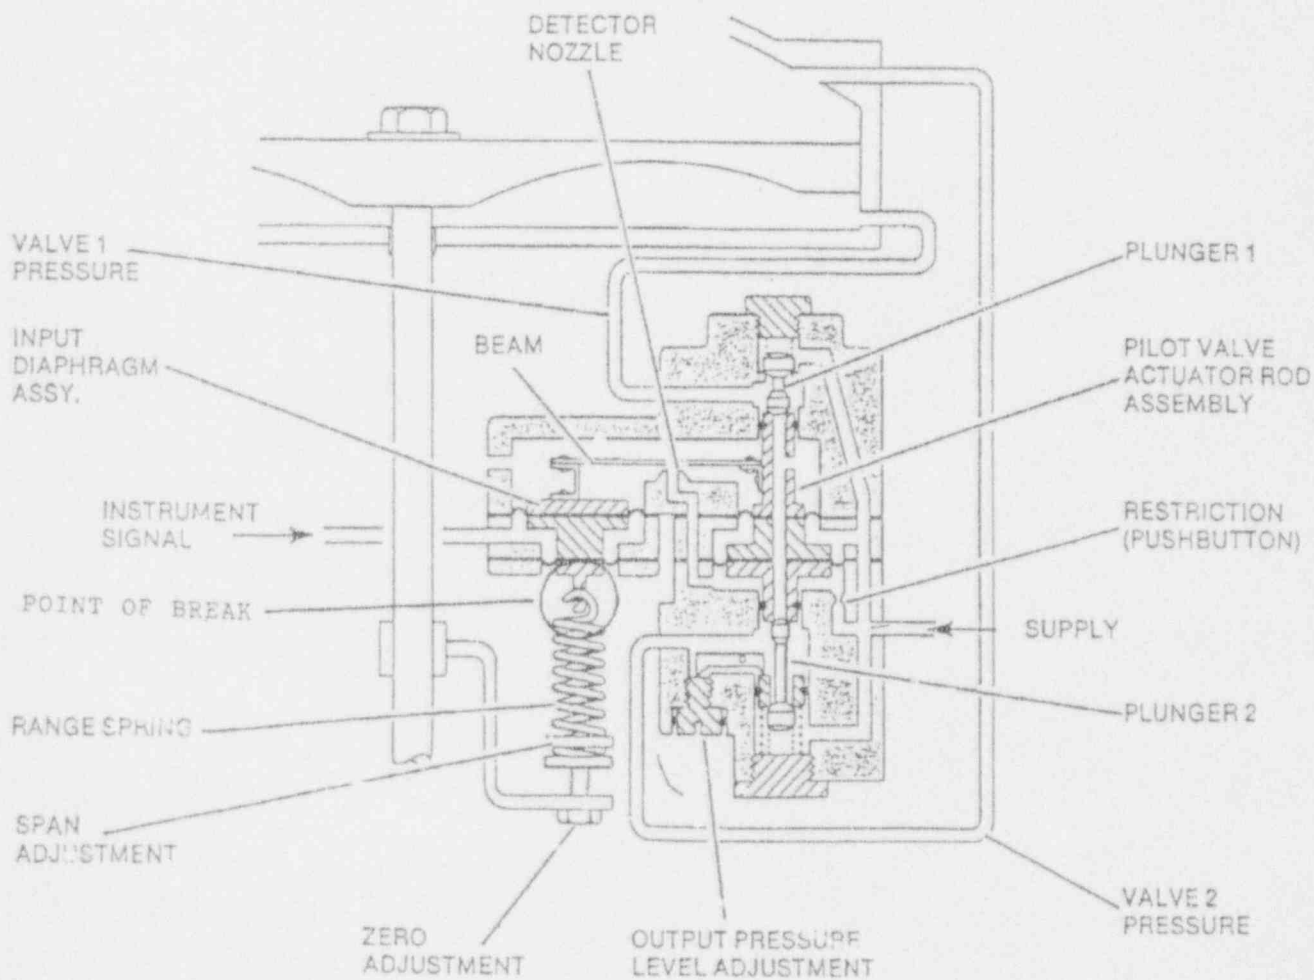
Figure 1
Atmospheric Steam Dump Valve Positioner

The cause of the initiating event on February 22, 1993, was the "A" steam generator ADV failing open. The ADV failed open when the spring attachment fitting broke at the point where the spring attaches to the inner diaphragm assembly. The break at the attachment point resulted from a combination of misalignment of the feedback spring and bending of the range spring attachment (possibly during installation), and positioner vibration during normal plant operation. See Figure 1 for a diagram of the ADV valve positioner.

The valve positioner for the "A" steam generator ADV was replaced and the feedback spring was realigned. The valve positioner for the "B" steam generator ADV was replaced, and the as found feedback spring alignment was satisfactory.

- The ADV Positioners have been added onto the Production Maintenance Management System (PMMS) and will be replaced every outage.
- All licensed operators have received specific classroom training on the construction of the new steam generators with emphasis placed on how the differences between the old and new steam generators will affect level response.
