EFFECTS OF APRIL 17, 1978 TORNADO  
ON CATEGORY I STRUCTURES AT THE  
GRAND GULF NUCLEAR STATION

PREPARED BY  
BECHTEL POWER CORPORATION  
JULY, 1978

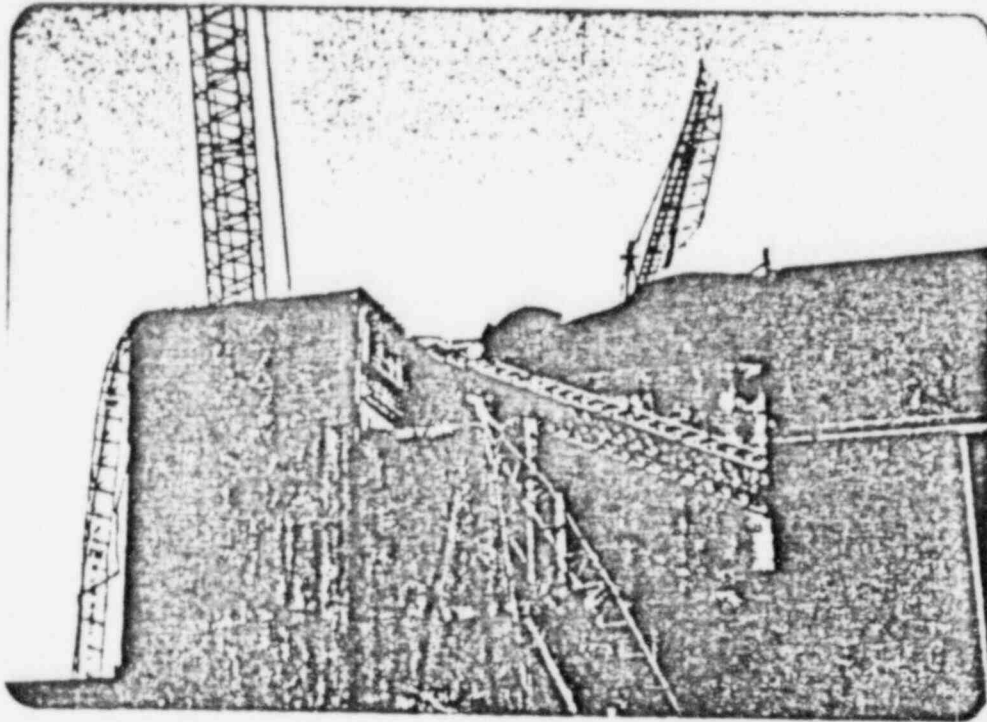
Tornado winds caused the collapse of the south tower construction crane which damaged the freestanding Unit 1 containment liner plate hip course (see drawing SKC-0012T and Photograph 4-1). Most of the damage extended between azimuth  $53^{\circ}$  and azimuth  $153^{\circ}$  above elevation  $247' - 6''$  (see Photograph 4-2) and between azimuth  $213^{\circ}$  and azimuth  $273^{\circ}$  above elevation  $247' - 6''$ .

When the south tower construction crane collapsed over the Unit 1 auxiliary building the counterweight and motor fell onto the roof slab at El. 228'-0". The weight of the motor and counterweight was estimated to be 12 tons.

- 4.1 South elevation of the Unit 1 containment and auxiliary building showing the collapsed south tower crane across the auxiliary building roof slabs at El. 228'-0" and El. 266'-0" (not poured) with boom draped over the west (left) side.

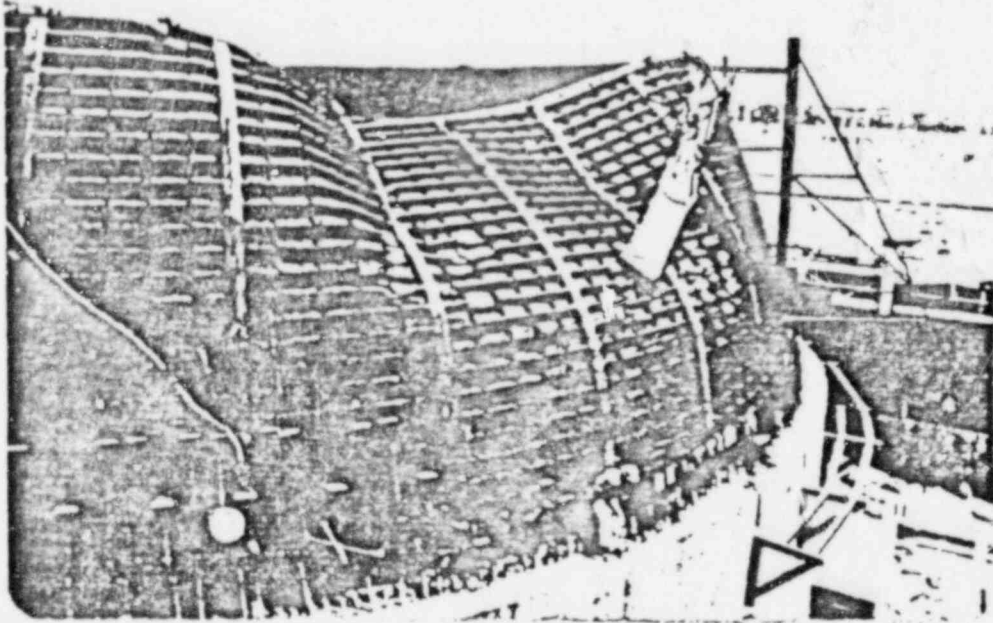
There was less severe damage between azimuth 173° and azimuth 213° above elevation 268' - 0". This consisted of buckling of the liner plate due to the impact. The portions of liner plate that were damaged were being erected at the time of the tornado and had not been accepted as part of the permanent plant. The fabricator of the liner plate has removed the damaged portions and replaced with new material.

4.2 Damage to the freestanding Unit 1 containment liner plate between azimuth  $53^{\circ}$  and  $153^{\circ}$ . Concrete shown is poured to El. 243'-6".
