MIDLAND PROJECT -
DOCKET NOS 50-329 AND 50-330
BORATED WATER STORAGE TANK FOUNDATION OL DESIGN CALCULATIONS
FILE: 0485.16, 0.4.9.49 SERIAL: 16172

The Existence of Cracks in the Borated Water
Storage Tank Foundation - Units 1 and 2

FINAL REPORT

PROJECT: Consumers Power Company
Midland Plant Units 1 and 2
Bechtel Job 7220

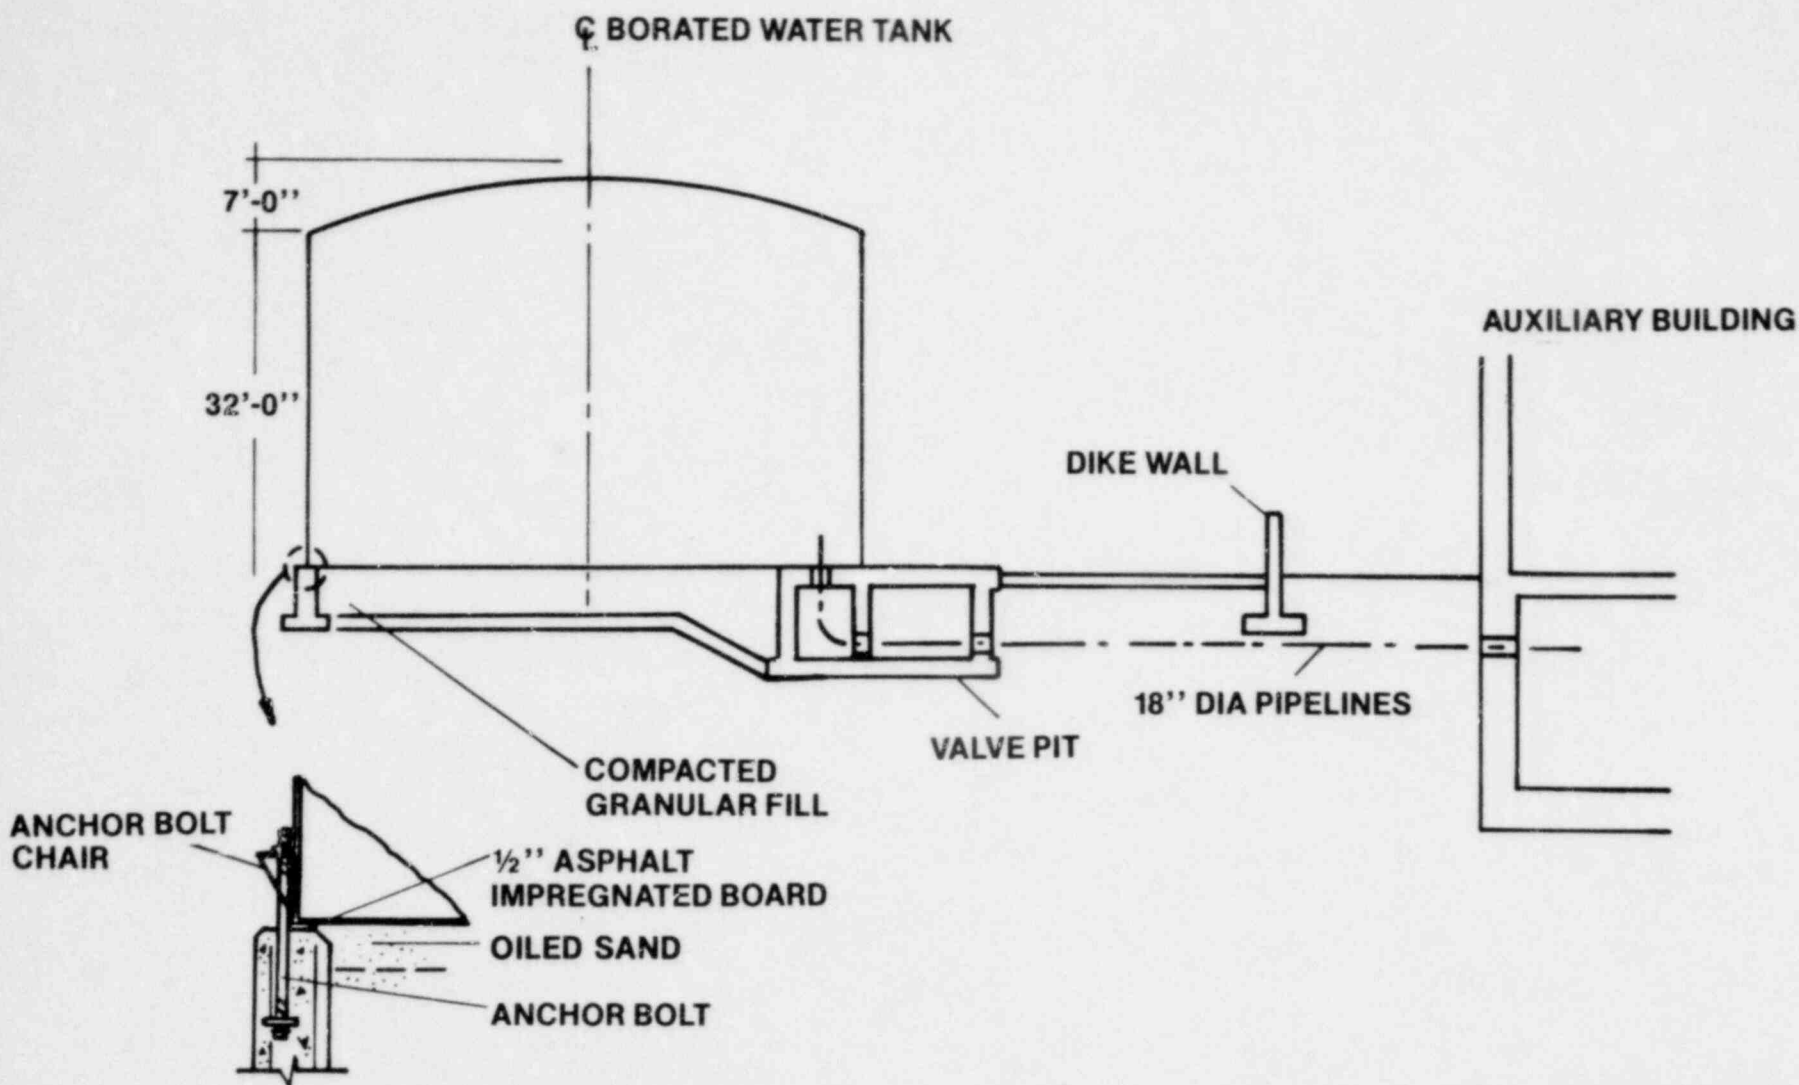
FIGURE BWST-1

As shown in Figure BWST-1, the tanks' outside shell is attached to the ring wall foundation by equally spaced anchor bolts that transfer induced forces from the anchor chair. Field observations indicated gaps between the anchor bolt nut and anchor chair in several locations around the periphery of the tank. In other locations, the anchor chairs were deflected, indicating high tensile stress in the bolts. This anchor bolt behavior results from the distortion of the foundation ring which is caused by differential settlement; this agrees with the conclusions of the modified structural analysis. The tension induced in the bolts is similar to the tension induced by a preload phenomenon and does not affect the ability of the bolts to resist design loads. Although the ring wall is cracked, it is capable of providing the necessary anchorage for the anchor bolts to resist tension due to externally applied forces.

The concrete ring wall confines the foundation material which is loaded by the tank; this confinement causes hoop tension in the ring wall. Cracks equal in size to those observed in the ring wall expose the reinforcing steel to the groundwater and atmosphere. If the reinforcing steel carrying the hoop tension were to corrode significantly, the ability of the ring wall to resist the hoop tension would be reduced. Reduction of overall strength of the ring wall, combined with increased displacements (both vertically and laterally) of the ring wall, may occur, causing stress concentrations in the tank near anchor chairs.

Review of field observations and analytical investigations leads to an understanding of the probable cause. When the tank was loaded, the bearing pressure on the tank area was increased to approximately 2 ksf greater than the valve pit area; however, this 2 ksf differential was not accounted for in the calculation for ring beam reinforcing. As a result, the valve pit restrained the tank foundation from settling uniformly, causing bending at the ring wall/valve pit junction.

2. A reinforcing ring beam will be constructed around the existing ring wall. The new ring beam is sized to resist all imposed loading from the tank, including additional future bending induced by the predicted residual differential settlement between the ring wall and the valve pit. Shear connectors transfer the shear force from the existing ring wall to the new ring beam. One end of the shear connectors will be installed in the existing ring wall by drilling and grouting. The other end will be cast in the new ring beam. All cracks in the existing ring wall that exceed 10 mils will be repaired by pressure grouting. The main reinforcing bars in the new ring beam that terminate at the valve pit are anchored in the roof or base slab of the valve pit by grouting them into drilled holes.

3. After ring beam construction is complete, the Unit 1 tank (BWST 1T-60) will be releveled. The Unit 2 tank (BWST 2T-60) need not be releveled because the ring wall foundation is not severely distorted.
