LICENSEE EVENT REPORT

TOLEDO EDISON COMPANY
DAVIS-BESSE NUCLEAR POWER STATION UNIT ONE
SUPPLEMENTAL INFORMATION FOR LER NP-32-82-03

DATE OF EVENT: April 19, 1982

LER # 82-019

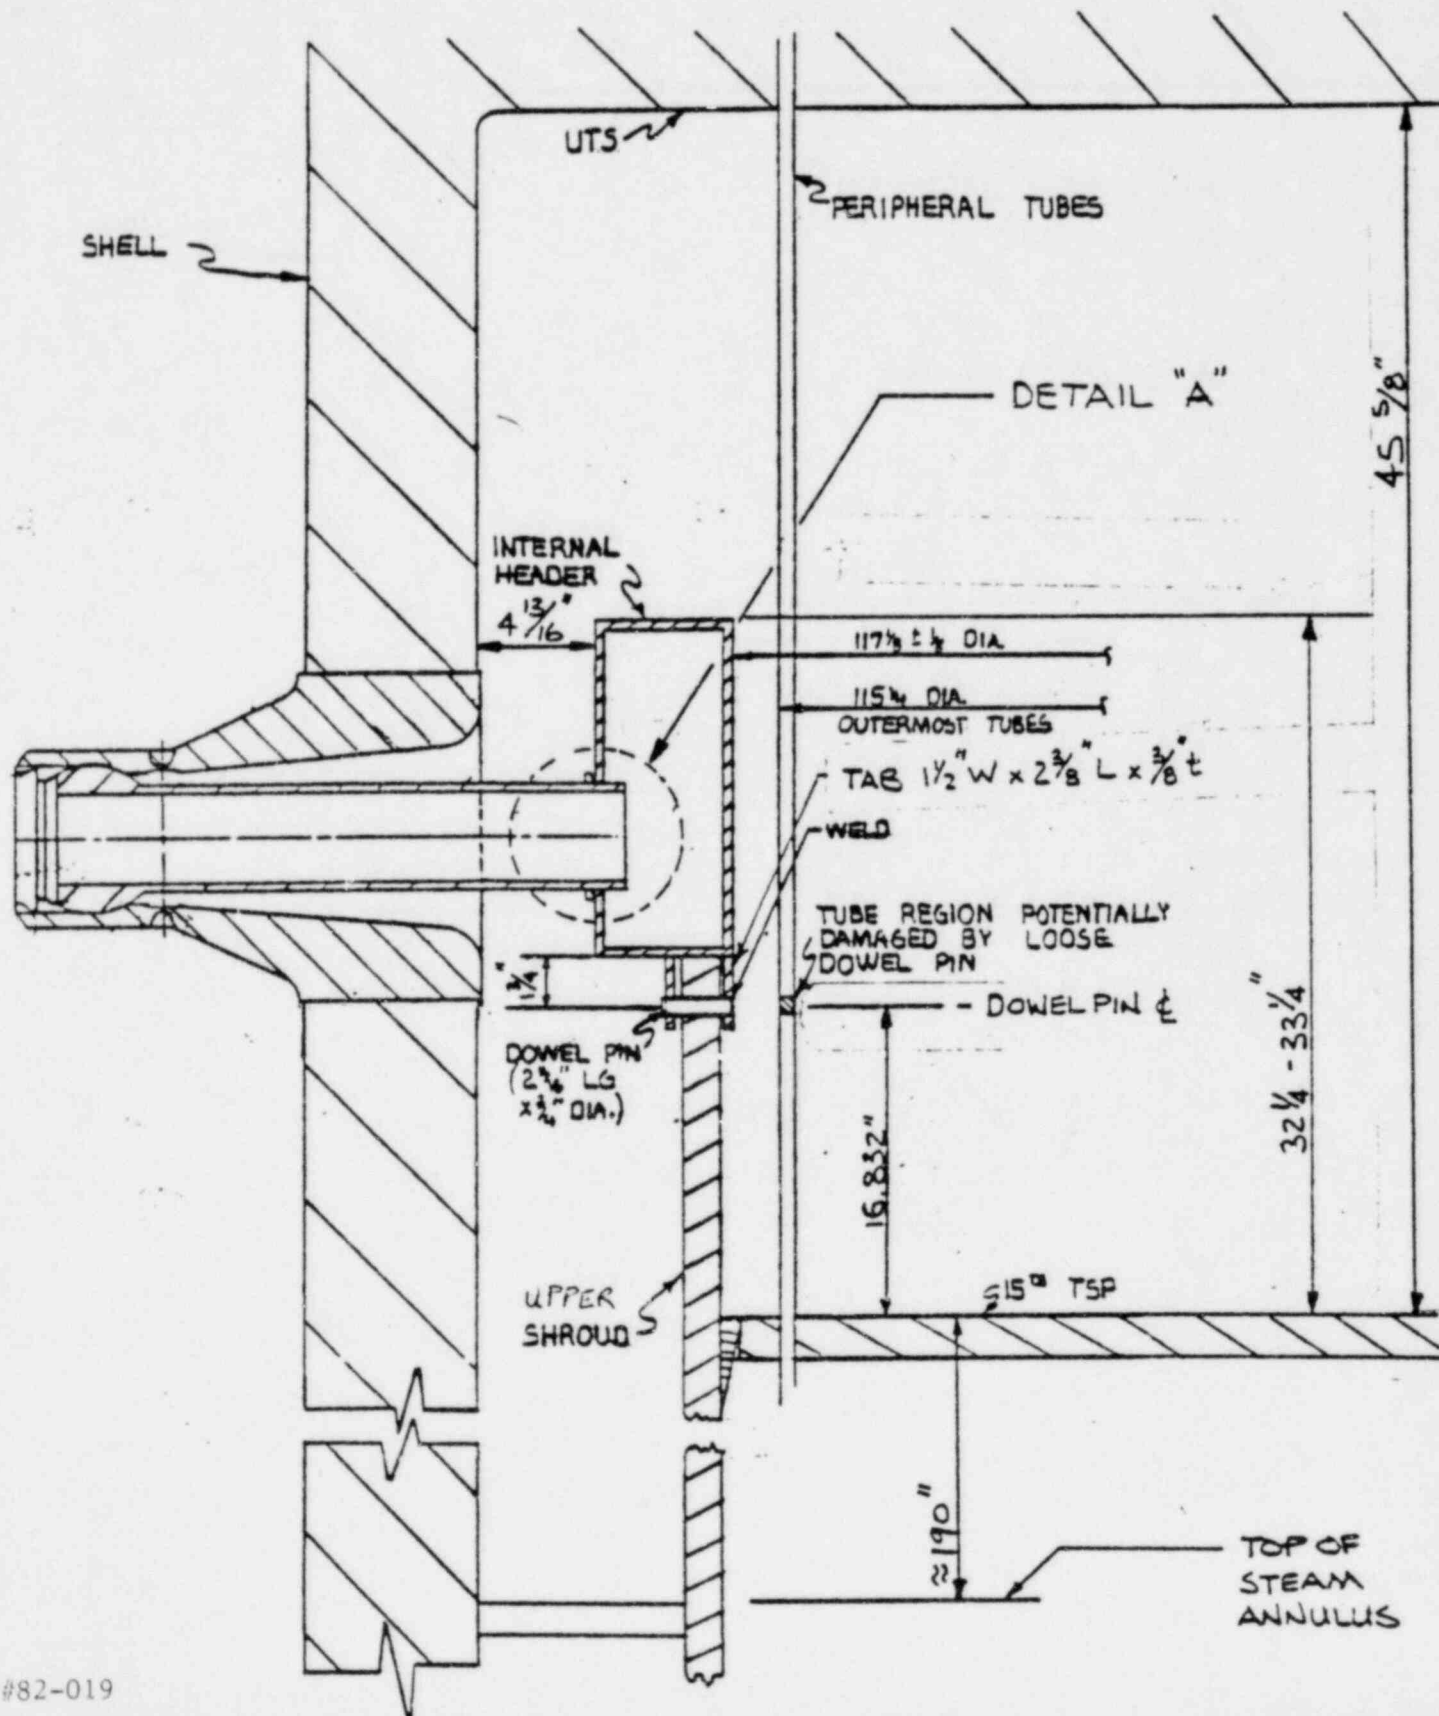
LONGITUDINAL SECTION AT DOWEL PIN

- (6) Dowel pins are missing at six of eight locations inspected. Three dowel pins and two brackets have been retrieved from the steam annulus area in 1-2 SG.

- (7) There is evidence of wear on dowel pins and brackets.
- (8) The auxiliary feedwater nozzle thermal sleeve was not in alignment with the header on Unit #1 (1-1 SG).

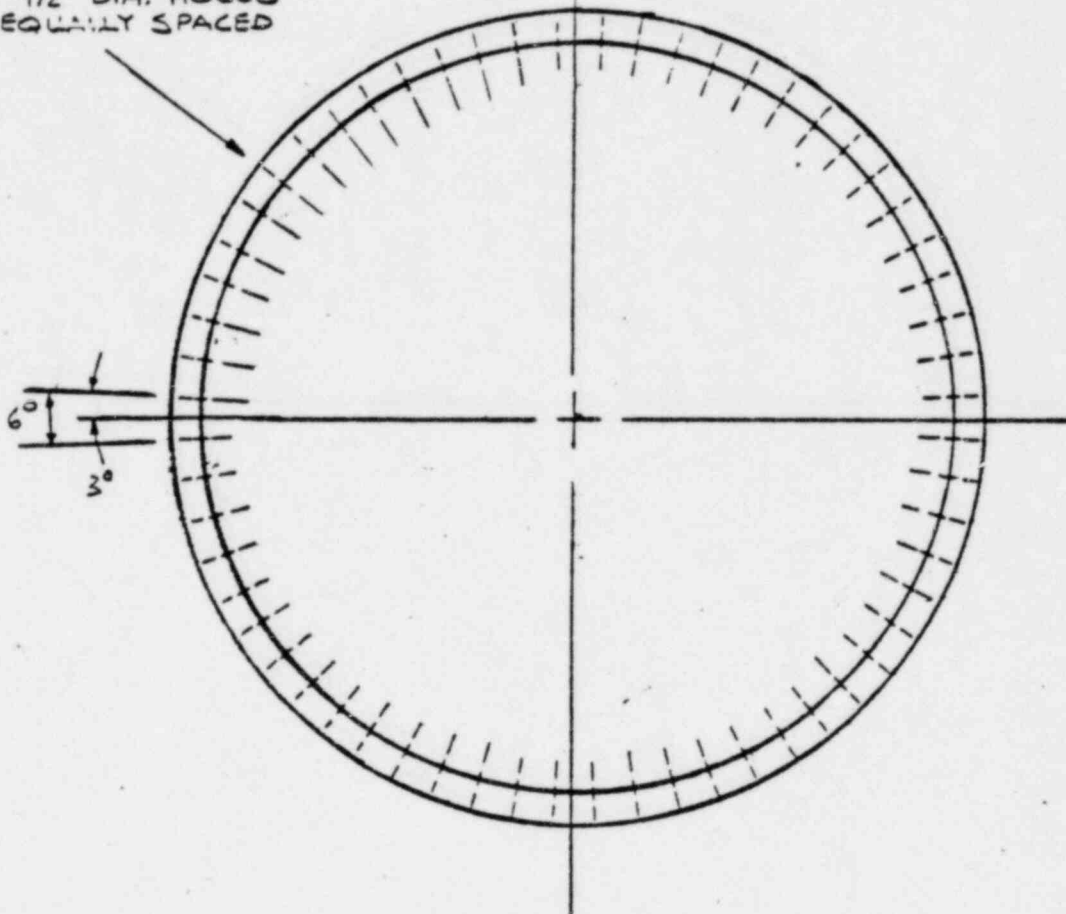
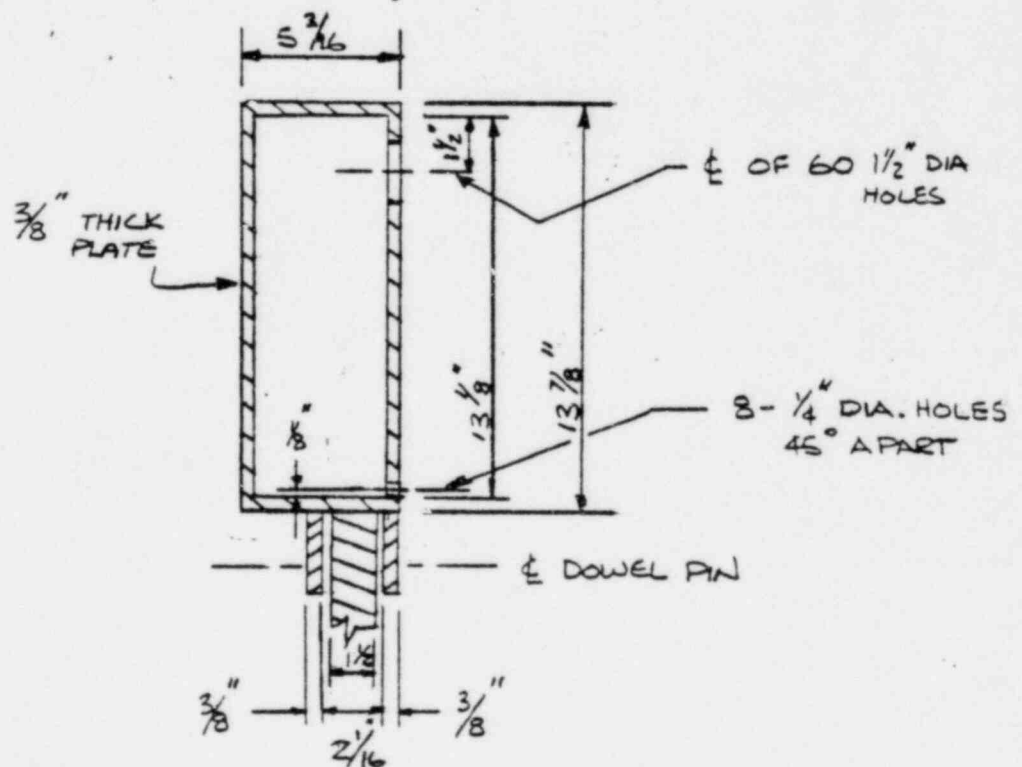
LOCATION OF AUXILIARY FEEDWATER

- (4) The outward wall of the header is distorted inward (concave) as much as $4\frac{1}{2}$ ".
- (5) Certain header support brackets are bent, and on some the bottom ligaments are torn out or have broken off.
