REPORT AND SAFETY EVALUATION  
OF THE  
BROWNS FERRY UNIT 3 PARTIAL SCRAM FAILURE  
OF JUNE 28, 1980

DIVISION OF NUCLEAR POWER  
July 6, 1980

prepared by  
TENNESSEE VALLEY AUTHORITY  
Reactor Engineering Branch

REPORT ON  
THE BROWNS FERRY 3  
PARTIAL FAILURE TO SCRAM EVENT  
ON JUNE 28, 1980

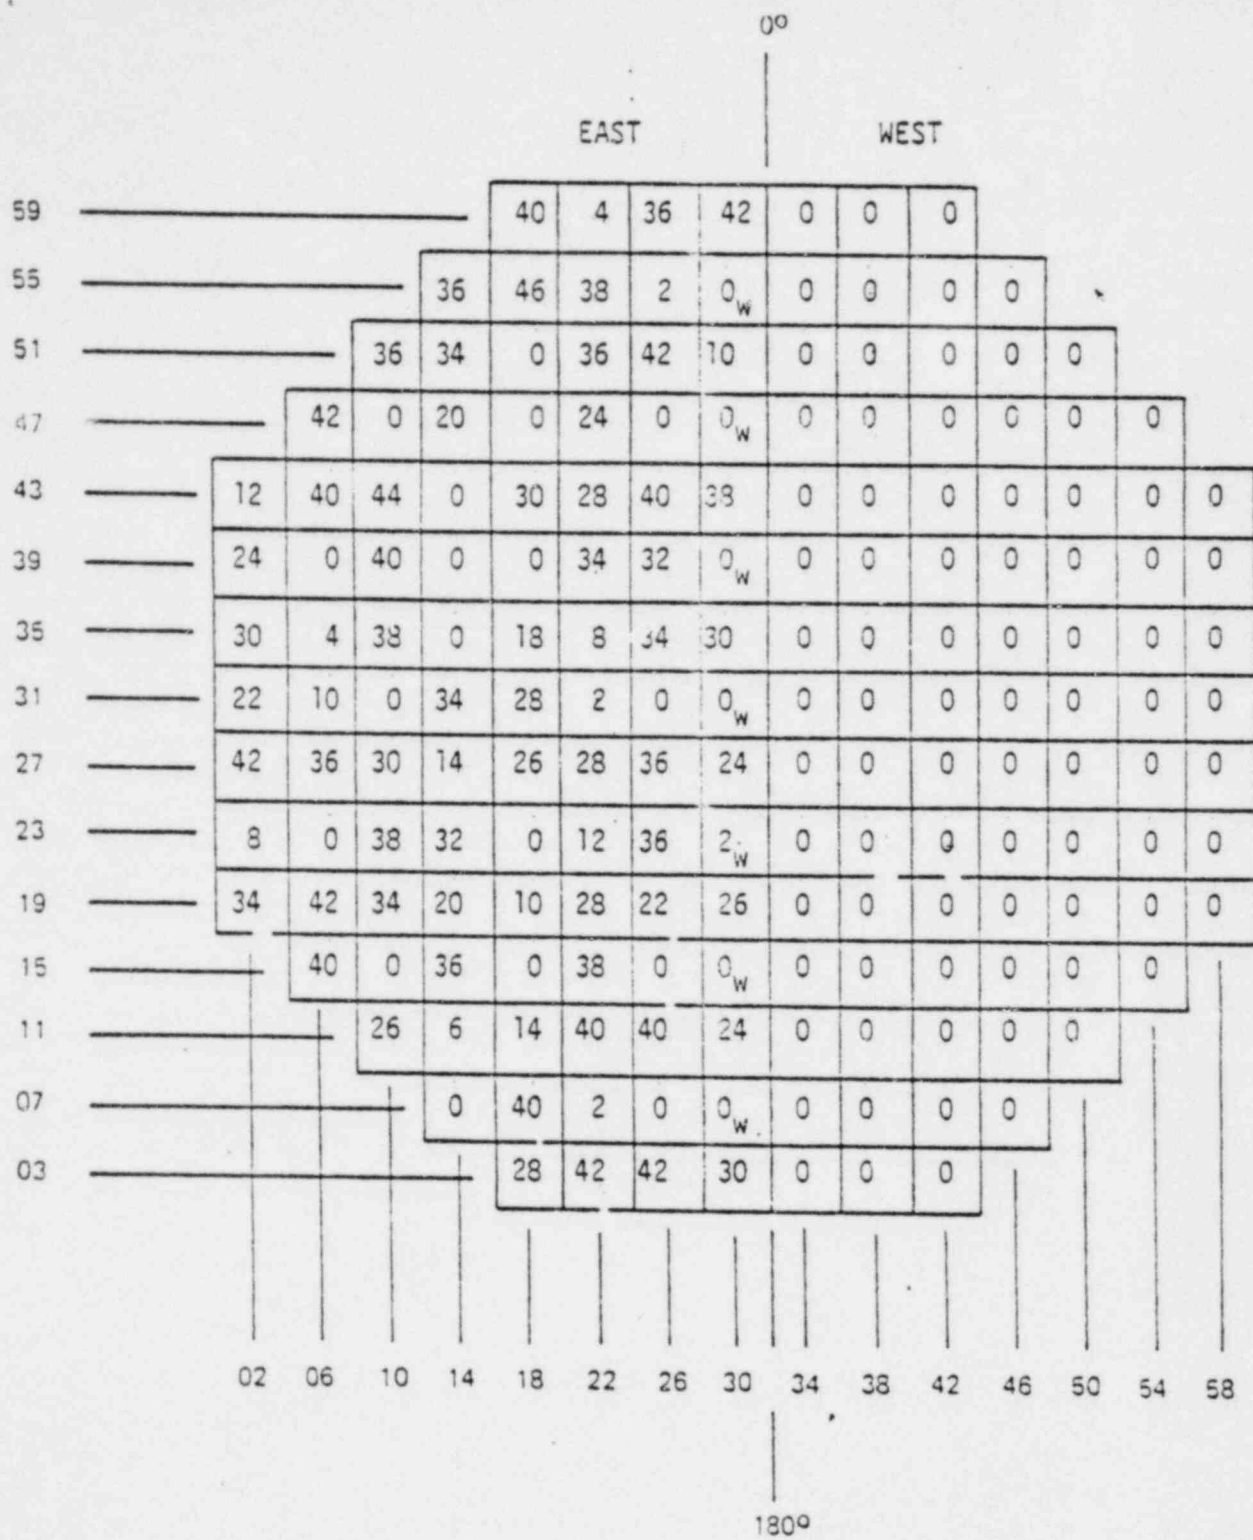
Figure 2-2 Control Rod Positions After First Scram

This same approach can now be used to infer the cause of limited control rod motion during the first manual scram. From Figures 2-2 and 2-3, the average control rod insertion during the first scram was 20 positions. From this value we would infer (using the GE test results) that there was an average of only .35 gallons per drive available (or about 33 gallons total) in the

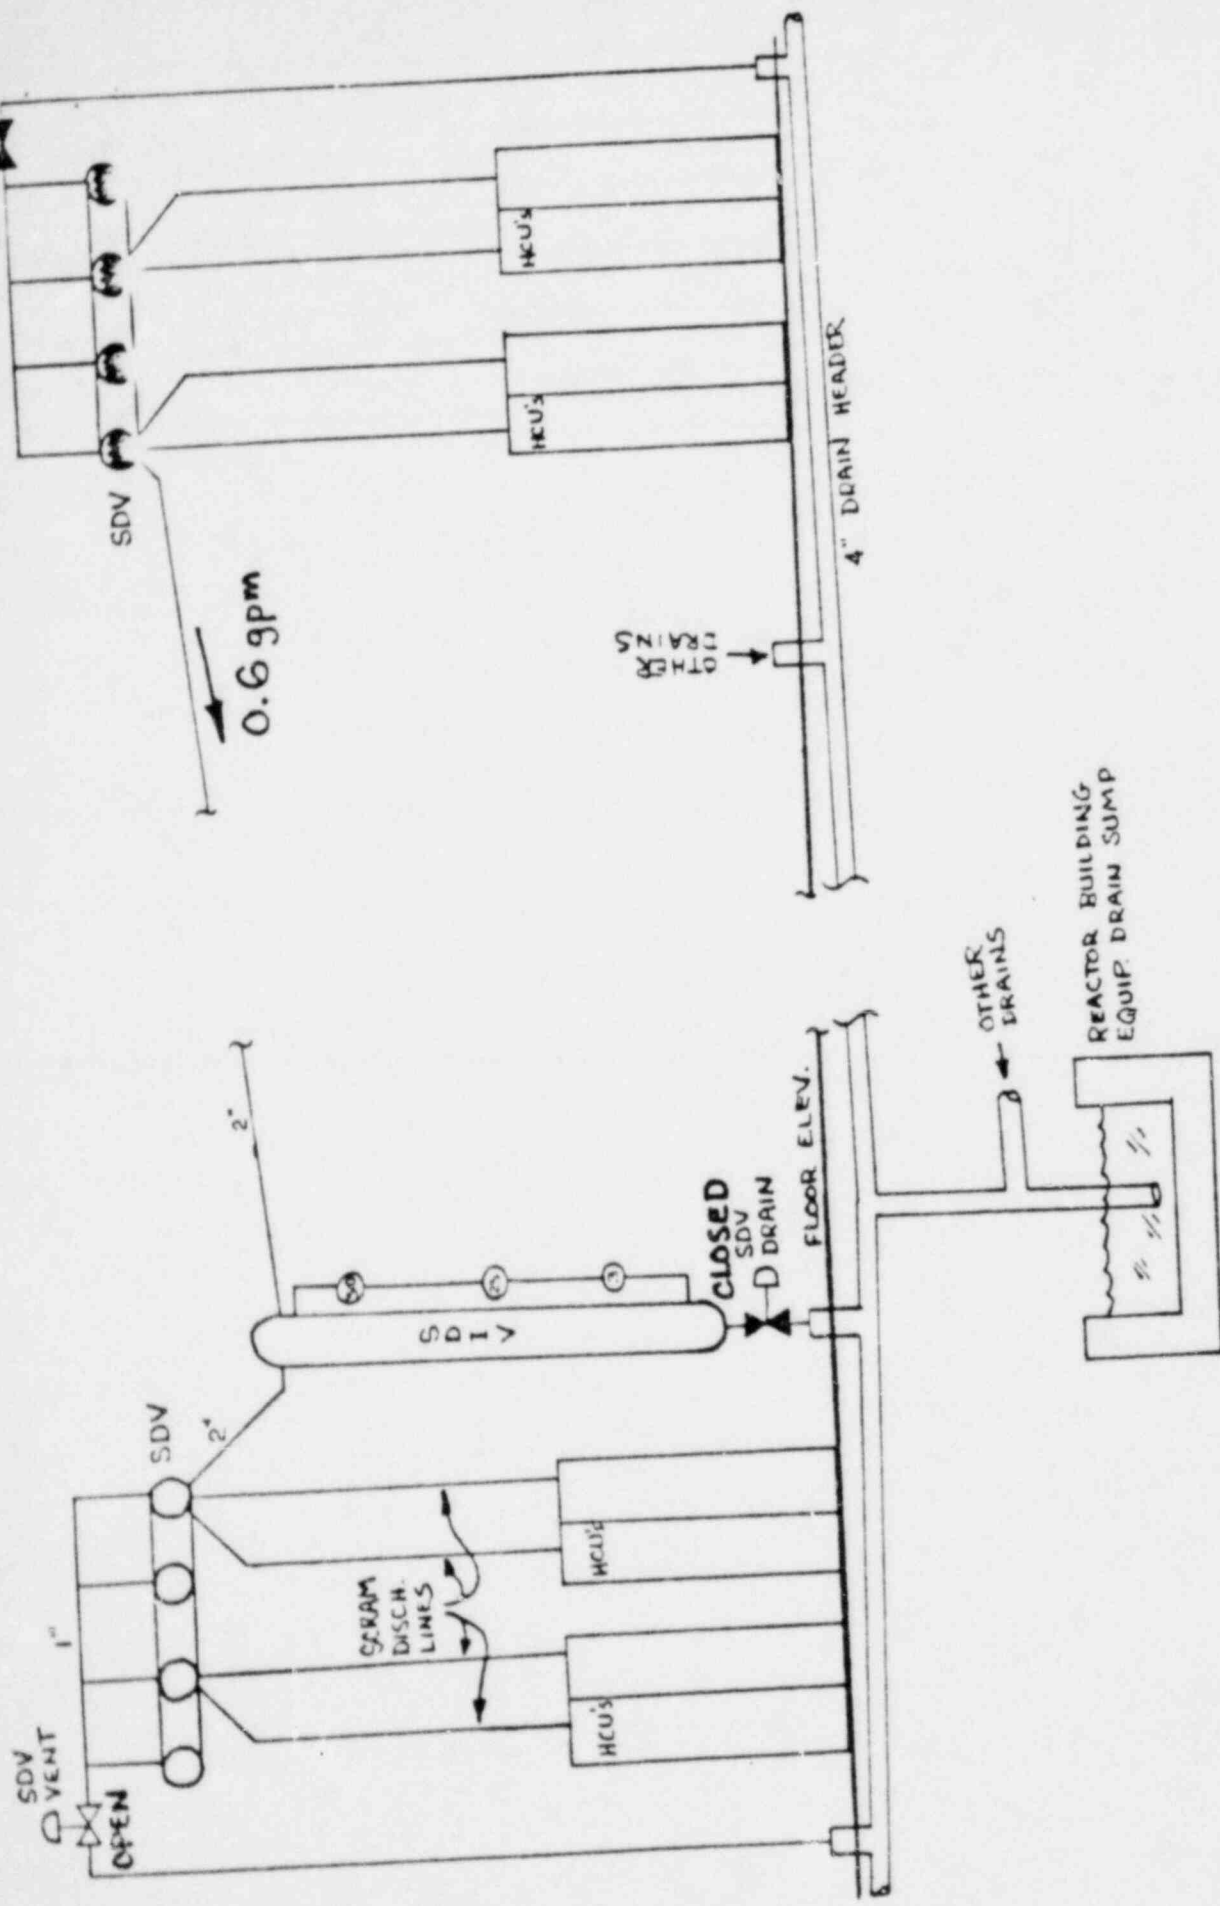
FIGURE 3.6 SIMULATED EAST SDV VENT LINE BLOCKAGE TEST

With the West header drained to empty, the East header was allowed to drain into the SIV with the East header vent valve and SIV drain valve closed and the West header vent valve open. For this condition (which simulated a blocked East header vent), water drained from the East SDV into the SIV tank at a rate of only 0.6 gpm.

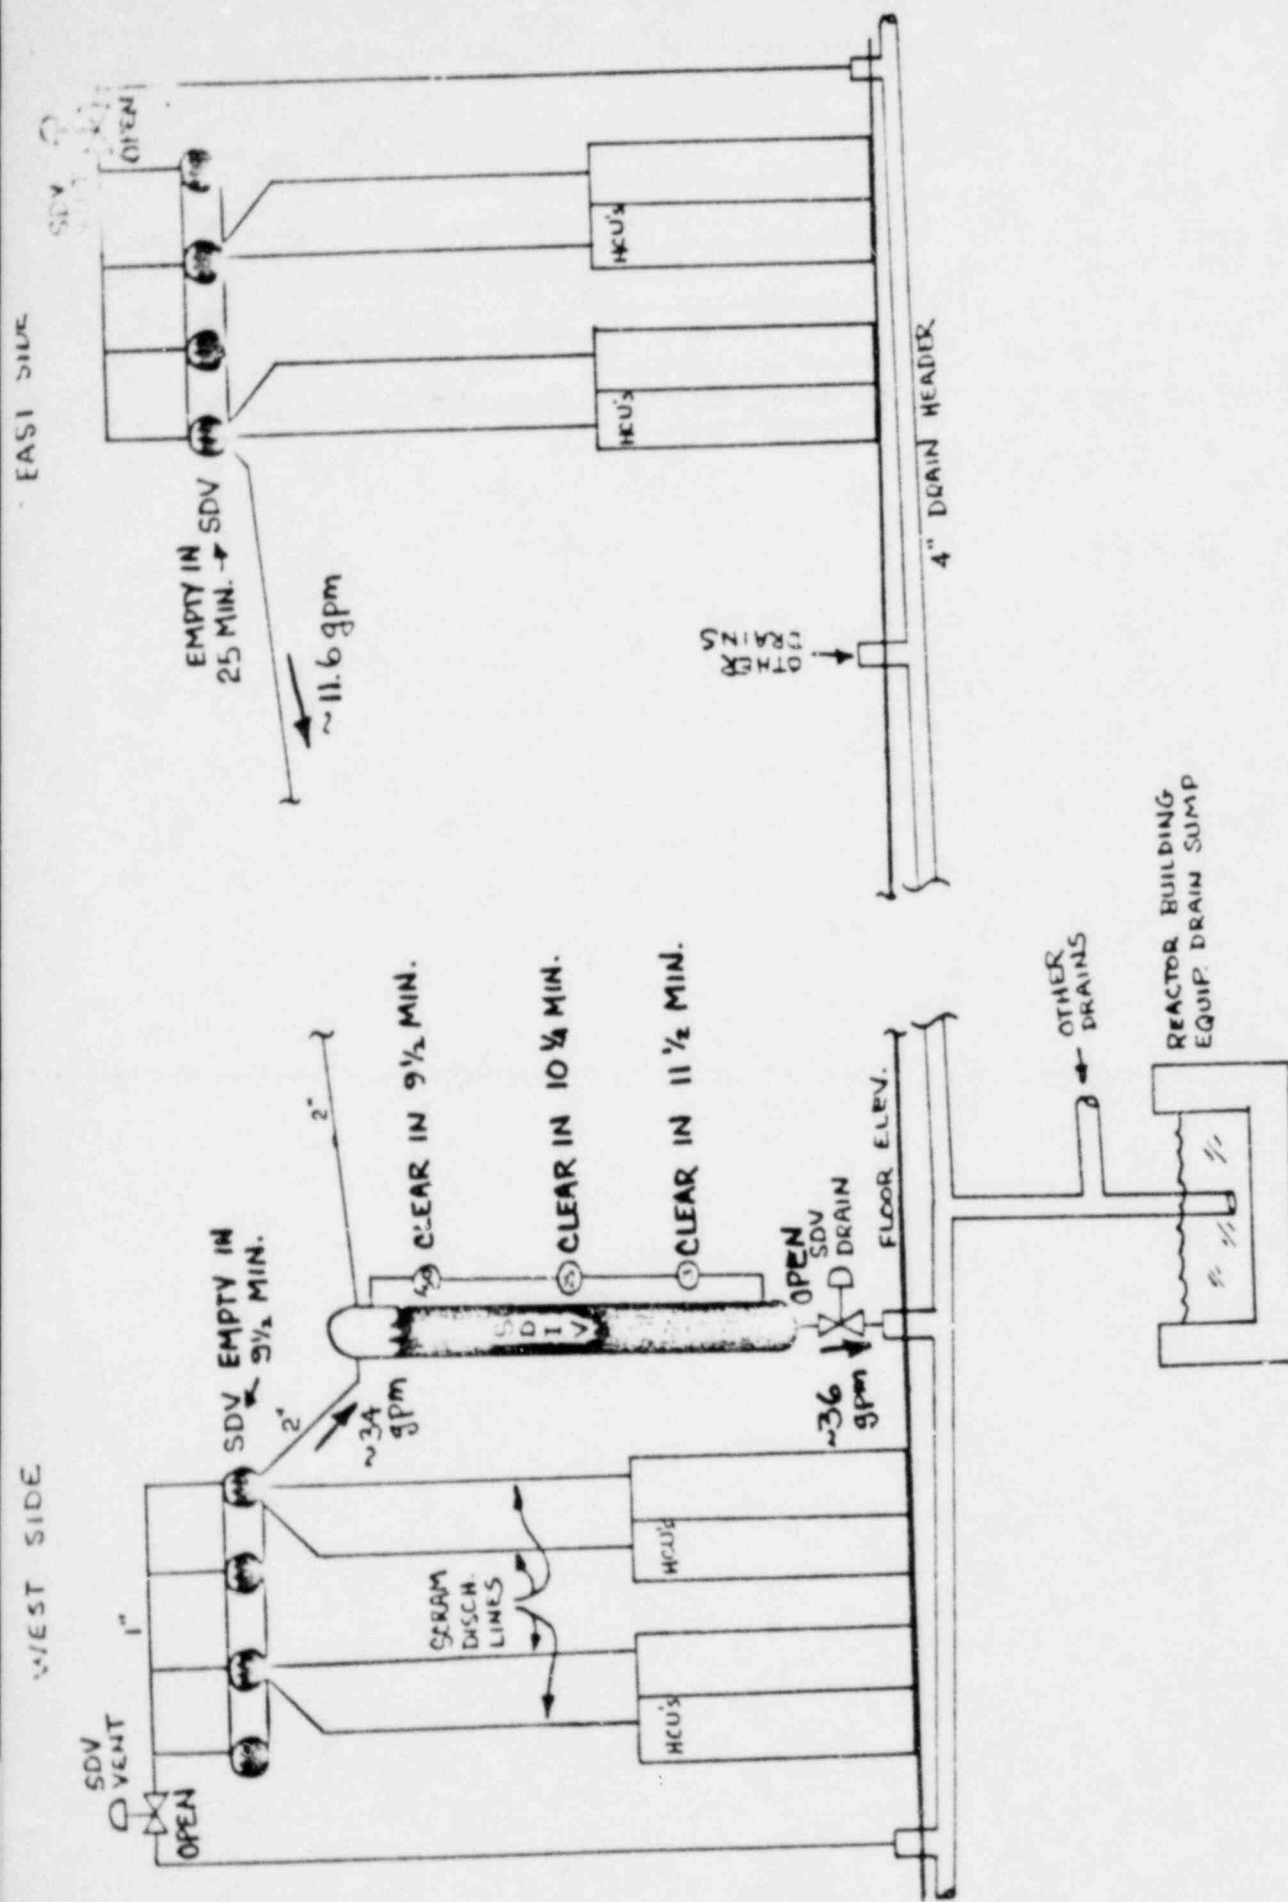
FIGURE 3.9 NORMAL DRAIN TEST

These tests were performed to determine the drain times and drain rates of the SDV and SIV during normal draining (open vent and drain) conditions. Drain tests were performed for both East and West headers draining at the same time. The system was first filled with the SDV vent valves open and the SIV drain valve closed. At time zero the drain valve was opened. Ultrasonics indicated that the West header emptied after about 9½ minutes while the East header emptied considerably later at about 25 minutes. Additionally, the 50 and 25 gallon switches in the scram instrument volume cleared at about 9½ minutes and 10 1/4 minutes, respectively. The SIV 3 gallon switch cleared after 11 minutes and 20 seconds had elapsed. Based on the volumes associated with the SDV headers, these tests showed the average drain rate (with both SDV headers draining together) of the East SDV header to be 11.6 gpm while the average drain rate of the West SDV header was shown to be about 35 gpm. The average drain rate for the SIV based on clearing of the SIV level switches was 24.5 gpm. However, this drain rate was with the East SDV header still draining into the SIV at an average rate of 11.6 gpm. That is, the SIV drained 24.5 gpm faster than the East SDV drained.

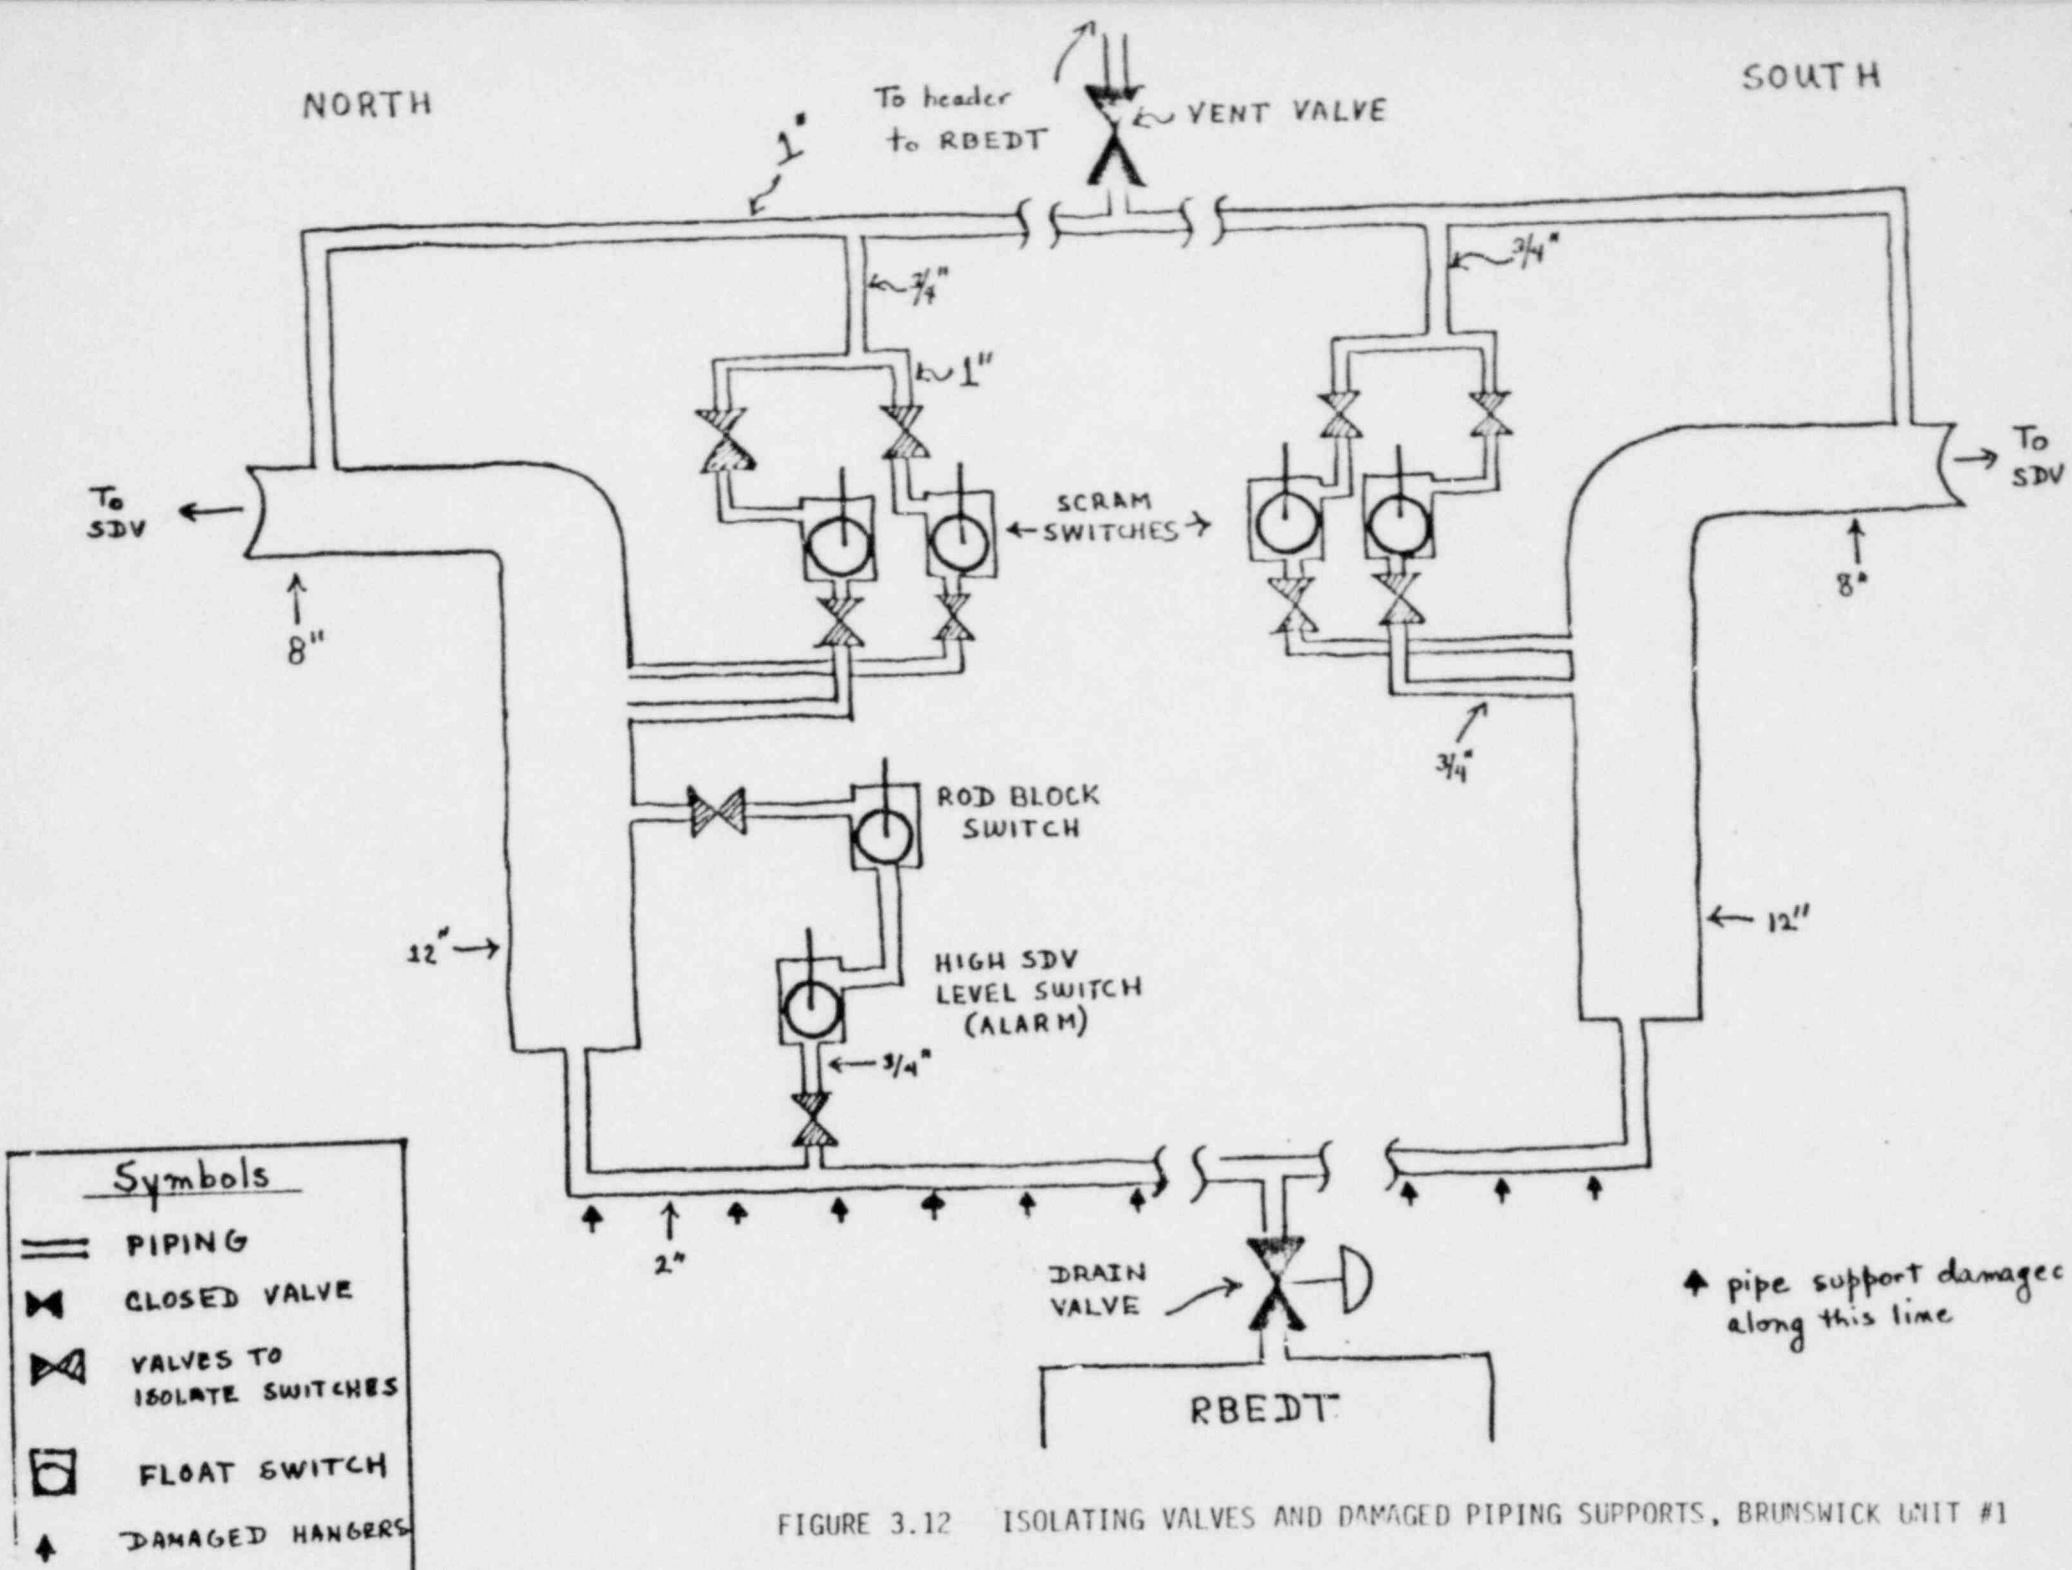
FIGURE 3.12 ISOLATING VALVES AND DAMAGED PIPING SUPPORTS, BRUNSWICK UNIT #1
