FINAL REPORT
IN RESPONSE TO PETITION MADE BY
THE OFFICE OF THE ATTORNEY GENERAL, STATE OF ILLINOIS,
IN THE MATTER OF REINFORCING STEEL DAMAGED DURING
THE INSTALLATION OF CORED AND DRILLED HOLES
AND THE MATTER OF THE OFF- GAS BUILDING ROOF
FOR LASALLE COUNTY, UNITS 1 & 2

Commonwealth Edison Company
Chicago, Illinois

May 7, 1982

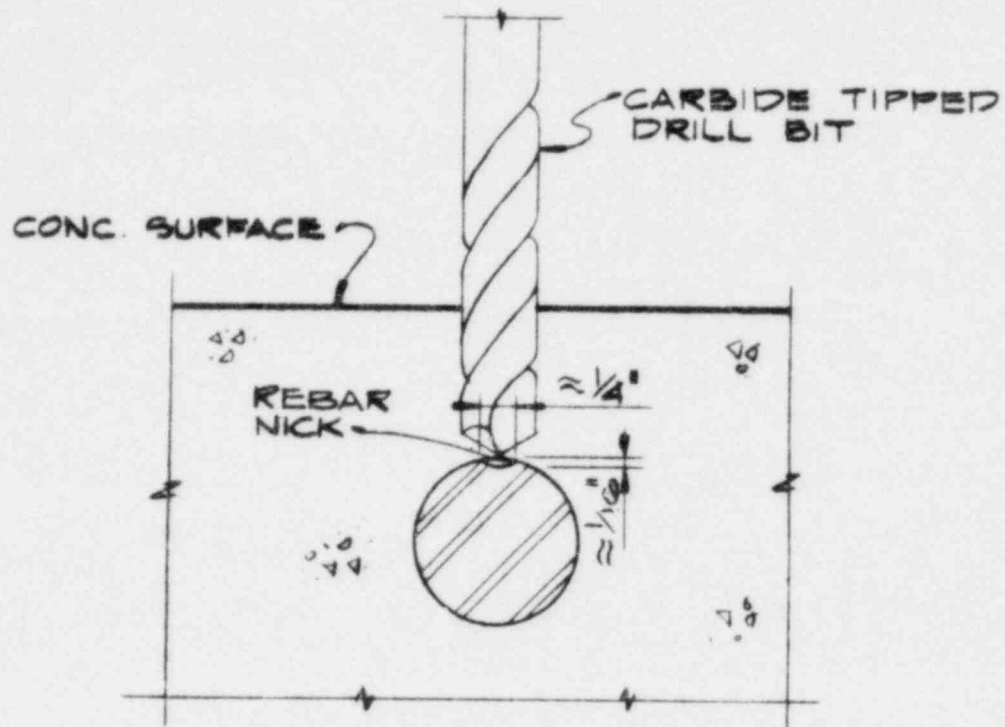
FIGURE 2.2-4

NICKED REINFORCING STEEL

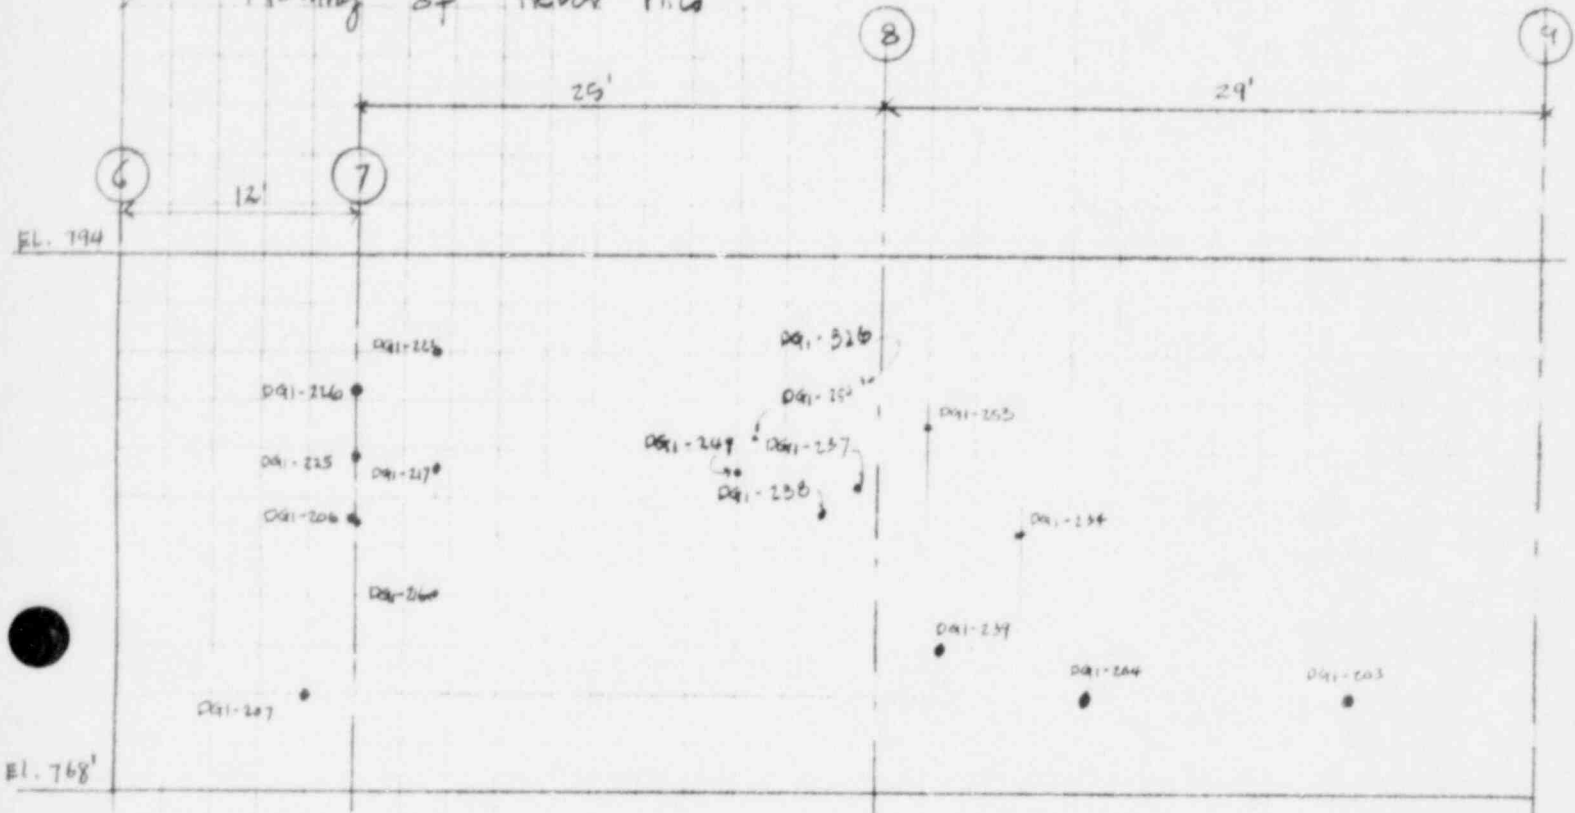
EAST WALL
CRITICAL ELEVATION

FOR REBAR CUTS ON THE WEST SIDE SEE NOTE ON P. 198

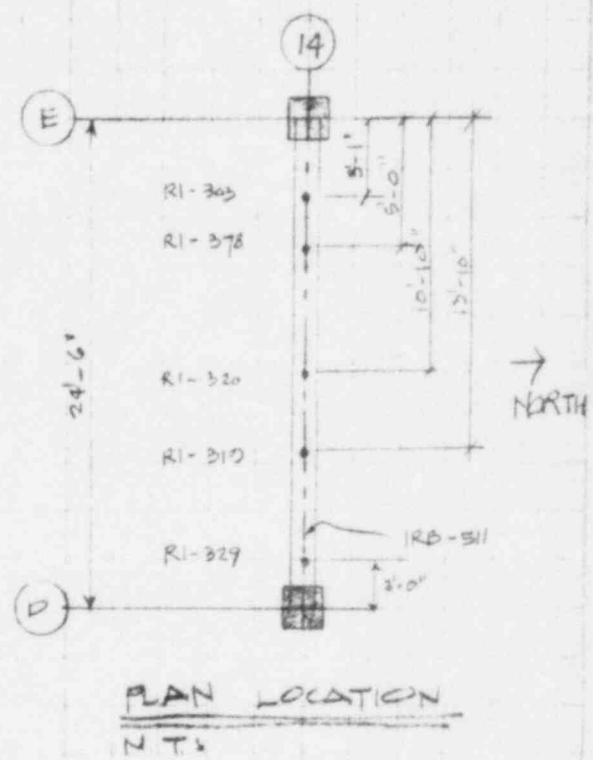
Calcs. For EVALUATION OF REBAR CUT	
OF BEAM 1RB-511 (H, B, E) S-215	
<input checked="" type="checkbox"/> Safety-Related	<input type="checkbox"/> Non-Safety-Related
