CREATORS OF ELECTRICAL
POWER SUPPLY SYSTEMS

Reference: Possible Reportable Defect 10CFR21
Component: Robertshaw Controls Company
Temperature Control Valve Models 1284 & 1825
Size 5" & 6"

ROBERTSHAW CONTROLS COMPANY

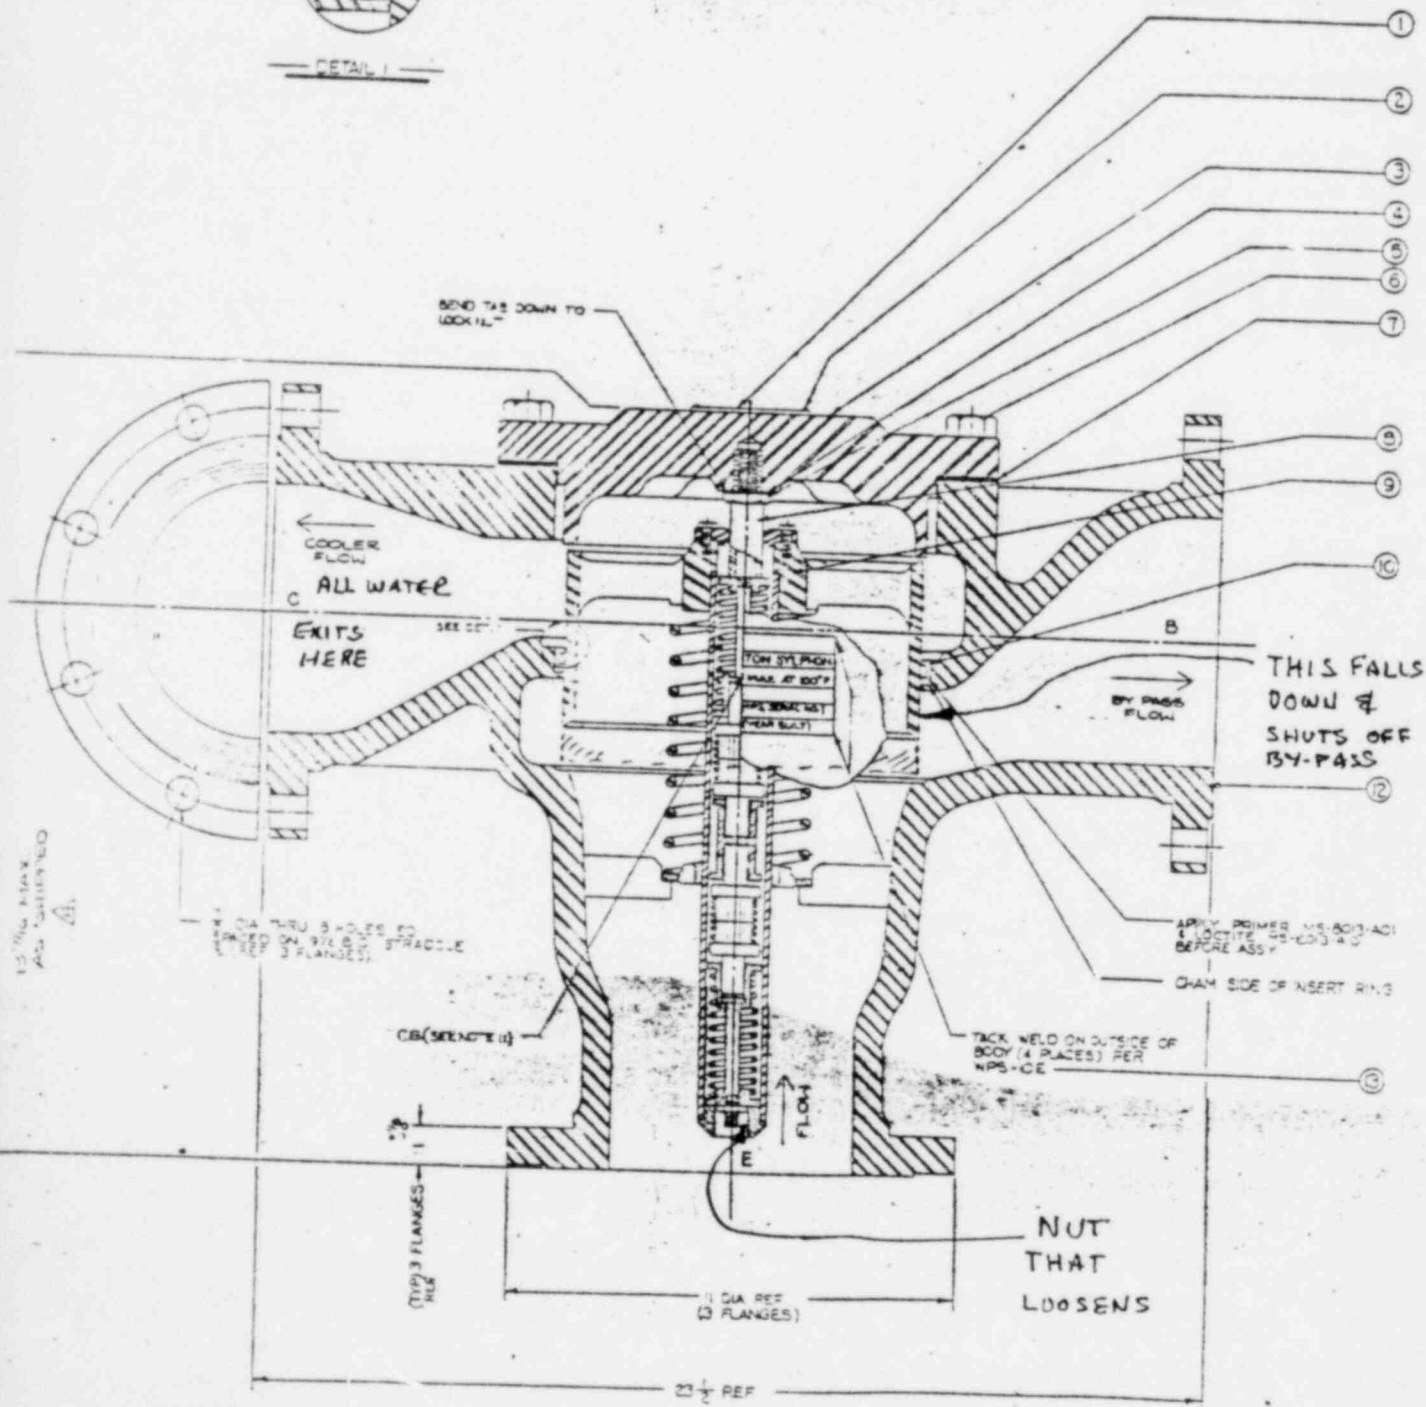
W849847

Attached is a copy of a letter from the Robertshaw Controls Company dated May 13, 1982. The nut referred to is shown on the attached partial drawing N84984-F3.

Robertshaw Models 1284 and 1825 in the 5" and 6" sizes incorporate a lower overrun assembly which absorbs movement generated by the thermal assemblies under certain conditions. The overrun assembly consists of a spring restrained between two end pieces whose length and "breakdown" is set by an axial bolt and nut. Under normal conditions, this assembly acts as a rigid member. Should the nut not be firmly affixed in place and "backoff" the longer length of the overrun assembly results in valve stroke which is not generated by the thermal assembly. This additional stroke makes the thermal assembly control at a lower temperature, thus, over cooling the system.

In the Fall of 1977, it was reported to us that the nut had completely "backed off" in one valve intended for nuclear service. This allowed the valve to go into the full cooling position. At that time the design of the overrun assembly called for the nut to be staked in place. The design was revised to require soldering the nut to the bolt. No further reports were received of any difficulty.

In our investigation, we also discovered that at least one lot of overrun assemblies for the 5" size valves had been placed in our stock without solder locking the nut in place. Again, since this is also used in commercial valves, we cannot determine if any of this group was actually supplied to you for use at a nuclear power plant site.

DRIVE INSERT LIP INTO RETAINING GROOVE
8 PLACES MIN. EQ. DISTANCE APART
AN 8T32 PLUS GAGE MUST GO THRU
INSERT AFTER STAKING
