**Wisconsin Electric** POWER COMPANY  
231 W. MICHIGAN, P.O. BOX 2046, MILWAUKEE, WI 53201

DOCKET NO. 50-266  
STEAM GENERATOR REPAIR  
POINT BEACH NUCLEAR PLANT, UNIT 1

REPLACEMENT STEAM GENERATOR EQUIPMENT  
TECHNICAL DESCRIPTION

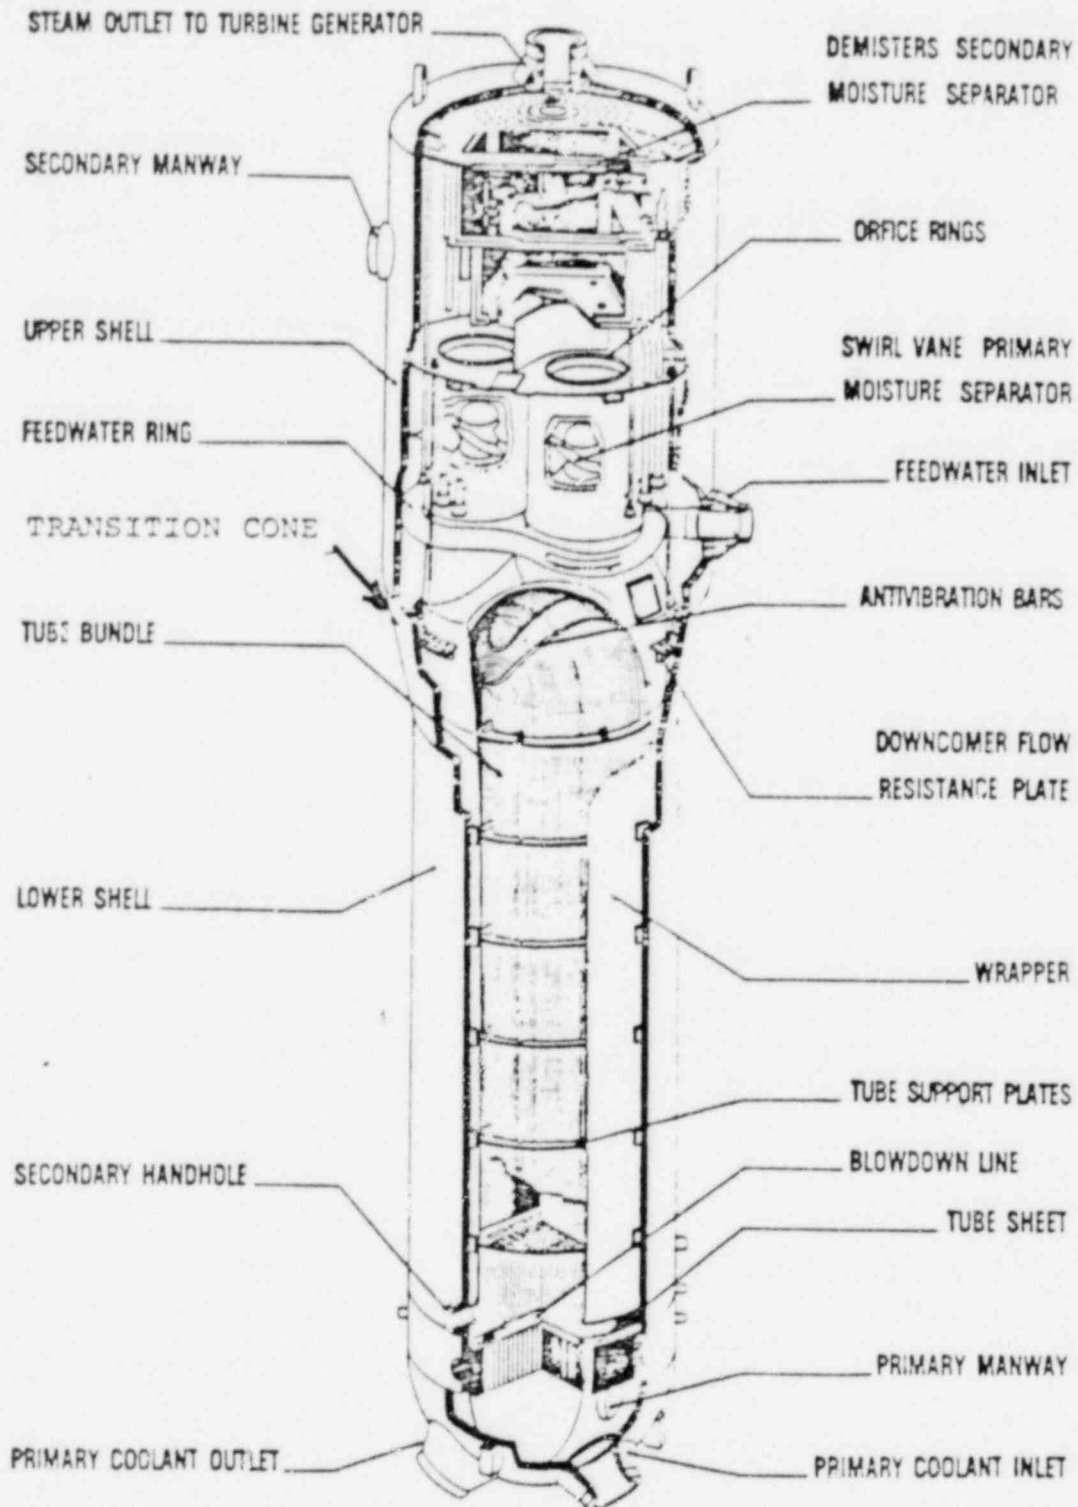
FIGURE 1

2. Cut the steam generators at the transition cone above the tube bundle, as shown in Figure 1.
3. Remove the upper shell and place on storage stand inside containment for refurbishing of moisture separation equipment.

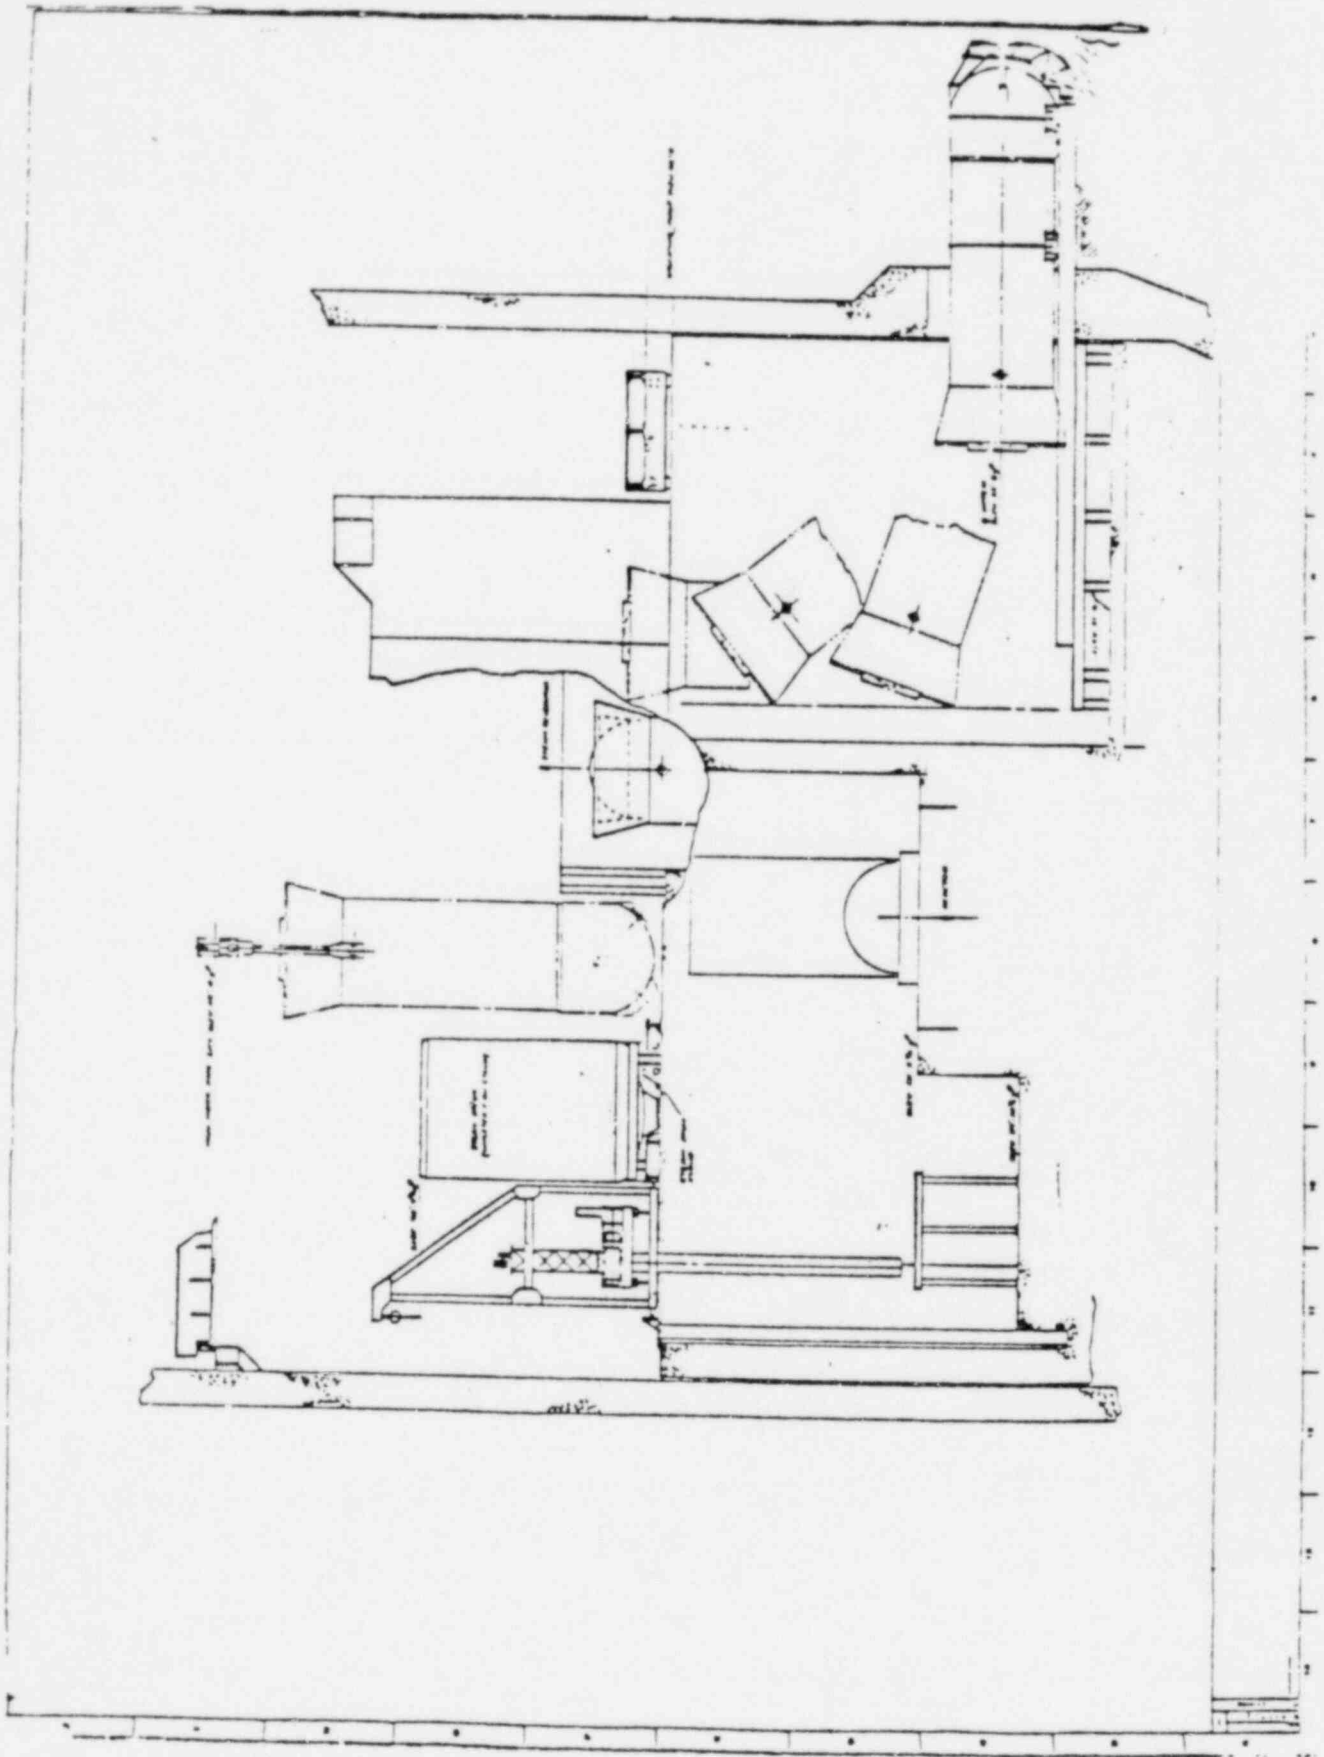
FIGURE 2

4. Disconnect steam generator supports.
5. Remove the lower section of the steam generator from containment, as shown on Figure 2, and transport to the storage building.

6. Move the replacement lower section from storage into containment and lower onto supports in the reverse sequence shown on Figure 2.
7. Weld replacement sections of reactor coolant piping to the replacement steam generator.
