MIDLAND PROJECT -
DOCKET NOS 50-329 AND 50-330
DESIGN OF INTERNAL AUXILIARY FEEDWATER
HEADER IN B&W STEAM GENERATOR
FILE: 0.4.9.62 SERIAL: 17504

This letter provides an interim 50.55(e) report concerning the B&W steam generator auxiliary feedwater header. This item was declared "potentially reportable" in a telephone conversation with R C Knop of your staff on May 26, 1982. The decision to make this item "potentially reportable" was based on the damage recently experienced by other utilities (Davis-Besse, Rancho Seco and Oconee #3), which have steam generator internal auxiliary feedwater header of a similar design to Midland. Consumers Power Company is presently working closely with both B&W and other utilities, having similar designed steam generators, to address the problem and develop a long-term solution.

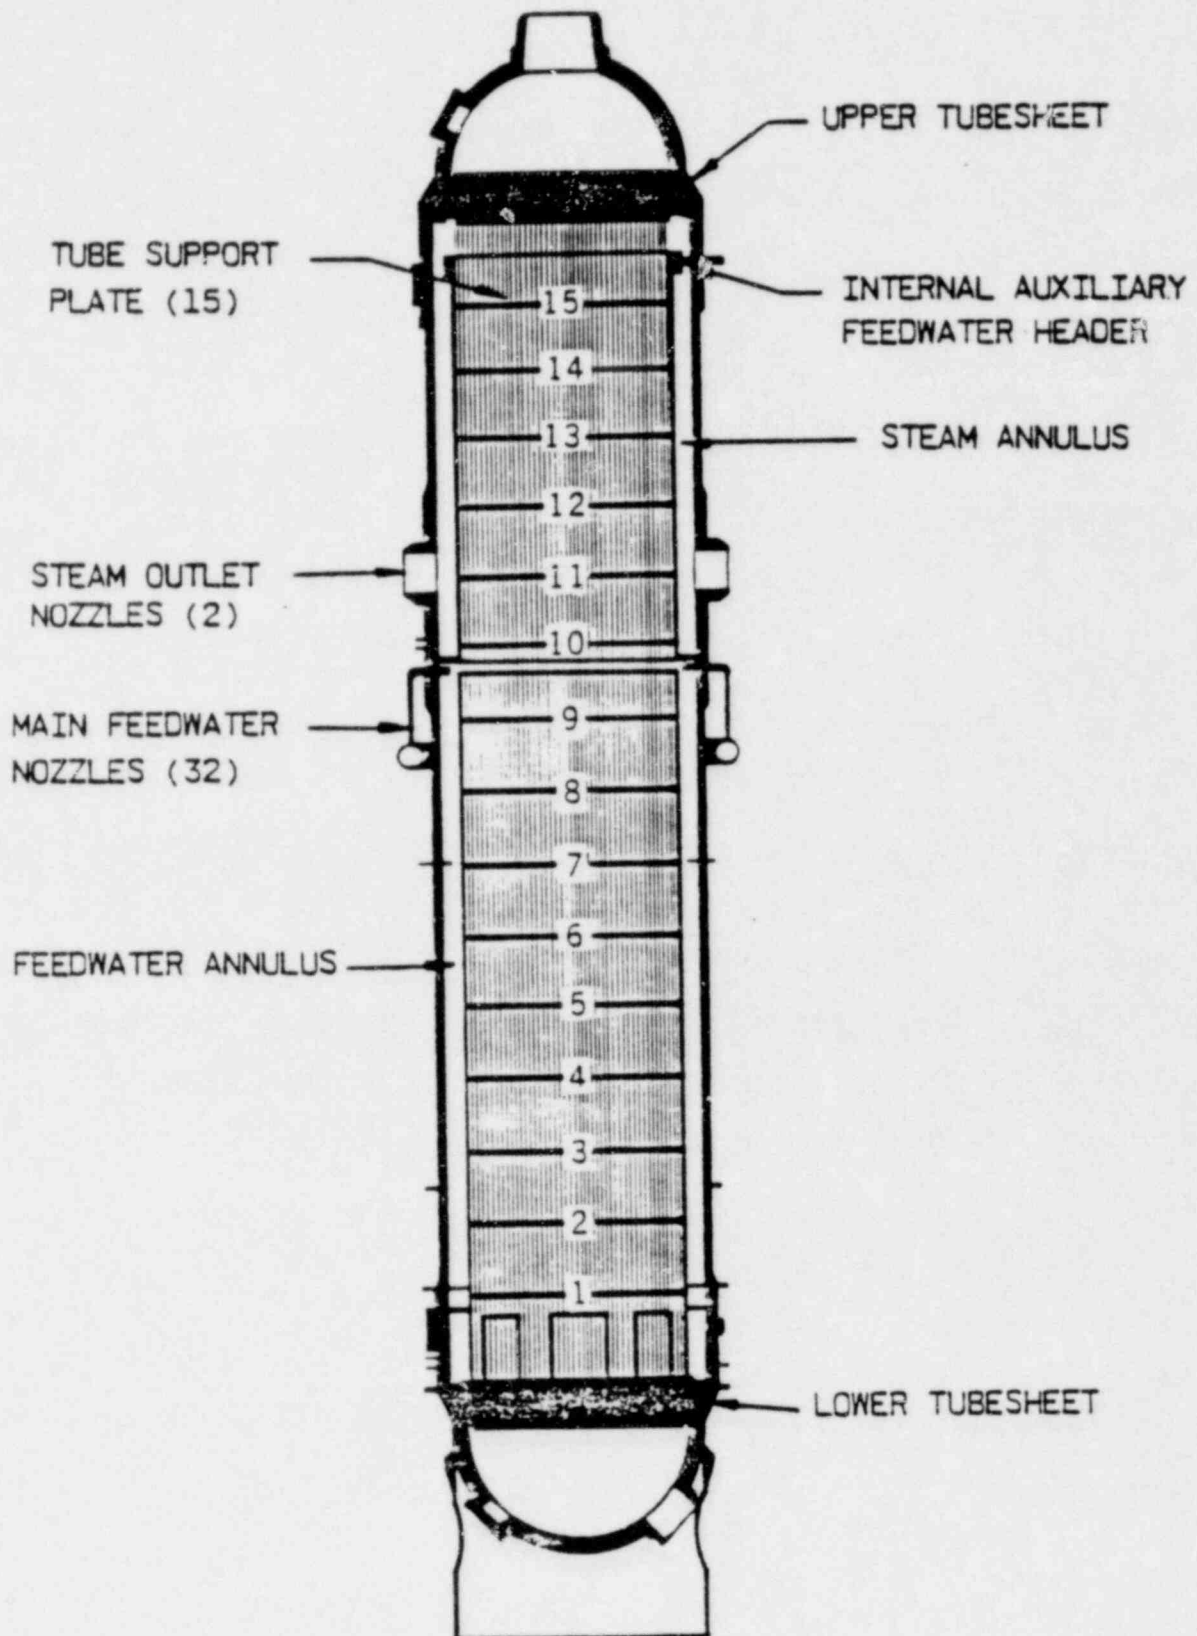
177FA ONCE-THROUGH
STEAM GENERATOR (OTSG)
LONGITUDINAL VIEW

Attachment 1 shows a longitudinal view of the Once Through Steam Generator (OTSG) and indicates the position of the internal AFW header. Attachment 2 shows a longitudinal view of the internal AFW header at the single AFW nozzle position. As indicated in these attachments, the internal AFW header is mounted on top of the upper shroud between the 15th Tube Support Plate and the Upper Tube Sheet. The internal AFW ring header is constructed of 3/8 inch plate metal with a 13 inch by 5 inch rectangular cross-section. There is a single AFW nozzle injecting into the header to fill the header with water. The water flows into the steam generator tube bundle through sixty 1 1/2 inch diameter holes located near the top of the header and equally spaced around it. The header rests on the top of the shroud and is attached to it by eight pairs of brackets which are equally spaced around the header. Each bracket (or Tab) measures 1 1/2 inches wide x 2 3/8 inches long x 3/8 inch thick and is welded to the header. A 2 11/16 inches long x 3/4 inch diameter

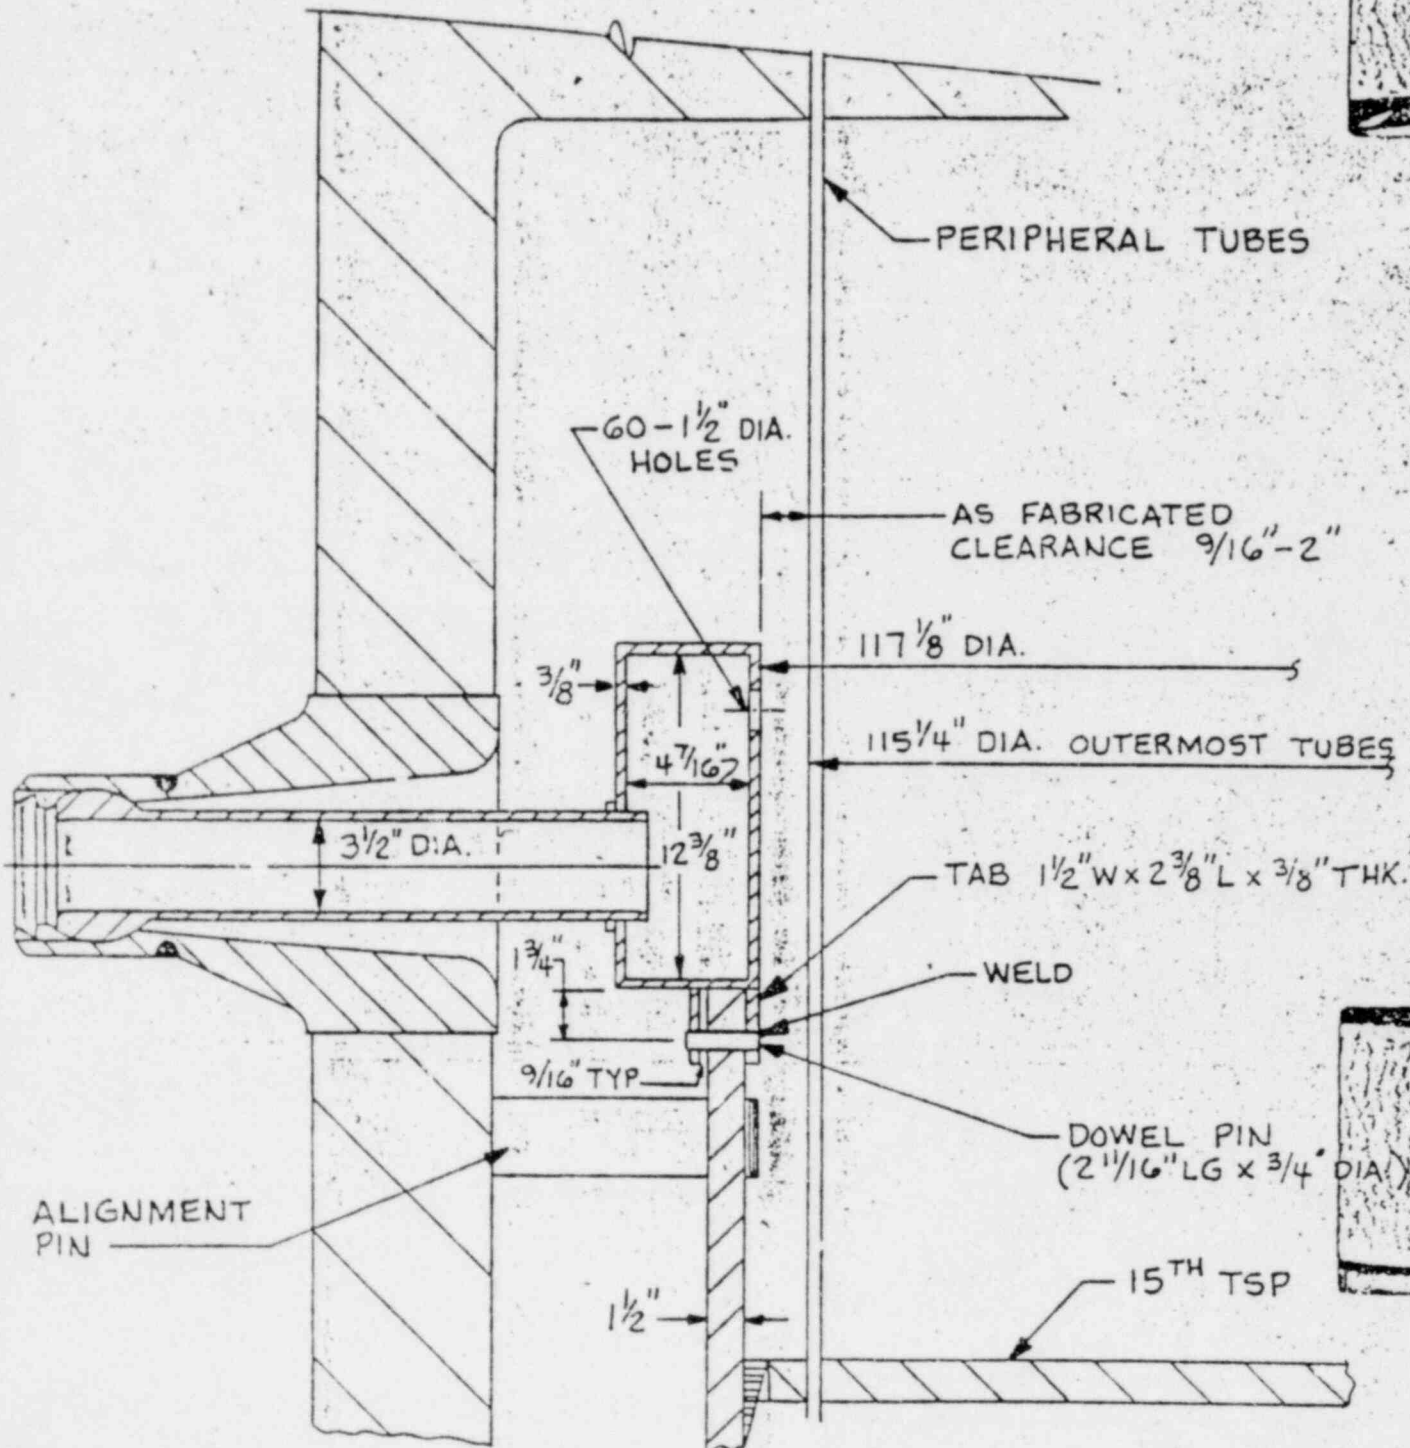
Internal AFW Header Design Longitudinal Section

dowel pin is welded to the inner bracket and slip-fit through the shroud and the outer bracket to hold the header in place while allowing for differential thermal movement between the header and the shroud.

The damage that has been experienced at the operating plants consist of deformations of the header, bent brackets, missing dowel pins, and apparent contact between the header components and the tubes. We understand the operating plants are providing more details to the NRC on the damage experienced at their Units.

The cause of the damage is being investigated. However, the apparent cause of the deformation of the internal auxiliary feedwater header is its inability to withstand the large thermal and pressure forces generated when cold auxiliary feedwater is injected into the header. During normal operation, the header would be filled with super-heated steam as the header sits in the upper super heat region of the OTSG. When cold auxiliary feedwater (80°F) is injected into the rectangular header, very large local pressure differences can occur with large steam-water contact areas which cannot be locally compensated for quickly enough through the 1½ inch diameter flow holes. Except for the extra strength weld areas, the 3/8 inch plate walls are not reinforced and are apparently inadequate for the loads generated under these conditions. In addition to the possibly large pressure drop areas, the header itself experiences very high thermal differences when the cold APW enters the header and begins to fill from the bottom up and flows around the header from the single nozzle. While the exact failure process is not totally known, the above forces are believed to be the dominant factors.

The most probable modification that will be implemented at Midland is the installation of an external ring header similar to those presently being installed at the above referenced operating plants. Another option related to APW system operation as a means of preventing damage to the existing intact Midland design is also being investigated.
