MONTICELLO NUCLEAR GENERATING PLANT
Docket No. 50-263 License No. DPR-22

Supplemental Information on Event Involving Loss of
Instrument Air Compressor and Subsequent Events

Supplemental Information On Event Involving Loss of Instrument
Air Compressor and Subsequent Events

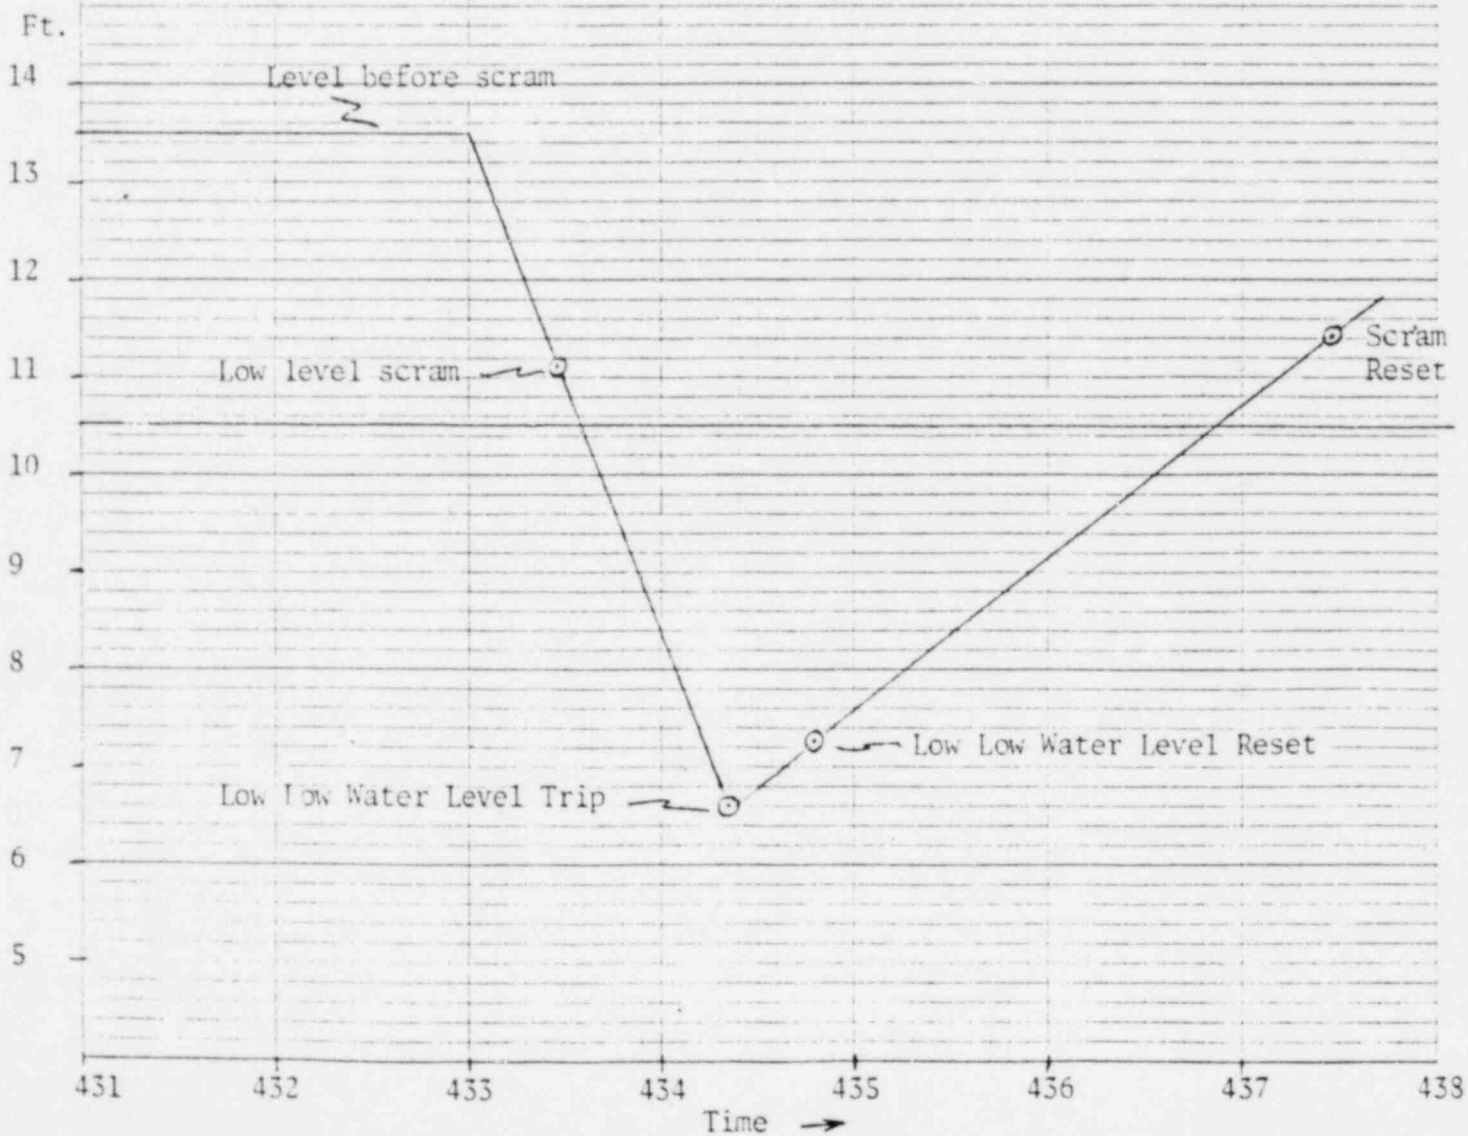
043447 to 043450 The four low-low water level switches reset as water level inventory recovered. A graphical analysis (Attachment 1) indicates that the water level didn't drop much below the low-low water level trip setpoint. This occurred due to the manual initiation of HPCI concurrent with low-low level trip. This would indicate that the lowest water level during the scram was 6'-6" above the top of the core.

Water level above top of Core.
All Initiations and Resets are
Relative to Yarway Switches.
Setpoints are as found Feb 19, 1981
