UNITED STATES OF AMERICA  
NUCLEAR REGULATORY COMMISSION

(Shoreham Nuclear Power Station, )  
Unit 1) )

PREPARED DIRECT TESTIMONY OF  
DALE G. BRIDENBAUGH AND GREGORY C. MINOR  
ON BEHALF OF SUFFOLK COUNTY

PASSIVE MECHANICAL VALVE FAILURE

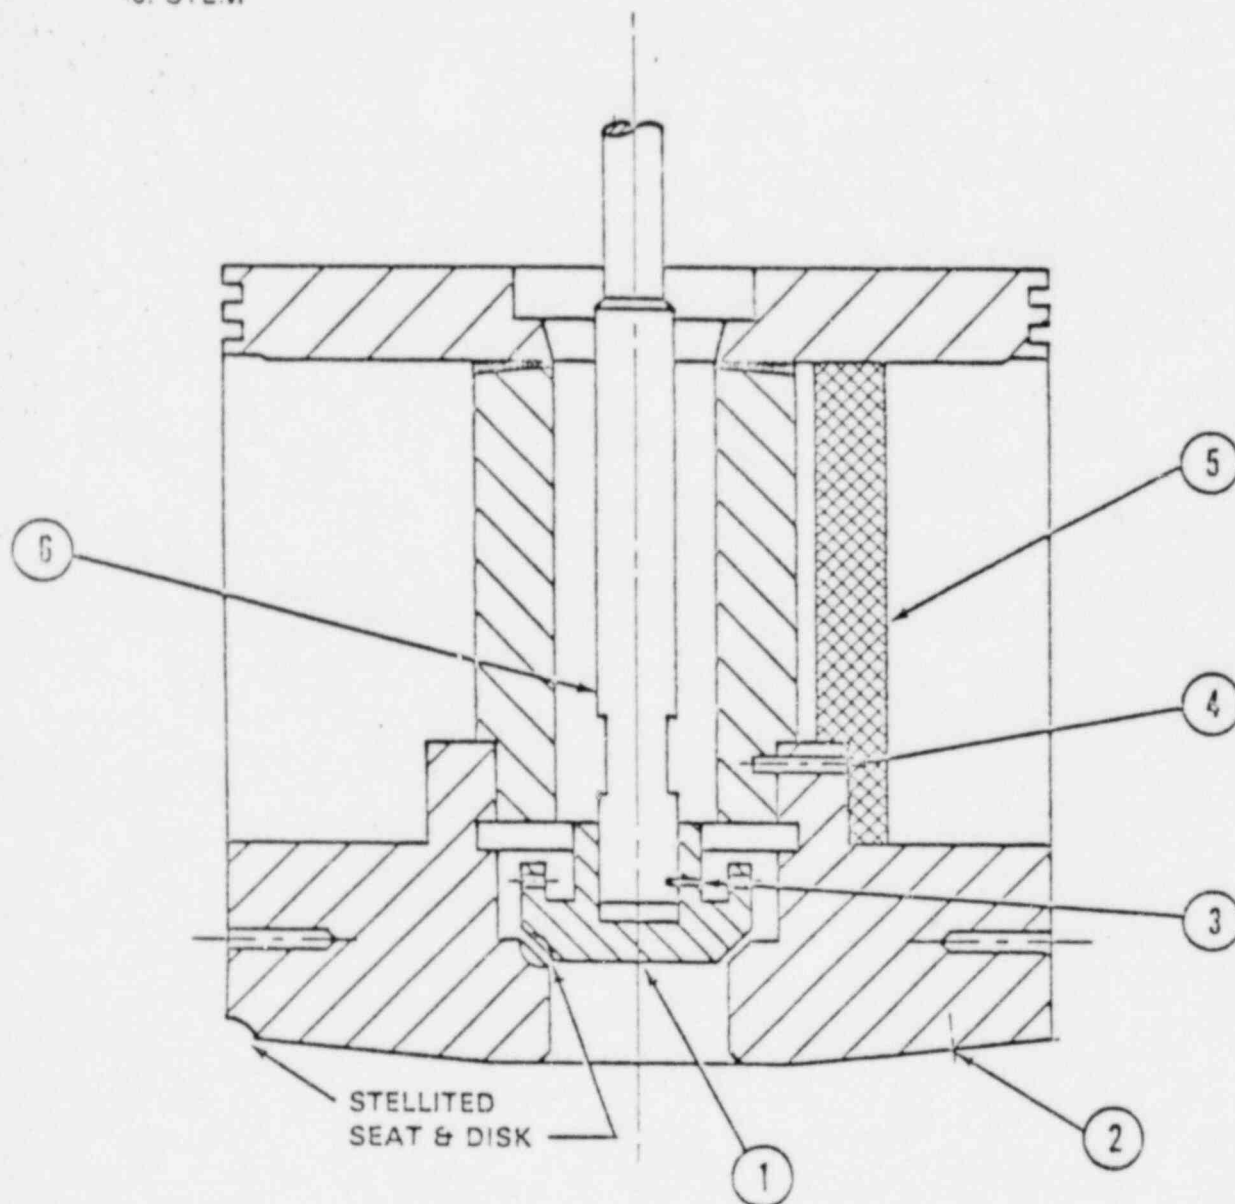
Figure 1. Main Disk Assembly of Flow Stop Valve

The valve components that have failed are shown in Figure 1. The piston assembly is attached to the main disk (2) by thread engagement and then restrained from unwinding by pin (4). The stem disk (1) is also attached to the stem (6)

1. STEM DISK
2. MAIN DISK
3. ANTIROTATION PIN - STEM DISK TO STEM
4. ANTIROTATION PIN - MAIN DISK TO PISTON
5. STELLITED DISK GUIDES, 3 RIBS, 120° APART (OUT OF SHOWN VIEW)
6. STEM

by thread engagement tightened to 1050 ft-lb torque specifications with an anti-rotation restraint provided by pin (3). The valve is closed primarily by spring forces. The valve is installed so that reactor steam pressure works to seat the main disk. The stem disk provides pressure equalization action to reduce overseat load for opening the main disk against system pressure.

The failures which occurred involved a mechanical separation of valve internals. This separation was either at the stem-to-stem disk threaded connection or at the main-disk-to-piston threaded connection. Either failure permits the main disk to be free of the stem. The failure in either mode results from failure of the threaded connection, which in some cases is caused by vibration-induced rotation of the disk so that it becomes disconnected from its threaded mate. Such rotation is believed to be caused by or aided by the propensity of steam flow to produce vibration and to create turning forces on valve internal components when anti-rotation restraint is inadequate due to a failed or missing pin. Other contributing causes are believed to result from reassembly of the valve after disassembly at the site; such reassembly may have included inadequately torqued connections and failure to properly install the pins. Also, an examination of spare parts at the Brunswick site showed that the thread dimensions on the stems and stem disks did not meet drawing tolerances.

1. In January 1976 at Brunswick Unit 2, the D steam line inboard valve main disk separated from the piston. There was no evidence that pin (4) was installed.

2. On January 30, 1979 at Brunswick Unit 2, the A steam line inboard valve stem disk separated from the stem. A square pin was used in the round hole at point (3). The corners of the pin experienced high stress, thereby causing cracking of the pin.

3. On January 15, 1981 at Brunswick Unit 2, the C steam line outboard valve main disk separated from the piston. There was no evidence that pin (4) was ever inserted. This was deduced from finding the hole undamaged, with no sign of a plug weld.

4. On March 5, 1981 at Hatch Unit 2, the A steam line inboard valve stem disk separated from the stem. Pin (3) was not fully inserted.
5. On March 30, 1981 at Brunswick Unit 1, the C steam line outboard valve stem disk separated from the stem. Pin (3) failed and was not recovered.

6. On July 2, 1981 at Brunswick Unit 2, the C steam line inboard valve stem disk separated from the stem. Pin (3) was not properly installed.
7. On July 18, 1981 at Brunswick Unit 2, the D steam line inboard valve main disk separated from the piston. Pin (4) was not fully inserted.

Detailed investigation of the July failures at Brunswick Unit 2\* led to the preliminary findings of possible excessive vibrations on valve internals from steam flow turbulences created by the piping direction changes. In addition, there was evidence of loose thread connections. Further investigations and evaluations are currently in progress. Preliminary corrective actions by the licensee include increasing the stem pin size from 5/16 inch to 3/8 inch, using three pins instead of one or two pins, and increasing the hole depth 1/8 inch into the stem. In addition, corrective actions for the main-disk-to-piston connection include adding an extra pin (of the same 1/2-inch size) and increasing the hole depth by 1/8 inch.
