SUBJECT: Grand Gulf Nuclear Station
Units 1 and 2
Docket Nos. 50-416 and 50-417
File 0262/0472/L-860.0/L-401.0
Status of Evaluation of IE Bulletin 79-14
Ref: AECM-79/122 dated October 31, 1979
and AECM-81/212 dated August 11, 1981
AECM-81/474

IE BULLETIN 79-14

GRAND GULF NUCLEAR STATION

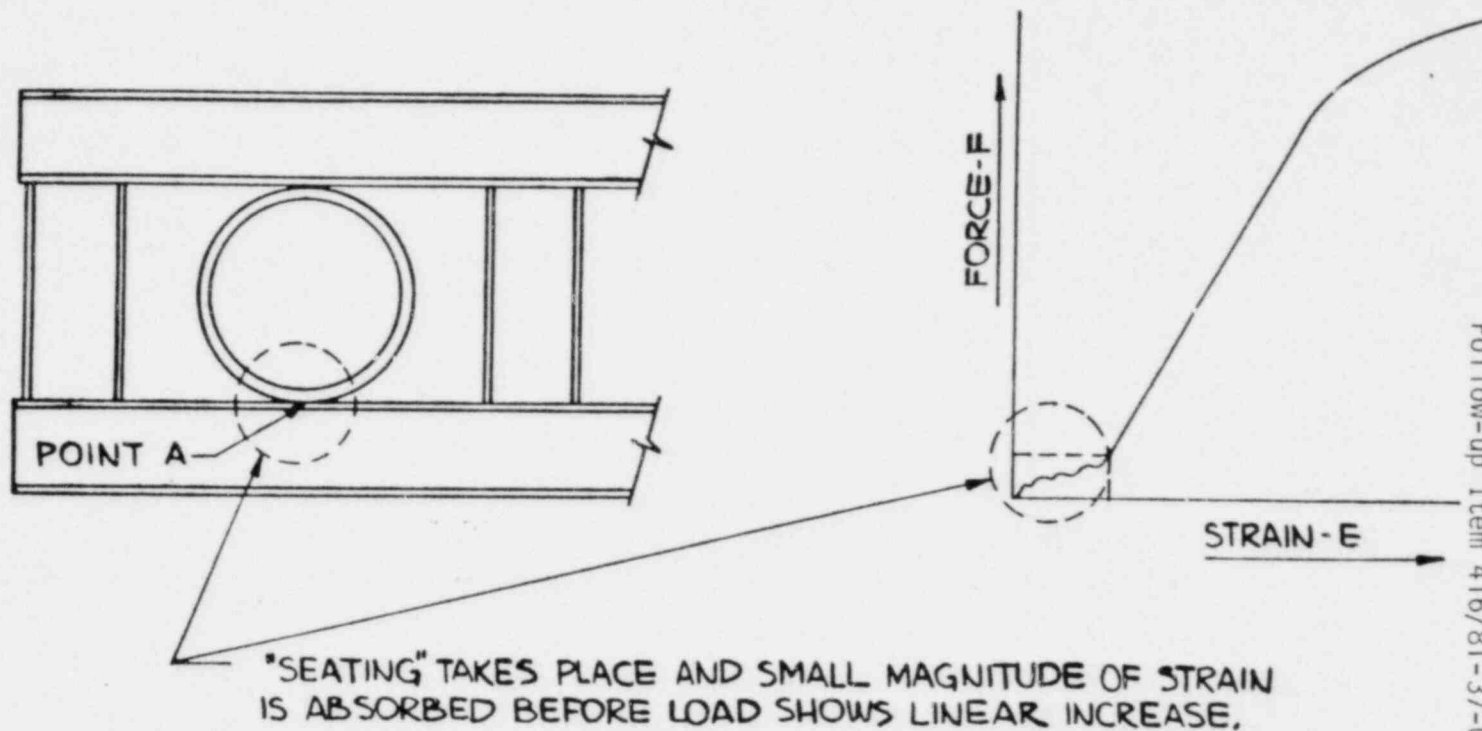
FIGURE 1
RESPONSE TO NRC FOLLOW-UP ITEM 416/81-37-02

4. Thermal stresses which would result from zero gap are secondary in nature and thus self-relieving.
5. In any loaded assembly a certain amount of strain will take place before the system starts to exhibit linear loading characteristics. This phenomenon is shown in Figure 1 and is caused by surface roughness and any out-of-flatness (or roundness) of the parts in contact.

CLAMPING FORCE DEVELOPED AT POINT A DEPENDS ON:

- (1) MAGNITUDE OF STRAIN
- (2) FLEXIBILITIES OF SUPPORT STEEL AND PIPE
- (3) SURFACE CHARACTERISTICS OF PIPE AND SUPPORT STEEL
