Public Service Company of Colorado

June 9, 1982
Fort St. Vrain
Unit No. 1
PPC-82-1175

As per your request, attached is information concerning the manual scram taken June 5, 1982, due to an undervoltage relay trip in the plant electrical system.

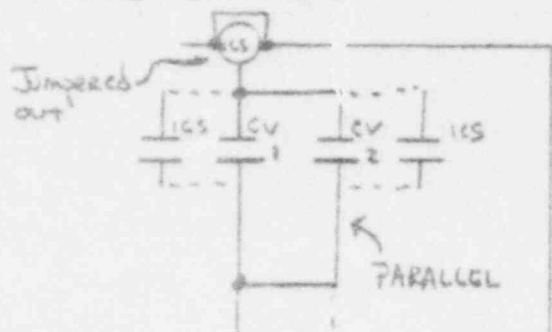
THE UNDERVOLTAGE RELAYS ARE SET UP SUCH THAT NO SEAL IN CONTACT IS USED (ICS). THE TWO UNDERVOLTAGE CONTACTS ARE CONNECTED IN PARALLEL. SEE DRAWING.

NORMALLY ICS CONTACTS AND CV CONTACT ARE CONNECTED per dotted lines.

THE RELAY SETTINGS WERE LAST CHECKED ON MAY 20, 1982. THE RELAY TECHNICIANS CHECKING THE SETTING WERE NOT AWARE OF THE CONTACT CONFIGURATION USED AT FORT ST. VRAIN. DURING THEIR CHECK THEY FOUND ONE CONTACT TO BE SET AT 44V (NORMAL SETTING IS 55V). THE CONTACT WAS ADJUSTED TO 55V. SINCE THE TWO UNDERVOLTAGE CONTACTS ARE NOT INDEPENDANT OF EACH OTHER, WHEN THE FIRST CONTACT WAS ADJUSTED FROM 44V TO 55V THE SECOND CONTACT WAS INCREASED TO 63V (69V IS 100%). WE FEEL THE IMPROPER SETTING ON THE RELAY CAUSED THE PREMATURE INITIATION OF THE LOAD SHED.
