NORTHEAST UTILITIES

Reference: Facility Operating License No. NTF-49
Docket No. 50-423
Licensee Event Report 90-018-00

FACILITY NAME (1)	DOCKET NUMBER (2)	LER NUMBER (6)			PAGE (3)		
		YEAR	SEQUENTIAL NUMBER	REVISION NUMBER			
Millstone Nuclear Power Station Unit 3	0 5 0 0 0 4 2 3	9 0	0 1 8	0 0	0 2	OF	0 4

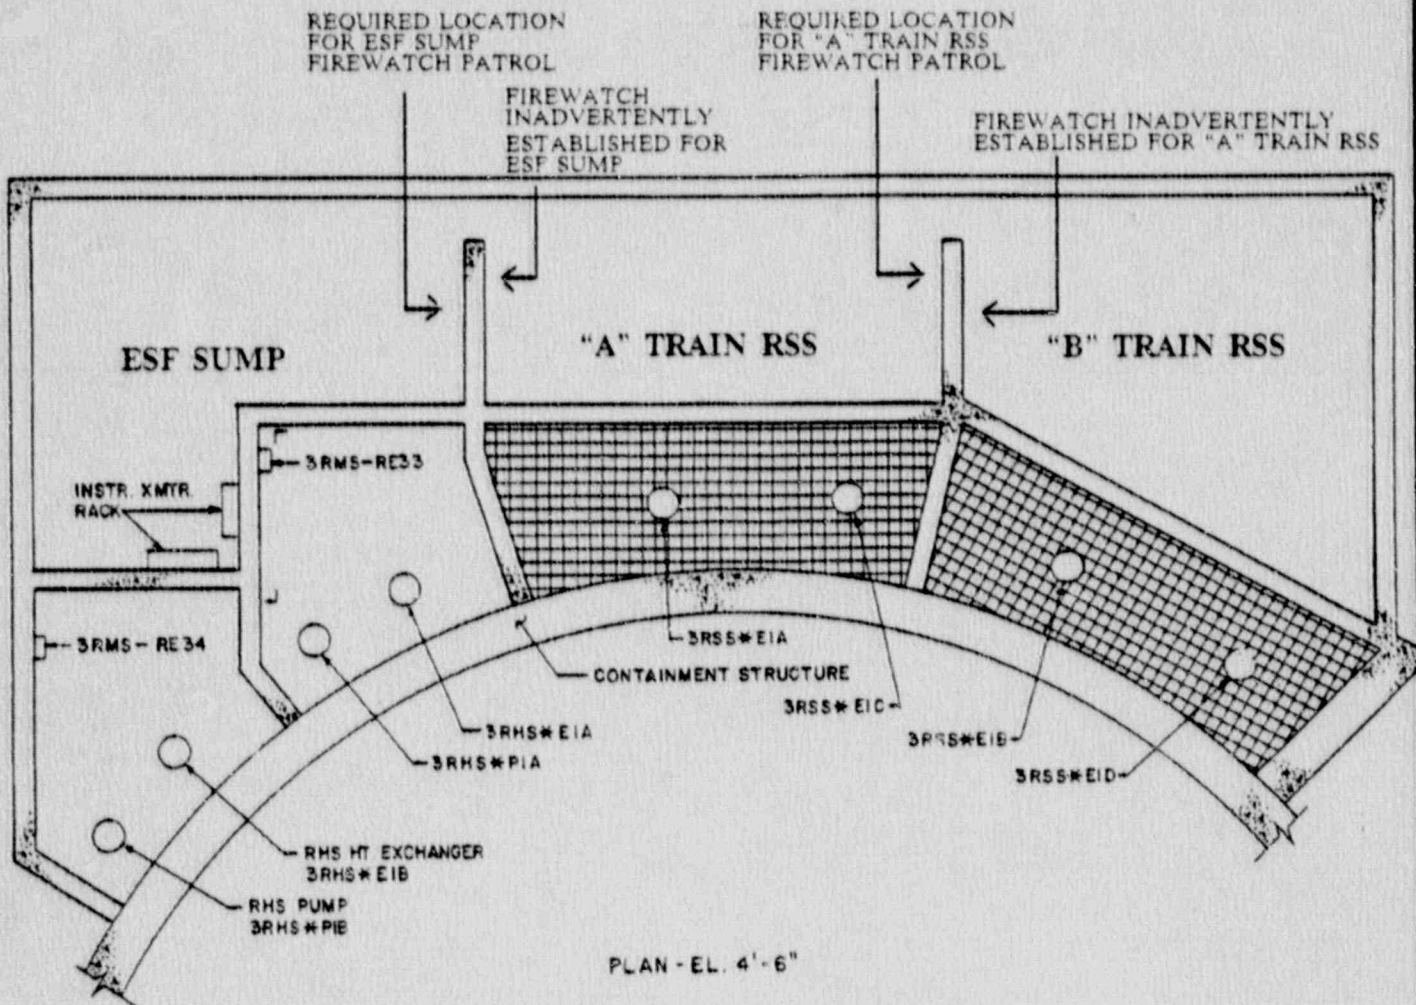
The unit staff improperly stationed an hourly firewatch patrol after declaring four Fire Stop and Seal penetrations in the Engineered Safety Features building (ESF) sump and "A" Train Containment Recirculation System (RSS) pipe tunnel areas located on the 4 ft. 6 in. elevation of the ESF building inoperable.

On June 1, 1990 at approximately 1100 hours, four Fire Stop and Seal penetrations were declared inoperable in the ESF sump and "A" train RSS pipe tunnel areas. This action was being taken in association with a Technical Specification surveillance involving the inspection of Fire Stop and Seal penetrations which were in progress. The Shift Supervisor (SS) assigned a non-licensed operator (PEO) to place the firewatch patrol signature sheets at the required locations (ESF 4 ft. 6 in. elevation - Sump and "A" Train RSS pipe tunnel areas). The SS assigned a PEO with this responsibility in order to minimize confusion and ensure proper location, although the evolution is normally the responsibility of firewatch patrol personnel. The PEO correctly interpreted the required locations for the signature sheets and directed fire watch personnel to place the signature sheets within the ESF building, but did not perform a verification to ensure proper placement. The signature sheets were positioned such that firewatch patrols were performed in the "A" and "B" Train RSS pipe tunnel areas located on the 4 ft. 6 in. elevation of the ESF building (see attached figure).

Immediate corrective action was to establish an hourly firewatch patrol in the ESF building sump pipe tunnel area located on the north end of the 4 ft. 6 in. elevation of the ESF building. As action to prevent recurrence, the SS has been counseled in the importance of verifying communications and concerns to the applicable plant personnel. In addition, a procedural revision has been completed requiring non-licensed operator verification of proper firewatch patrol boundaries within one hour of declaring fire rated assemblies inoperable.
