LIMERICK GENERATING STATION

SUBJECT: Licensee Event Report
Limerick Generating Station - Units 1 and 2

Reference: Docket Nos. 50-352
50-353
Report Number: 2-90-010
Revision Number: 00
Event Date: June 6, 1990
Report Date: July 6, 1990
Facility: Limerick Generating Station
P.O. Box A, Sanatoga, PA 19464

FACILITY NAME (1) Limerick Generating Station, Unit 2										DOCKET NUMBER (2) 0 5 0 0 0 3 5 3					PAGE (3) 1 OF 6	
TITLE (4) Inoperability of Standby Gas Treatment System due to Handswitch mispositioning due to personnel error																
EVENT DATE (5)			LER NUMBER (6)				REPORT DATE (7)			OTHER FACILITIES INVOLVED (8)						
MONTH	DAY	YEAR	YEAR	SEQUENTIAL NUMBER	REVISION NUMBER	MONTH	DAY	YEAR	FACILITY NAMES				DOCKET NUMBER(S)			
									Limerick, Unit 1				0 5 0 0 0 3 5 2			
0 6	0 6	9 0	9 0	0 1 0	0 0	0 7	0 6	9 0					0 5 0 0 0 1 1			
OPERATING MODE (9)		THIS REPORT IS SUBMITTED PURSUANT TO THE REQUIREMENTS OF 10 CFR 5: (Check one or more of the following) (11)														
1		20.402(b)				20.405(e)				50.73(a)(2)(iv)				73.71(b)		
POWER LEVEL (10)		20.405(a)(1)(i)				50.36(e)(1)				X 50.73(a)(2)(v)				73.71(c)		
0 6 1 1		20.405(a)(1)(ii)				50.36(e)(2)				50.73(a)(2)(vii

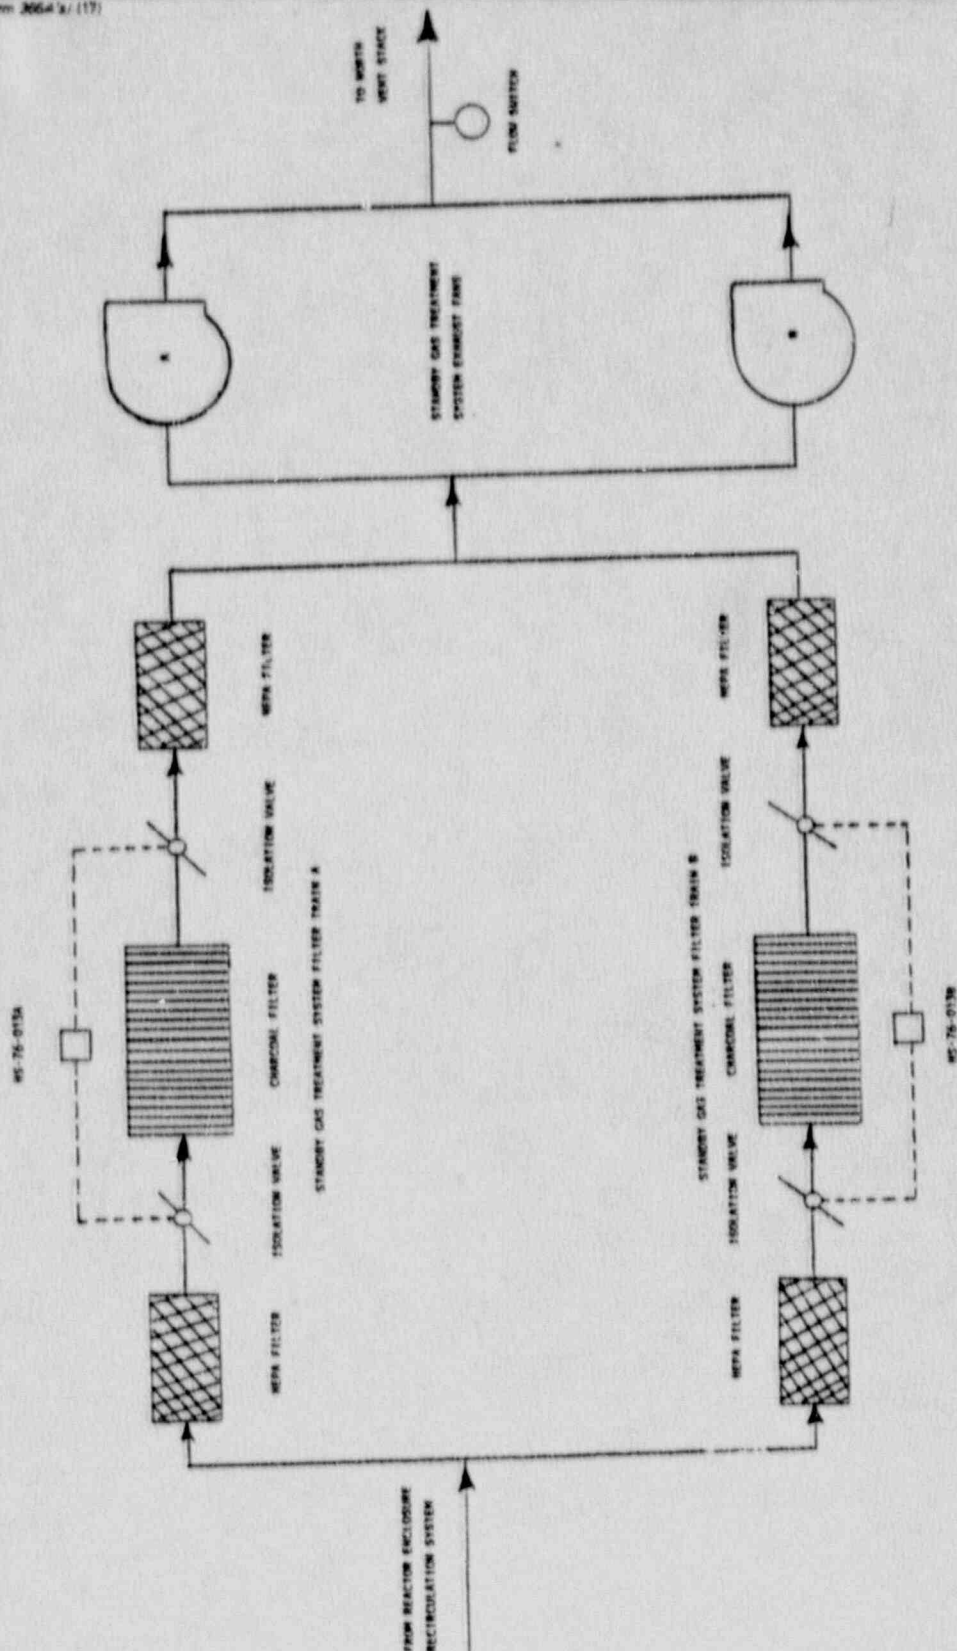
FIGURE 1

SIMPLIFIED STANDBY GAS TREATMENT SYSTEM DIAGRAM
