## NUCLEAR REACTOR LABORATORY

July 5, 1990

Subject: Item of Information Concerning Presence of a Foreign Object in the Reactor Core  
Tank. Facility License No. R-37, Docket 50-20.

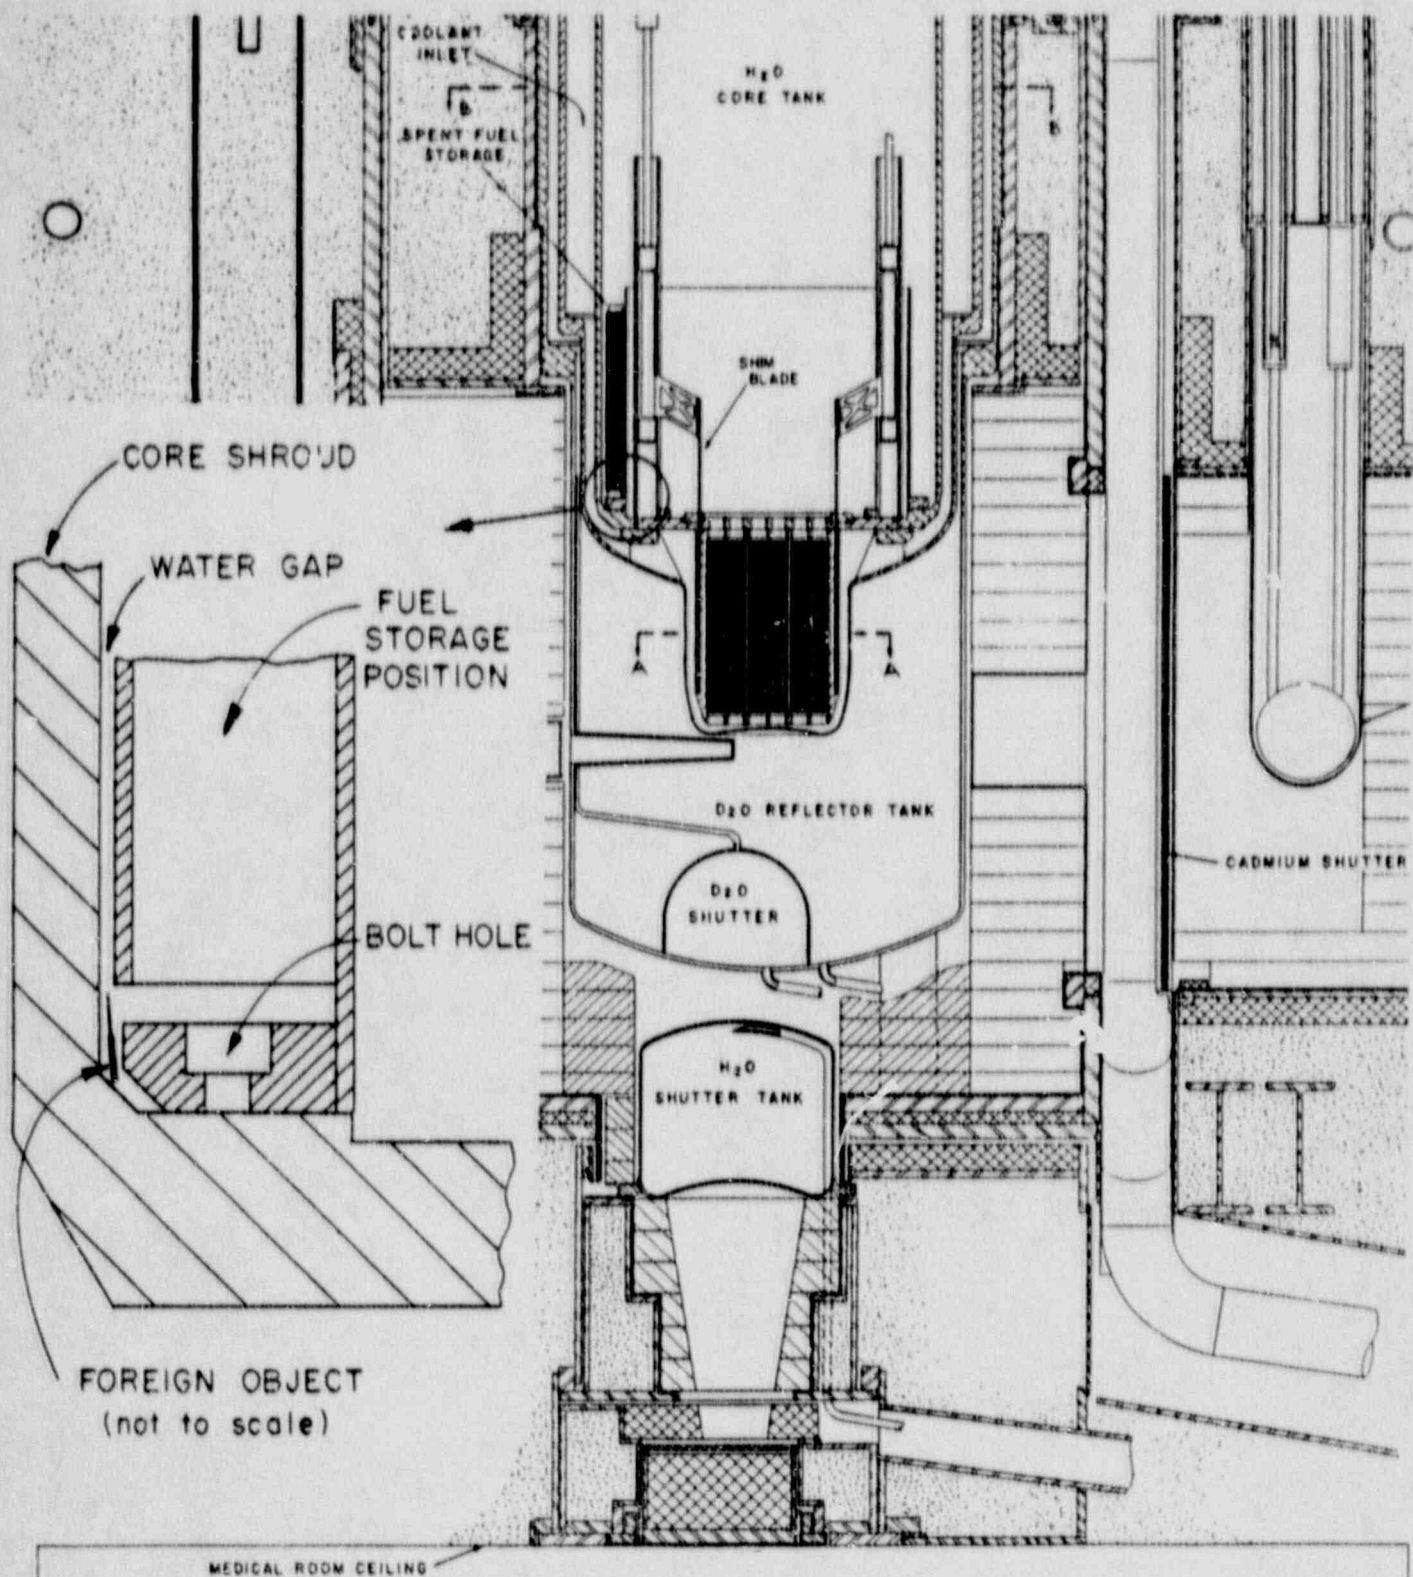
**Figure 1 Horizontal Cross-Section of Core Showing Location of Foreign Object**

- (o) Began preparations to remove the fuel storage rings. It was suspected that the blade was in the narrow space between the core tank wall and the outer wall of the fuel storage ring. During the course of these preparations, the blade was retrieved from fuel storage position #27. This occurred at 1558 on 25 June. Storage ring position #27 had been checked on previous occasions but the blade had not been found at those times because of the geometry of the position that it had entered. On this occasion, a more powerful magnet was used and it rotated the blade so that it came out through the storage ring position. Refer to Figure 2.

9. Corrective Action: This item has been discussed with all licensed personnel, the reactor maintenance staff, and the reactor radiation protection personnel. Policies governing the use of small tools over the core tank are under review. It is anticipated that tethers or floatation devices will be required for tools of less than a certain dimension.
