UNIVERSITY OF MISSOURI

Research Reactor Facility

REFERENCE: Document 50-186  
University of Missouri Research Reactor  
License R-103

SUBJECT: Report submitted under Technical Specification 6.1.h(2)  
concerning degraded operability of the mechanical  
equipment room exhaust system while the reactor was  
shutdown, but not secured.

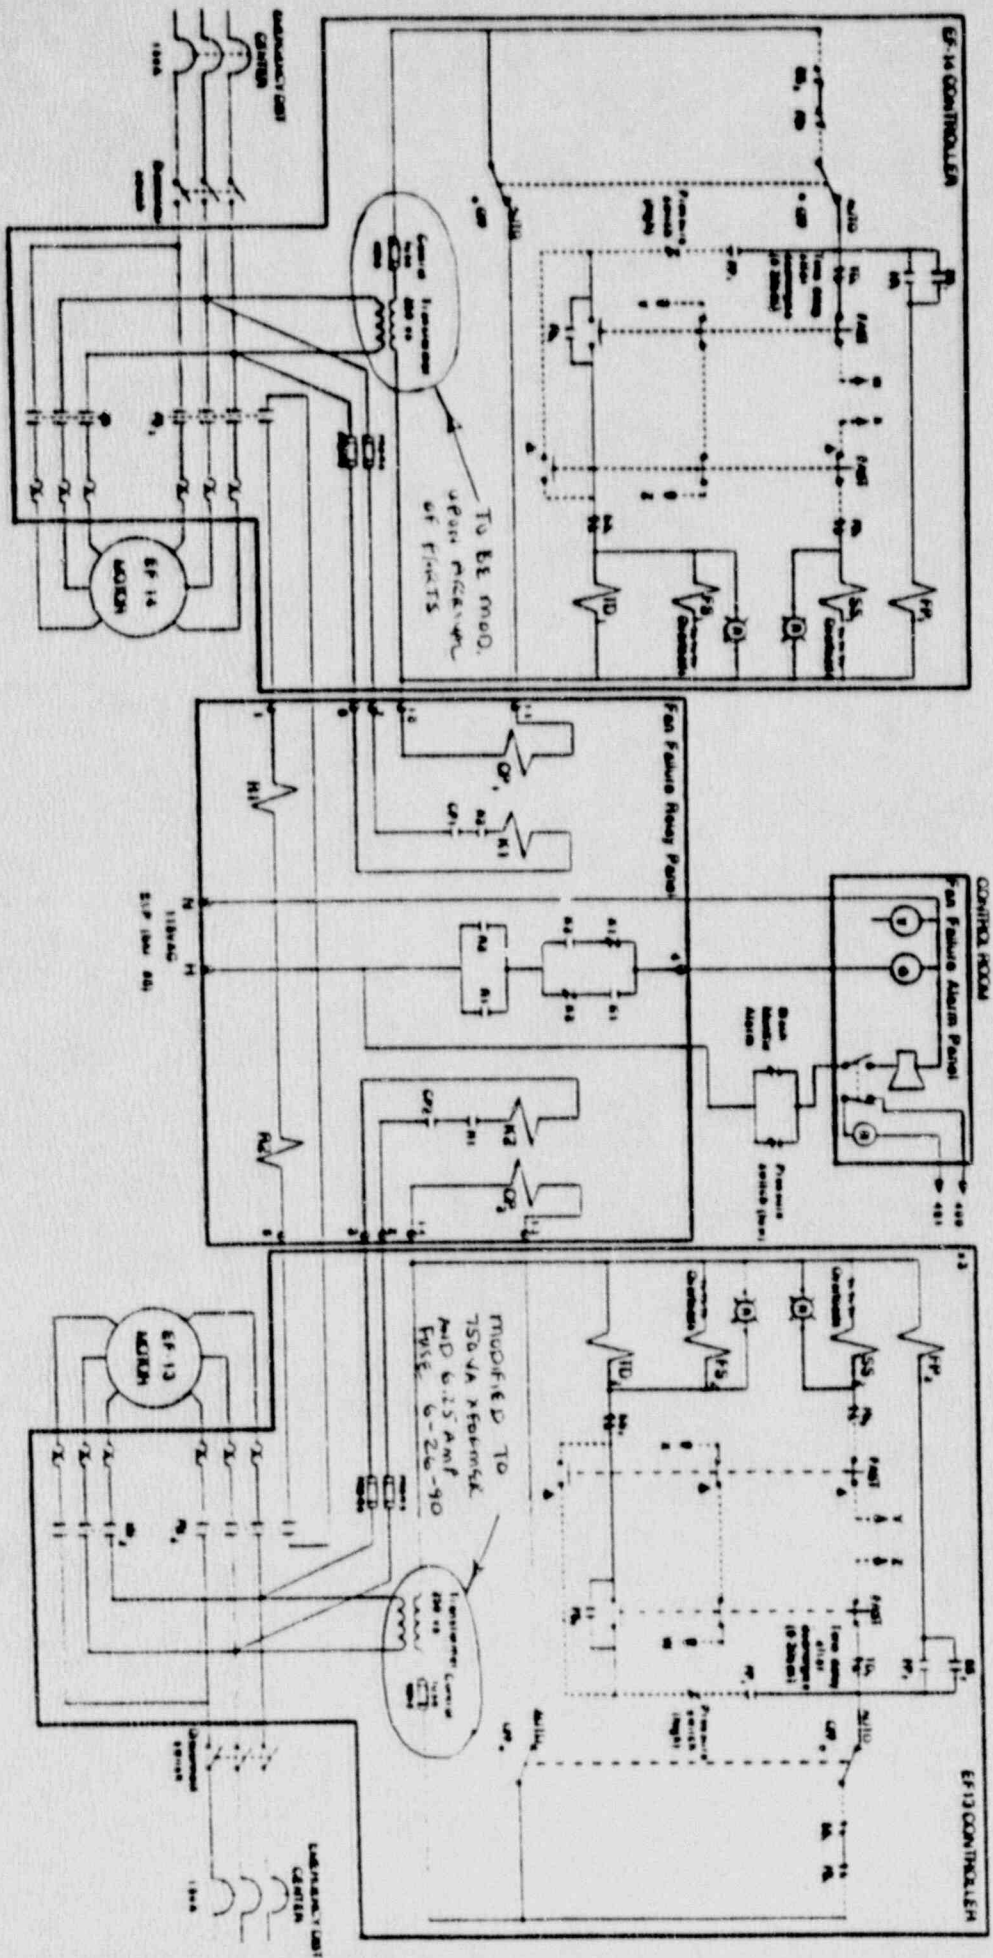
FIGURE 1. CONTROLS & Fan Failure Alarm  
for Ventilation Exhaust Fans  
(Rev. 70 6/6/90)

The cause for the blown control fuses for the exhaust fans was investigated. It was first thought that the fuses may have blown while the emergency generator was picking up the emergency load. An emergency generator load test (Compliance Procedure 17) was performed and the emergency generator picked up loads normally and neither exhaust fan control fuse was blown. During this test, normal power to the emergency power panel is interrupted, simulating a loss of electrical power and causing the emergency generator to start and supply loads. Further investigation of the exhaust fan controller diagram did not conclusively identify why the control fuses for each fan had blown. The University Power Plant verified that a lightning strike had occurred on the supply grid for MURR electrical power and it was concluded that an associated electrical transient on one phase may have caused the fuses to blow. The electrical power to each exhaust fan control circuit was found to be supplied from the voltage across the same two phases (see Figure 1). The design engineers who specified the exhaust fan controllers were contacted and asked to review the controller prints to see if there was a design problem with the fuse rating for these controllers. These controllers were part of a ventilation

After consultation with the controller vendor concerning the root cause of the blown fuses, two modifications were suggested. One modification separates the voltage source for control power to each fan such that the control power for each fan is developed across different phases. This was achieved on a maintenance day shutdown June 25, 1990. A second modification was suggested after measurement of the amperage through the control fuses for each controller. The 3 amp control fuses were found to be carrying 2.5 amps steady state current. It was concluded that these fuses

could not provide enough current margin to be sustained through the type of electrical transients experienced during a severe thunderstorm with lightning striking the electrical grid.

The controller vendor recommended using a 6.25 amp fuse in the control circuit for each fan which would also require replacement of the 480V/120V transformer rated at 250VA with one rated at 750VA. This modification was installed in the EF-13 controller on June 25, 1990. A second 480V/120V, 750VA transformer is on order and will be installed in the EF-14 controller on the first maintenance day after its arrival.
