**Duke Power Company
McGuire Nuclear Station
Unit 2 Steam Leak
August 31, 1993**

September 5, 1993

EXECUTIVE SUMMARY

Project Title: Unit 2 Steam Leak in Containment

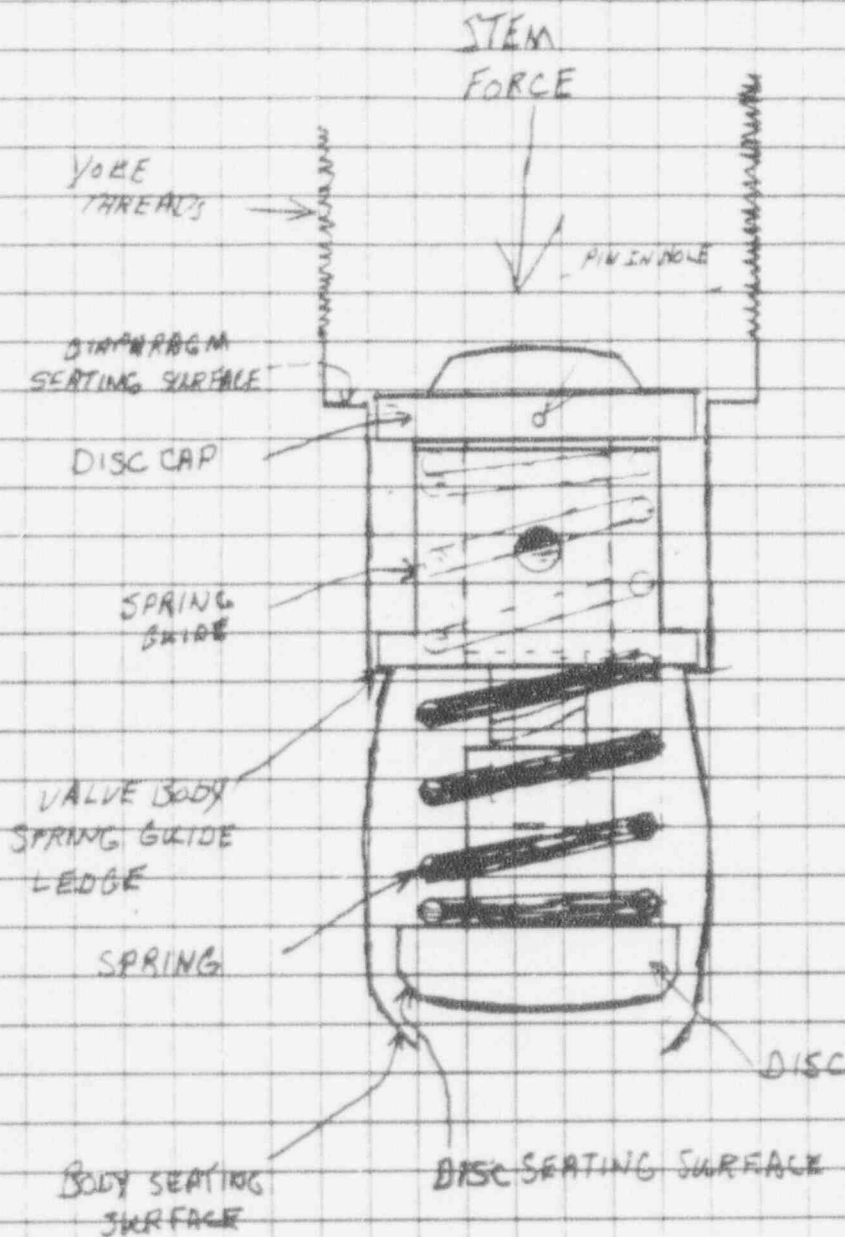
Station _____ Unit _____ Rev. _____ File No. _____ Sheet _____ Of _____
 Subject HEADTEST INTERNALS AS FOUND IN VALVE 2-CF-130 INSPECTION 9-2-93
 By TOBEY SELF Date 9-3-93
 Prob No. _____ Checked By _____ Date _____

The root cause of the failure of Kerotest drain valve 2CF-130 to isolate flow was the improper reassembly of the valve due to personnel error in following the maintenance procedures. During final reassembly of the disc assembly, the spring guide was installed upside down. When inserted in the valve, the improper configuration of the spring guide prevented the disc assembly from contacting the seat, prevented the diaphragms from seating and therefore prevented the valve from properly stroking. These conditions were verified during an as-found evaluation of valve 2CF-130 in the MNS Hot Machine Shop on September 2, 1993.

DISC ASSEMBLY WITH
 SPRING & SPRING GUIDE INSTALLED
 UPSIDE DOWN

STEM FORCE CAN'T MOVE
 DISC CAP AND DISC TOWARD
 SEAT

THE DISC IS THREADED INTO THE
 DISC CAP. THE PIN IS INSTALLED
 TO PREVENT SEPERATION.

Emphasize to all valve technicians the consequences of improper spring guide installation and the importance of following procedures. The consequences of this event should be included in these discussions.

Prior to startup, evaluate the consequences of improper maintenance on other Kerotest packless valve applications and take appropriate action.

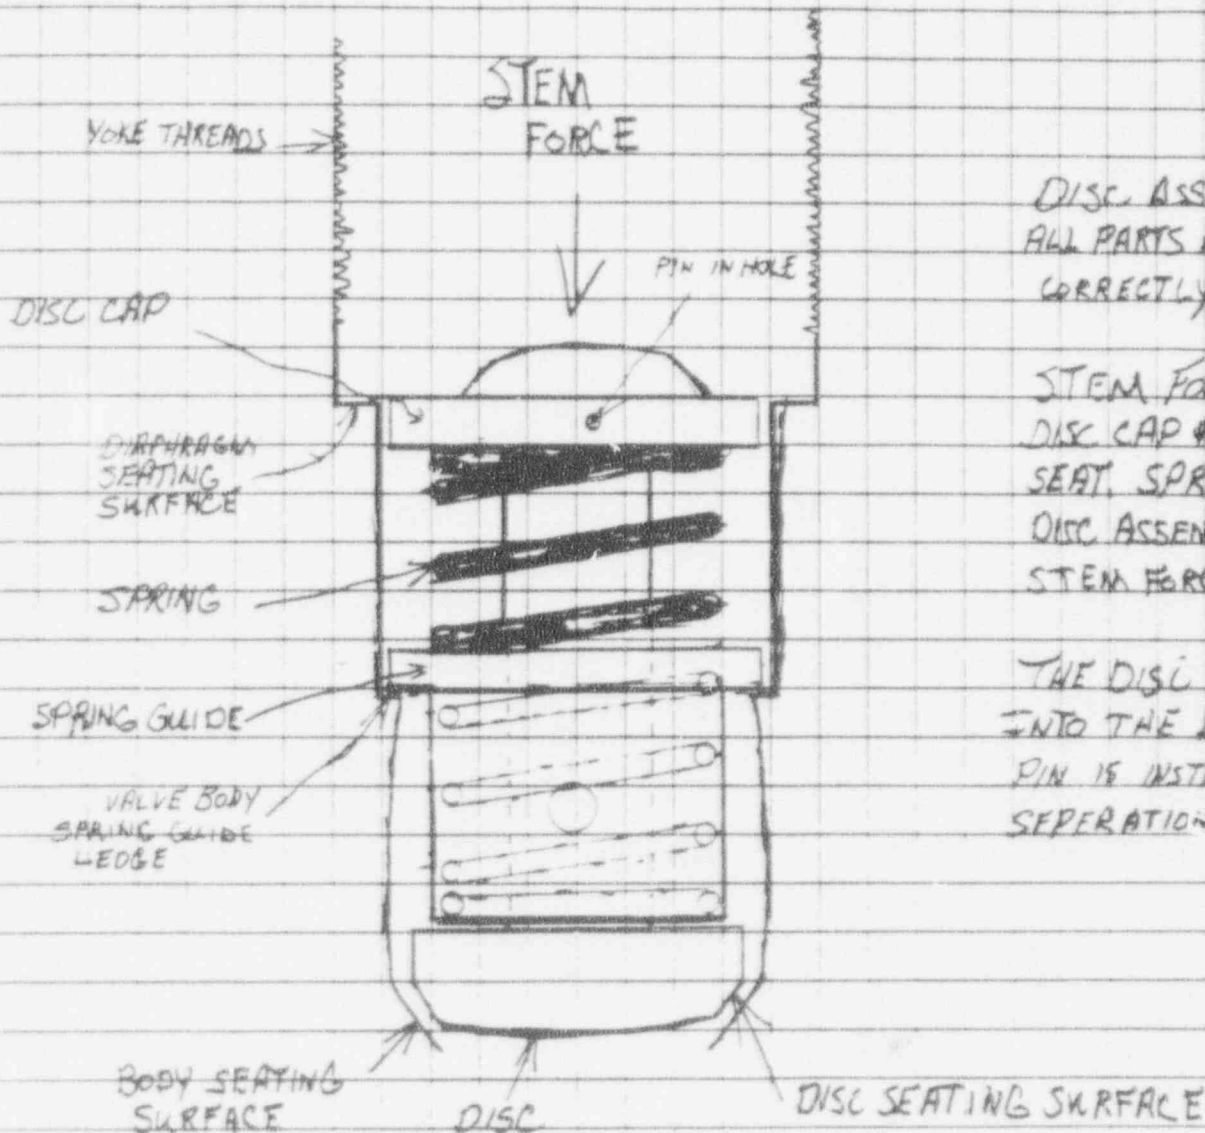
Station _____ Unit _____ Rev. _____ File No. _____ Sheet _____ Of _____
 Subject KERO TEST INTERNALS NORMAL
 By TOREY JELF Date 9-3-93
 Prob No. _____ Checked By _____ Date _____

DISC ASSEMBLY WITH
ALL PARTS ASSEMBLED
CORRECTLY

STEM FORCE MOVES
DISC CAP & DISC TO BODY
SEAT. SPRING OPENS
DISC ASSEMBLY WHEN
STEM FORCE IS REMOVED
