Iowa Electric Light and Power Company

Subject: Duane Arnold Energy Center
Docket No: 50-331
Op. License No: DPR-49
"D" Outboard MSIV Relief Request, RR-
002, Revision 1
Reference: Letter from J. Franz (Iowa Electric) to
T. Murley (NRC) dated September 11, 1993
(NG-93-3831)
File: A-100, A-286

SUPPORTING INFORMATION FOR RELIEF REQUEST RR-002, REVISION 1

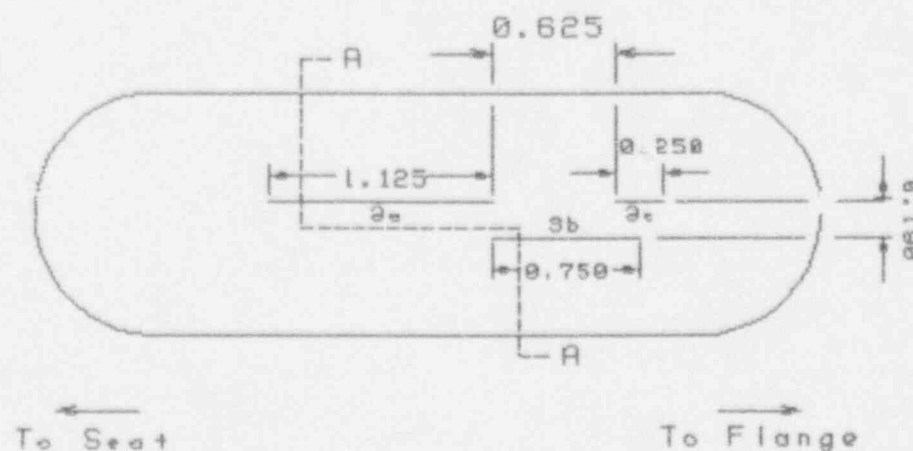
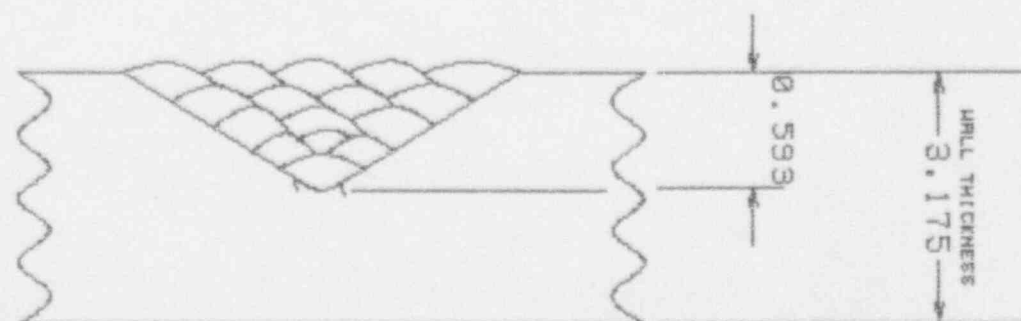
MAP OF SURFACE INDICATIONS OF AREA #3 AND
WELD BEAD PLACEMENT (AFTER $\approx 20\%$ EXCAVATION)

After discussions with your Staff and our further evaluation, these weld overlay repairs were removed and an attempt was made to reduce the indications to acceptable sizes by additional grinding. The depth of this grinding was limited to 20% of wall thickness due to GE and ASTM specifications requiring post weld heat treatment for welds exceeding 20% of wall thickness. This additional grinding process removed one indication and the excavated area was then repaired in accordance with the Code. During the attempt to remove the second indication, three more smaller indications were brought to the surface. One of these indications was an acceptable length. A total of three unacceptable surface indications remained (Attachment 1).

Grinding in area 1 resulted in the removal of the indication. Grinding in area 3 to 0.593 inches resulted in the presence of three more indications. One of the additional indications was of acceptable length; this left three unacceptable indications in area 3. These were repaired with a weld overlay. Since the indications were not reduced to an acceptable length before welding, the repair did not meet Code requirements.

- a. The area around the indications was ground to provide a groove configuration without sharp edges and leaving a blended contour.
- b. Weld material was deposited as follows:
 - The weld procedure specification used for the repair was Pl-AT-Lh (CVN 1-2), rev. 1, which is qualified for P1 material up to 8 inches thick using the shielded metal arc welding (SMAW) process with 200°F minimum preheat and 500°F maximum interpass temperatures. The procedure is also qualified to meet Charpy V Notch requirements. There are no Charpy V Notch requirements for the base metal.
 - The base metal thickness in the region of the repair is 3.175 inches and weld metal deposited was a maximum 0.593 inches. Post weld heat treatment (PWHT) was exempted per ASME Section III Table NB 4622.3-1, ASTM A216 and GE Specification 21A9230

- rev. 2.
- Weld material was deposited using E7018 3/32 inch diameter electrode. The first weld pass over the indication used a slight weave motion. The fluxing action of the E7018 electrode allowed the impurities from the casting to be deposited as slag, which was removed after each pass.

- Each weld pass was inspected visually and by MT.
 - The overlay technique was used to fill the excavation in a sequence so that the next weld bead covered the previous weld bead by approximately 50% of its width, thereby providing some stress relieving to the previous bead.

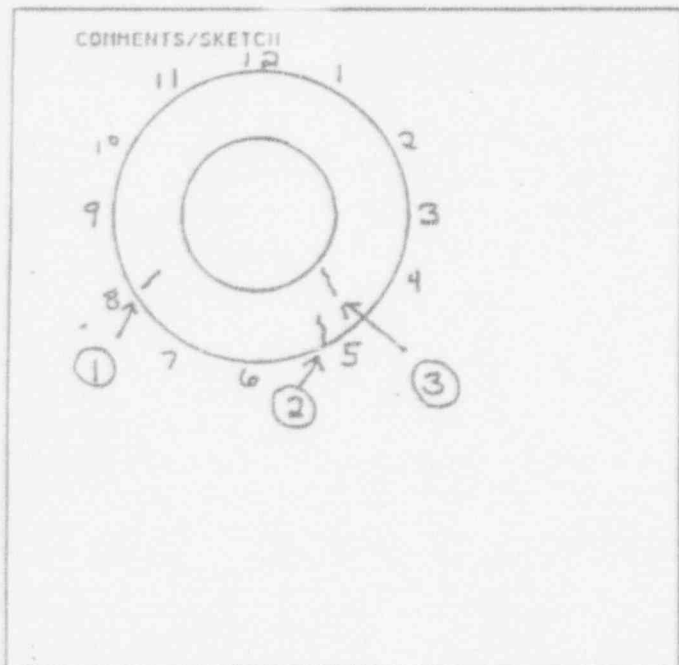
RECORD OF NONDESTRUCTIVE EXAMINATION
MAGNETIC PARTICLE - (DRY OR WET METHOD) MT-1

ITEM	INITIAL INSPECTION		DEFECT CODE*	INITIAL INSPECTION REMARKS (SIZE/LOCATION)	REINSPECTION		DEFECT CODE*	REINSPECTION REMARKS (SIZE/LOCATION)
	ACC	REJ			ACC	REJ		
①		✓	LI	1/4" @ 8 o'clock 3 1/4" from top Bore				
②		✓	LI	2" Intermittent @ 3 1/2" from top Bore				
③		✓	LI	1 1/4" @ 3 1/2" from Bottom of Bore

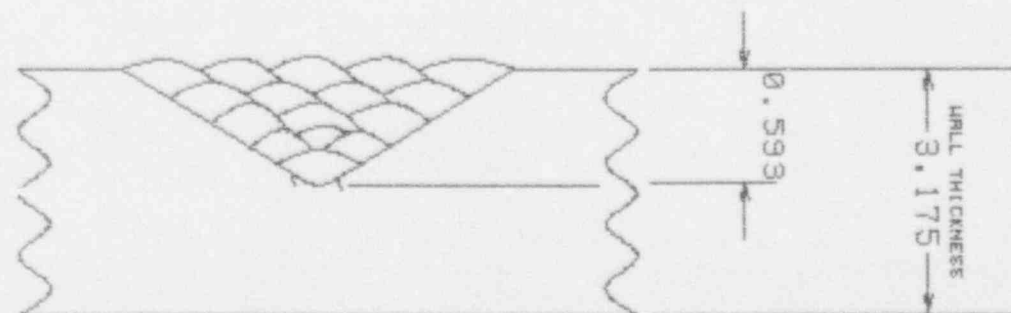
MAP OF SURFACE INDICATIONS OF AREA #3 AND
WELD BEAD PLACEMENT (AFTER $\approx 20\%$ EXCAVATION)

This evaluation is being performed to determine the bounding flaw depth for subsurface indications on the valve body in the upper bore region for the 'D' Outboard MSIV (CV4421). The indications were identified by magnetic particle (MT) examination after excavation. Subsequently, the excavation cavity was weld overlayed. The indications were unacceptable per ASME Section XI and a relief request has been submitted. The map of the preweld cavity is included as Attachment 1.

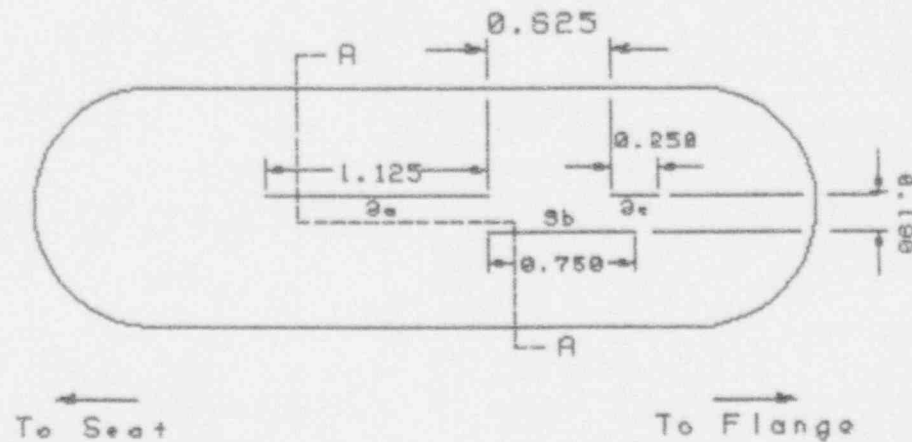
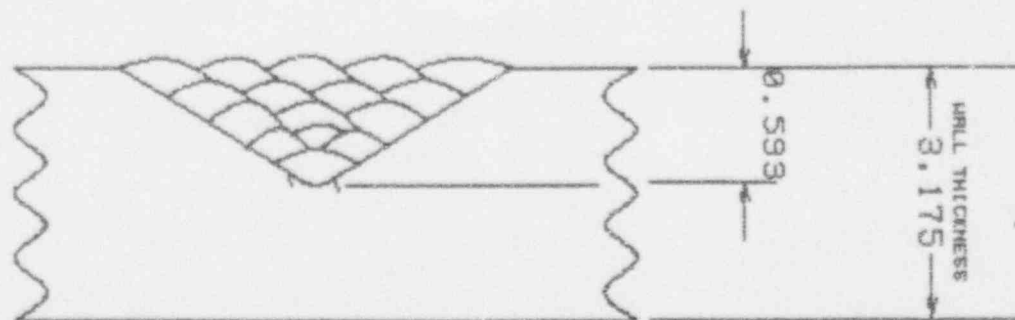
MAP OF SURFACE INDICATIONS OF AREA #3 AND
WELD BEAD PLACEMENT (AFTER $\approx 20\%$ EXCAVATION)

On September 17, 1993 final radiography was performed on the weld repair of area #3 inside the bore of "D" Outboard MSIV. The results of the radiography were satisfactory per ASTM E-186, Severity Level 2, as required by the original purchase specification (GE 21A9230 Rev. 2).
