Subject: Beaver Valley Power Station, Unit No. 1 and No. 2
BV-1 Docket No. 50-334, License No. DPR-66
BV-2 Docket No. 50-412, License No. NPF-73
Potential 10 CFR 21 Condition, Valve
Alignment Charging Pump Operation

10 CFR Part 21
BVPS Unit Nos. 1 and 2 - Valve Alignment/Charging Pump Operation

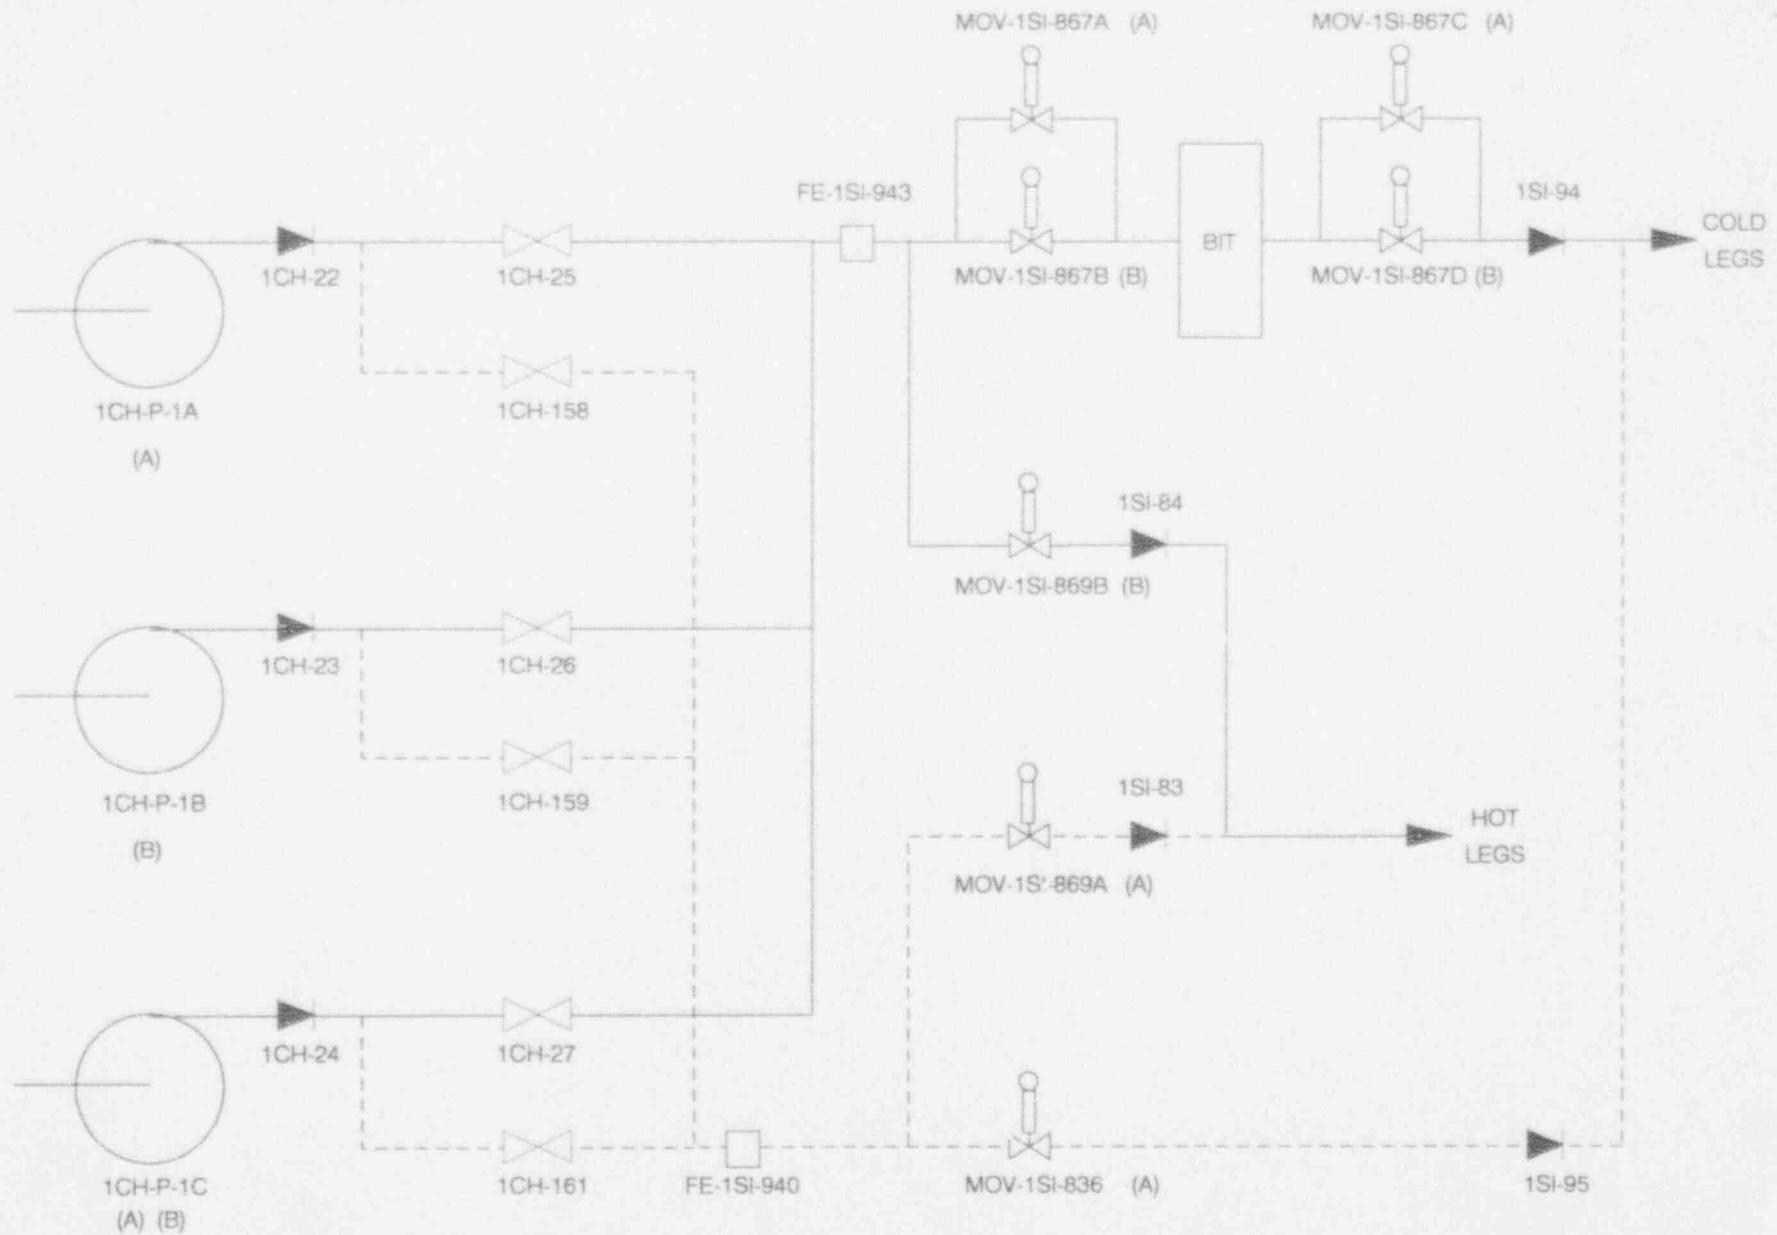
BVPS Unit 1
BHHSI/Charging Pump Flow Path

Per the Unit 1 Emergency Operating Procedure (EOP) ES-1.4, the Safety Injection System (SIS) transfer from RCS cold-leg to hot-leg recirculation is performed 14 hours after a LOCA event. After opening the HHSI-to-the-RCS-hot-leg isolation valve (MOV-SI-869B for BV-1; 2SIS*MOV-869B for BV-2), and while attempting to close the cold-leg inlet isolation valves (MOV-SI-867A&B for BV-1, and 2SIS*MOV-867A&B for BV-2), the postulated Train "A" failure is assumed to occur. The Train "A" power failure would prevent closure of the 867A (Train "A") valve. Operation of the "B" charging pump in this condition (i.e., multiple flow paths to both the RCS hot and cold legs) could cause a pump runout condition. Manual operator actions to locally open or close the affected valves would be impeded due to high radiation levels from prior cold leg recirculation operations.

The Unit 2 emergency operating procedure has been revised to preclude the possibility of unacceptable charging pump runout conditions for this particular LOCA scenario, and thereby ensure long term core cooling capability. Permanent changes to the Unit 1 emergency operating procedures require further engineering evaluation and safety review before the changes are incorporated. In the interim, Operations personnel have been apprised of this potential situation and a temporary change to the procedure has been issued to prevent placing the system in a configuration that could potentially allow flow greater than the limiting values for charging pump operation.

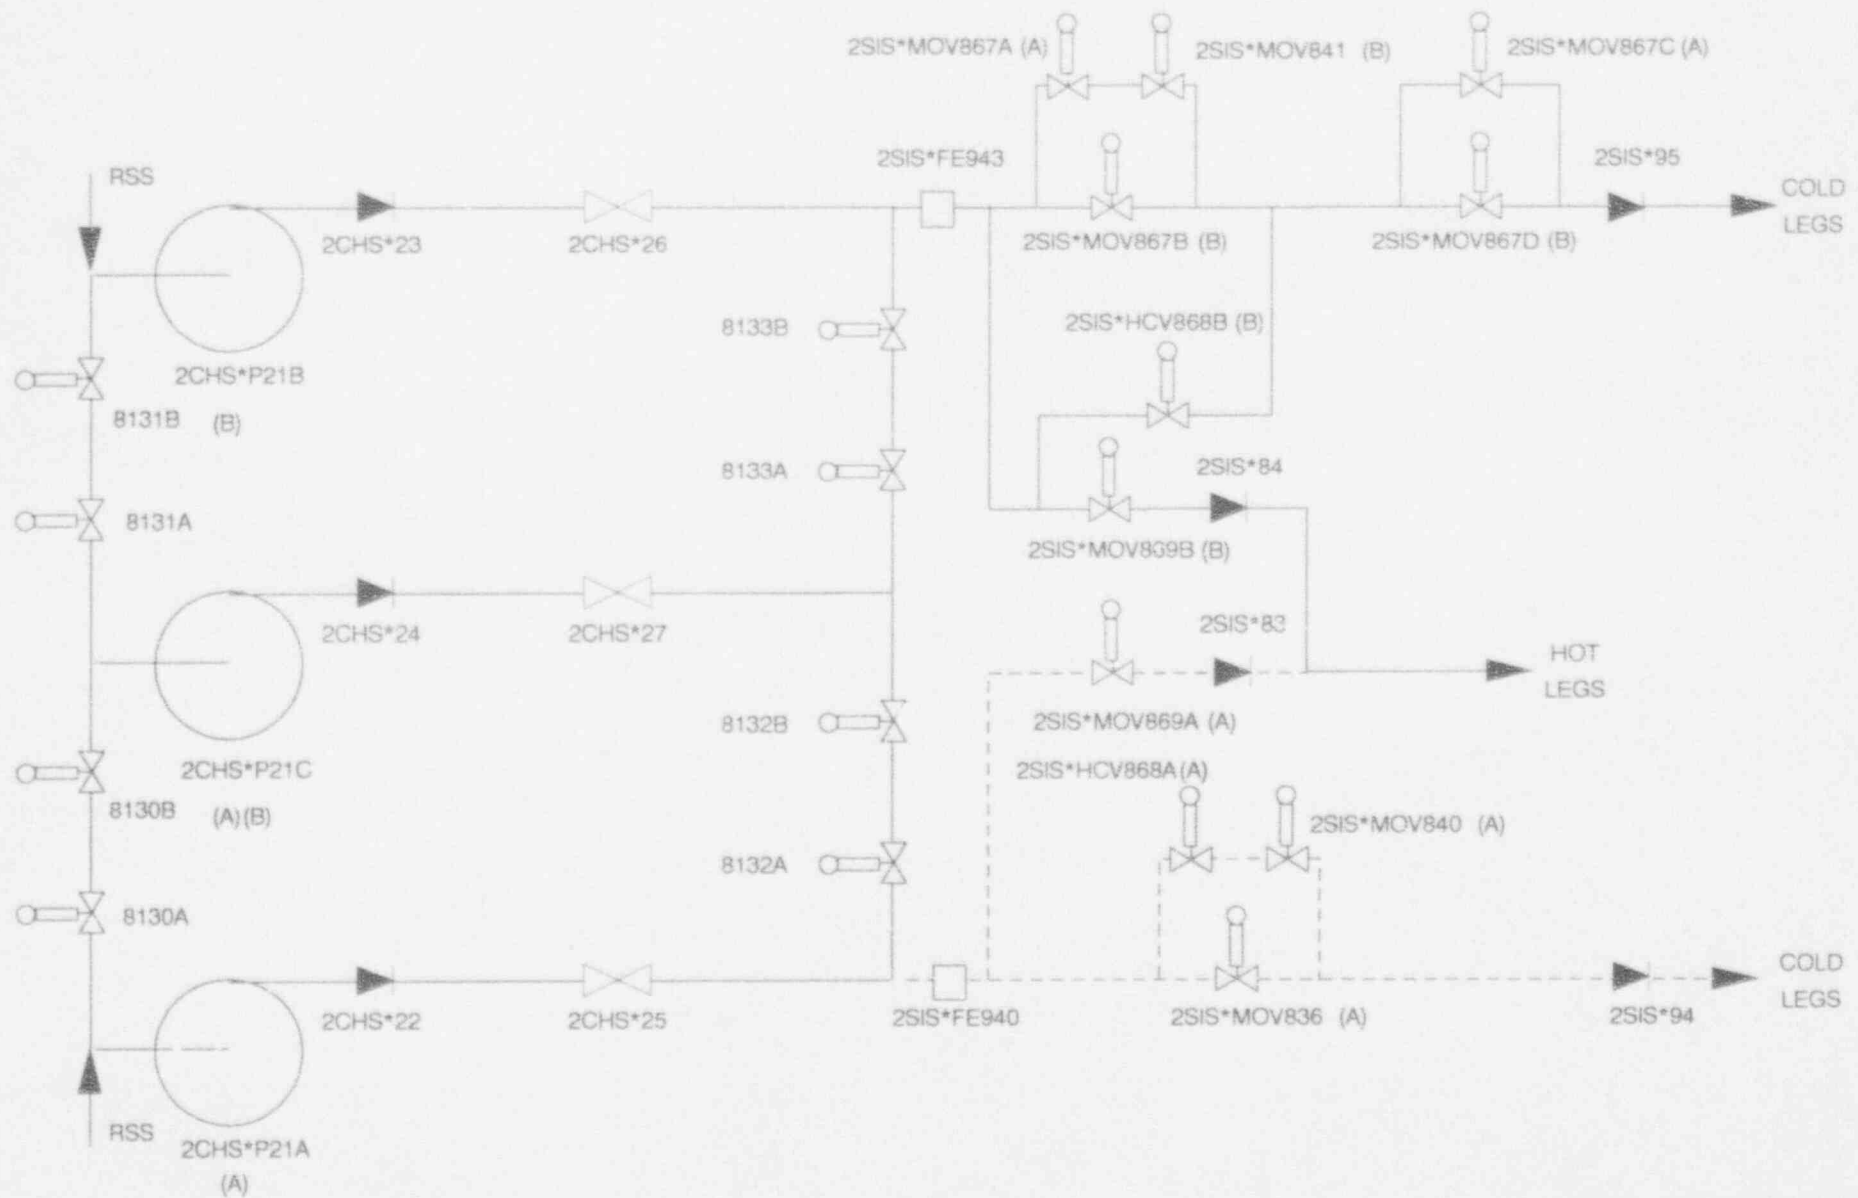
BVPS Unit 2
HHSI/Charging Pump Flow Path

The Unit 2 EOPs presently direct have the operators to shut down the HHSI pumps during the SIS re-alignment operations, and an additional flow path isolation valve is available from an opposite-train-powered, series valve (2SIS*MOV-841). Therefore, it is expected the failure of the "A" Train would be recognized and the charging pump would not be restarted until after valve power restoration, or until acceptable flow paths were established.
