LICENSEE EVENT REPORT

UPDATED REPORT - Previous Report Date 06-04-82

Virginia Electric and Power Company
North Anna Power Station, Unit No. 1
Docket No. 50-338
Attachment to LER 82-041/01X-1

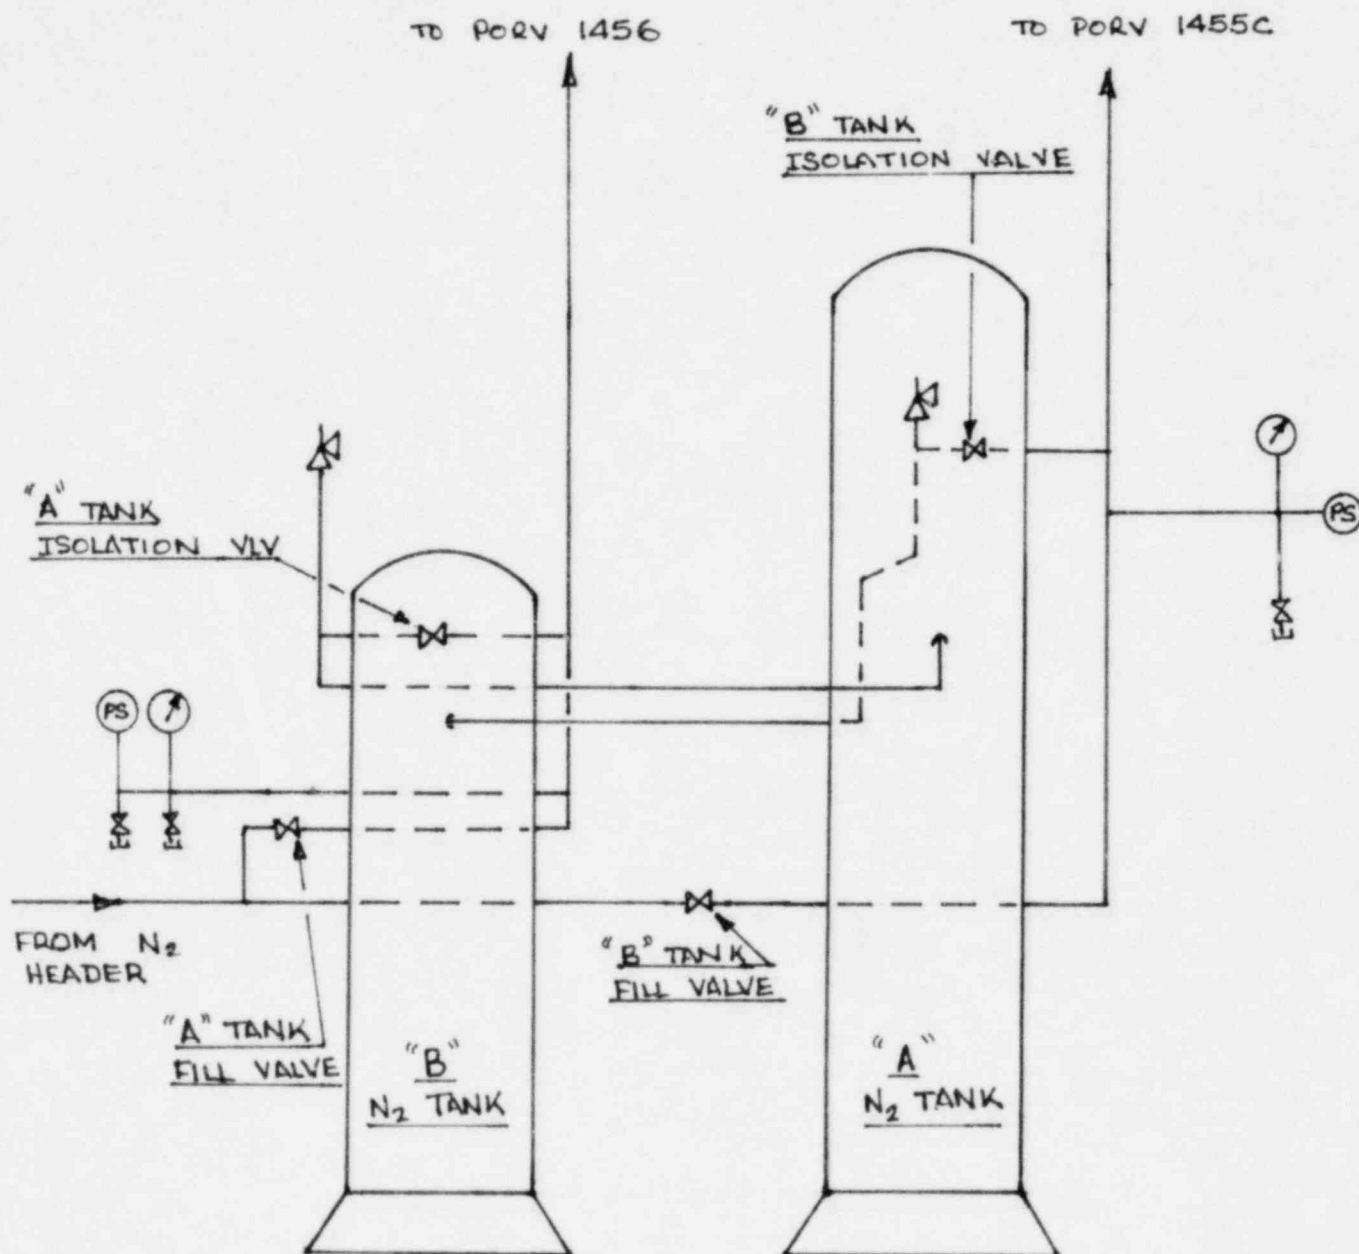
UNIT 1 NITROGEN SUPPLY

The second PORV became inoperable because a nitrogen supply (isolation) valve to PCV-1455C had been closed due to personnel error. Administrative errors were also a contributing factor in that the reservoir isolation valve was omitted from the controlled drawing revision performed by contracted personnel. In addition, formal written procedures or valve line-up sheets had not been provided to the operators although the overpressure protection system is taught in RO and SRO training classes.

There are also several factors related to the improper closure of the supply (isolation) valve. The repressurization of the nitrogen reservoir is normally performed under containment vacuum with full-face respirators and adverse environmental conditions. In addition, the isolation valve for each nitrogen reservoir is located behind the opposite nitrogen reservoir and neither isolation valve had been labeled with a mark number.

- b. It was determined, following the event, that the system drawing (FM-105A) did not show the valve identified by the operator.
- c. The system piping arrangement is unusual and the valve difficult to manipulate especially in respiratory protection equipment. For example, the B reservoir isolation valve is behind the A reservoir. (See attached sketch)

The reservoir isolation valve was opened and the reservoir pressurized to 1975 psig. The control room piping diagrams were annotated to show the correct piping and a Engineering Work Request submitted for a drawing revision and the assignment of mark numbers.

The controlled drawing will be revised.
