Evaluation of Foreign Objects in the SONGS Unit 3 Steam Generators

SOUTHERN CALIFORNIA EDISON

December 1993

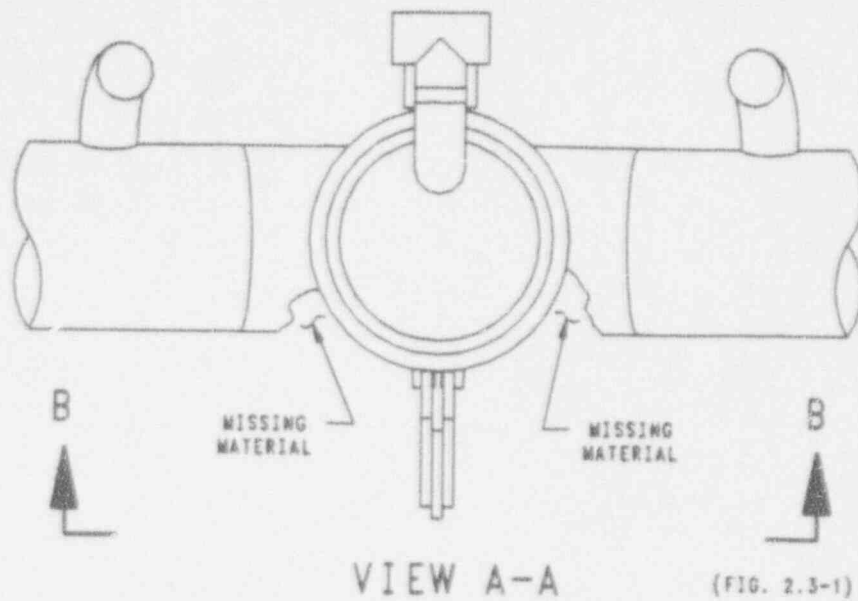
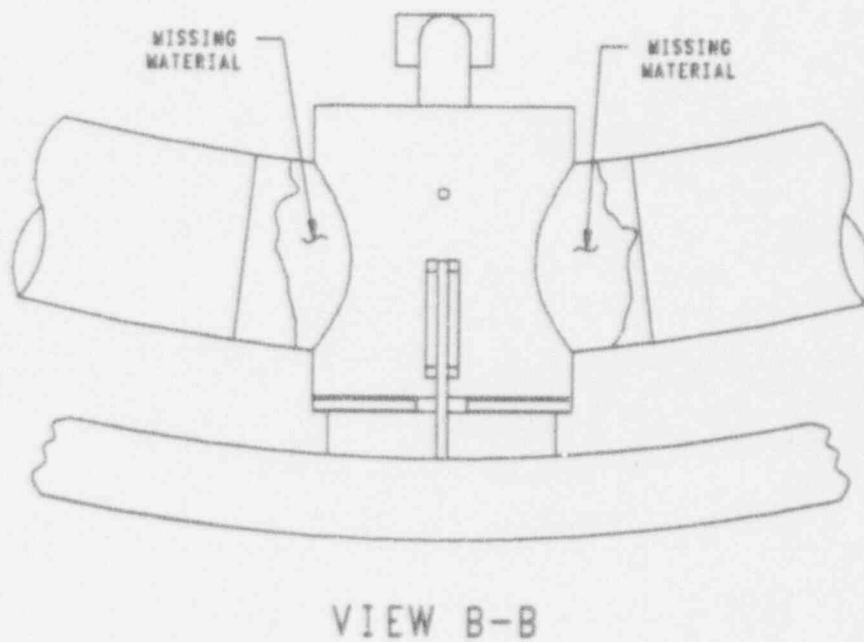
3E088 Feedwater
Distribution Box Erosion (1990)
Figure 2.3-2

The failure of the feedring resulted in through-wall cracking at the welded connection of the distribution box, excessive metal thinning and finally sparger debris being generated.

The failure of the vents and distribution box resulted in excessive metal loss inside the distribution boxes and separation of the vents from the distribution box due to severe erosion.

Repair of the feedring and distribution box was completed as part of the Cycle 5 Refueling Outage. However, the material removed from the feedring and vents was not all accounted for, resulting in the potential for loose parts to remain in the steam generators.

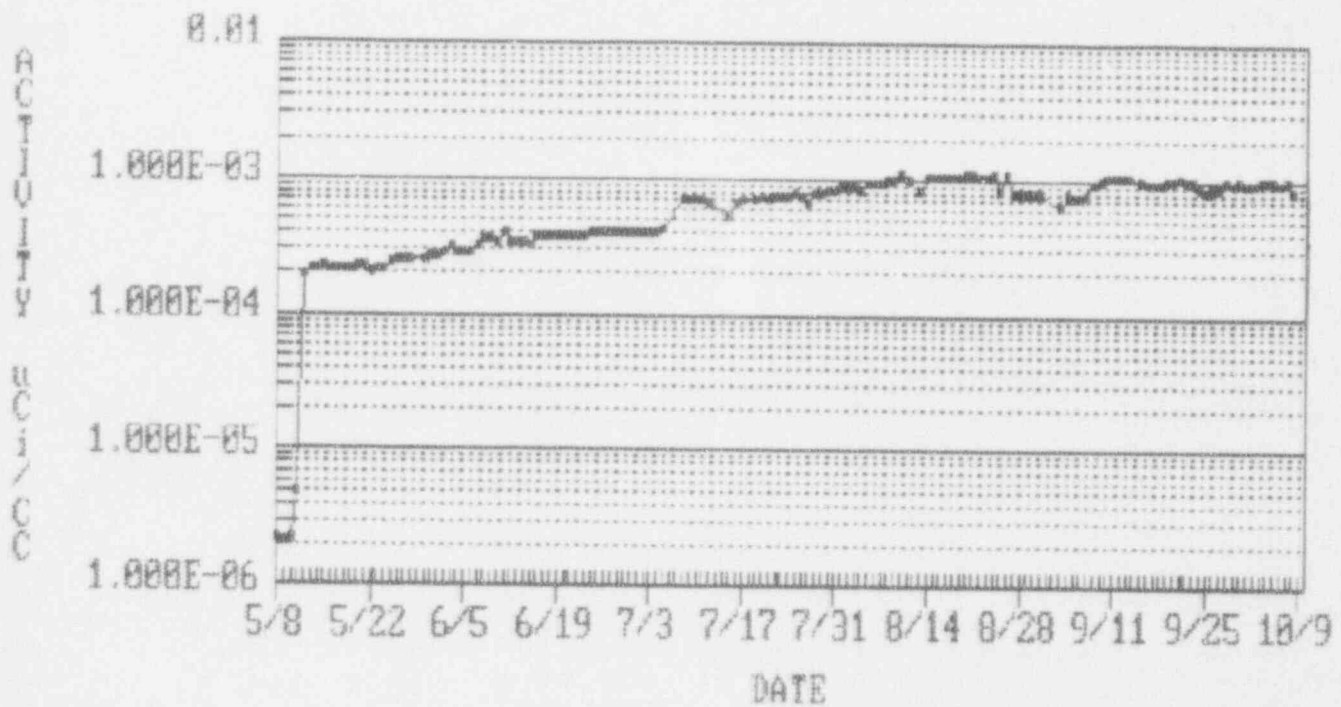
Figure 2.4-1

Prior to shutdown for the Unit 3 Cycle 7 refueling outage, a small gradually increasing tube leak existed in steam generator 3E088 as shown in Figure 2.4-1. Following shutdown, one tube was identified as leaking and the cause of leakage was determined to be wear from a foreign object. Eddy current testing was later used to identify the presence of other foreign objects. That testing is described in Section 3.2.

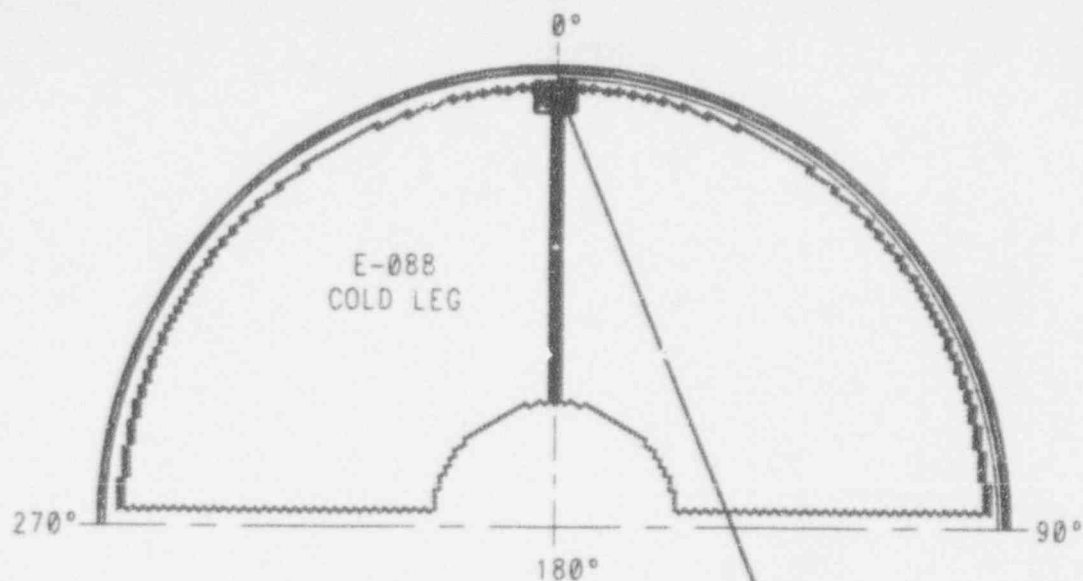
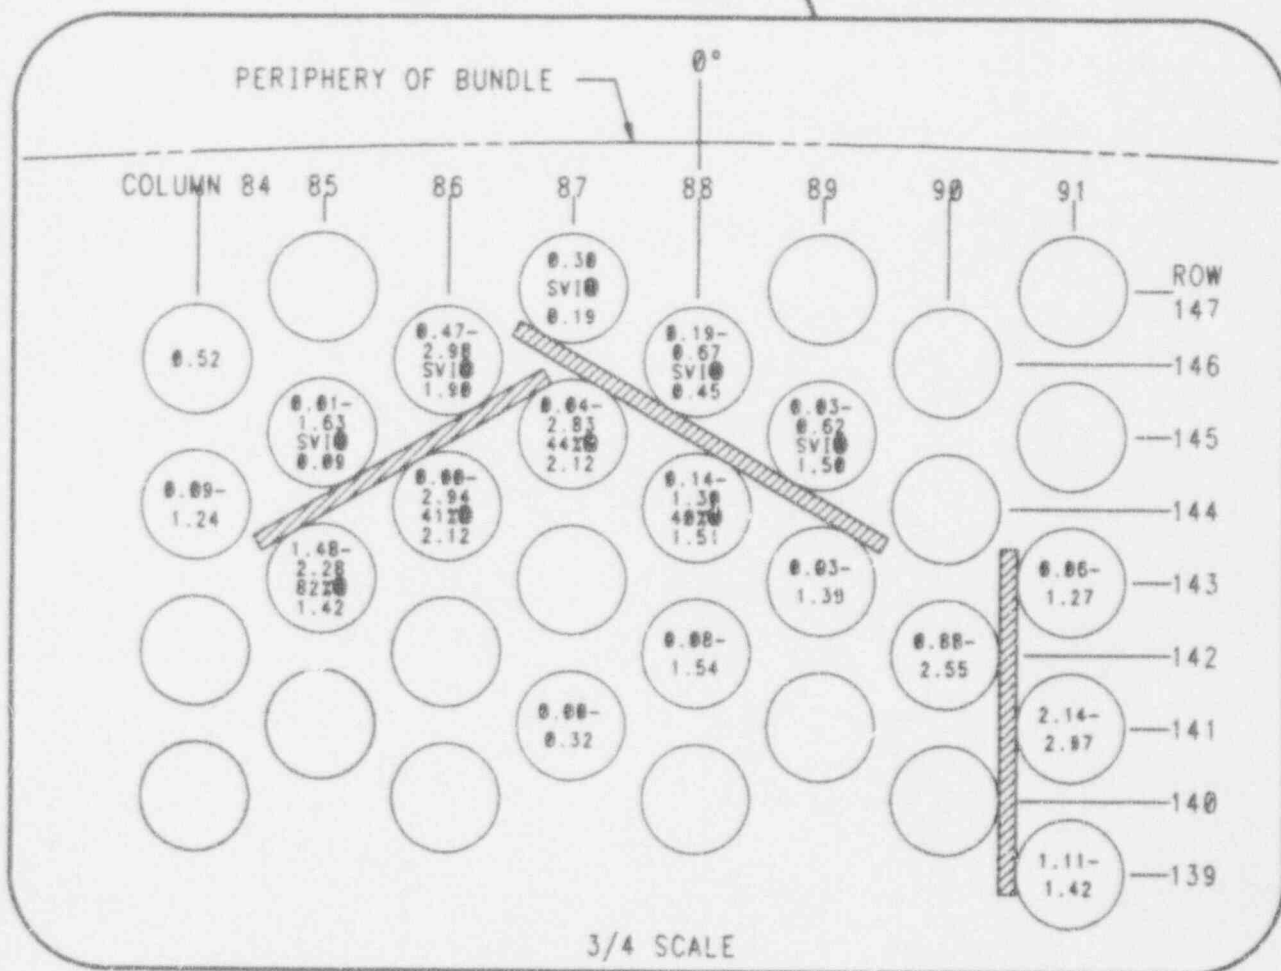
Location of Removed Loose Objects 88-3,4,5
Figure 3.2-1

The removed loose objects, designated 88-3, 88-4, and 88-5, are also described and dispositioned in Tables 3.2-3 and 3.2-4. Figure 3.2-1 shows the location and orientation of these parts prior to cleaning. Figure 3.2-2 provides the location of remaining ECT PLP indications subsequent to cleaning. As a result of the cleaning, all of these PLP indications were determined to not be valid.

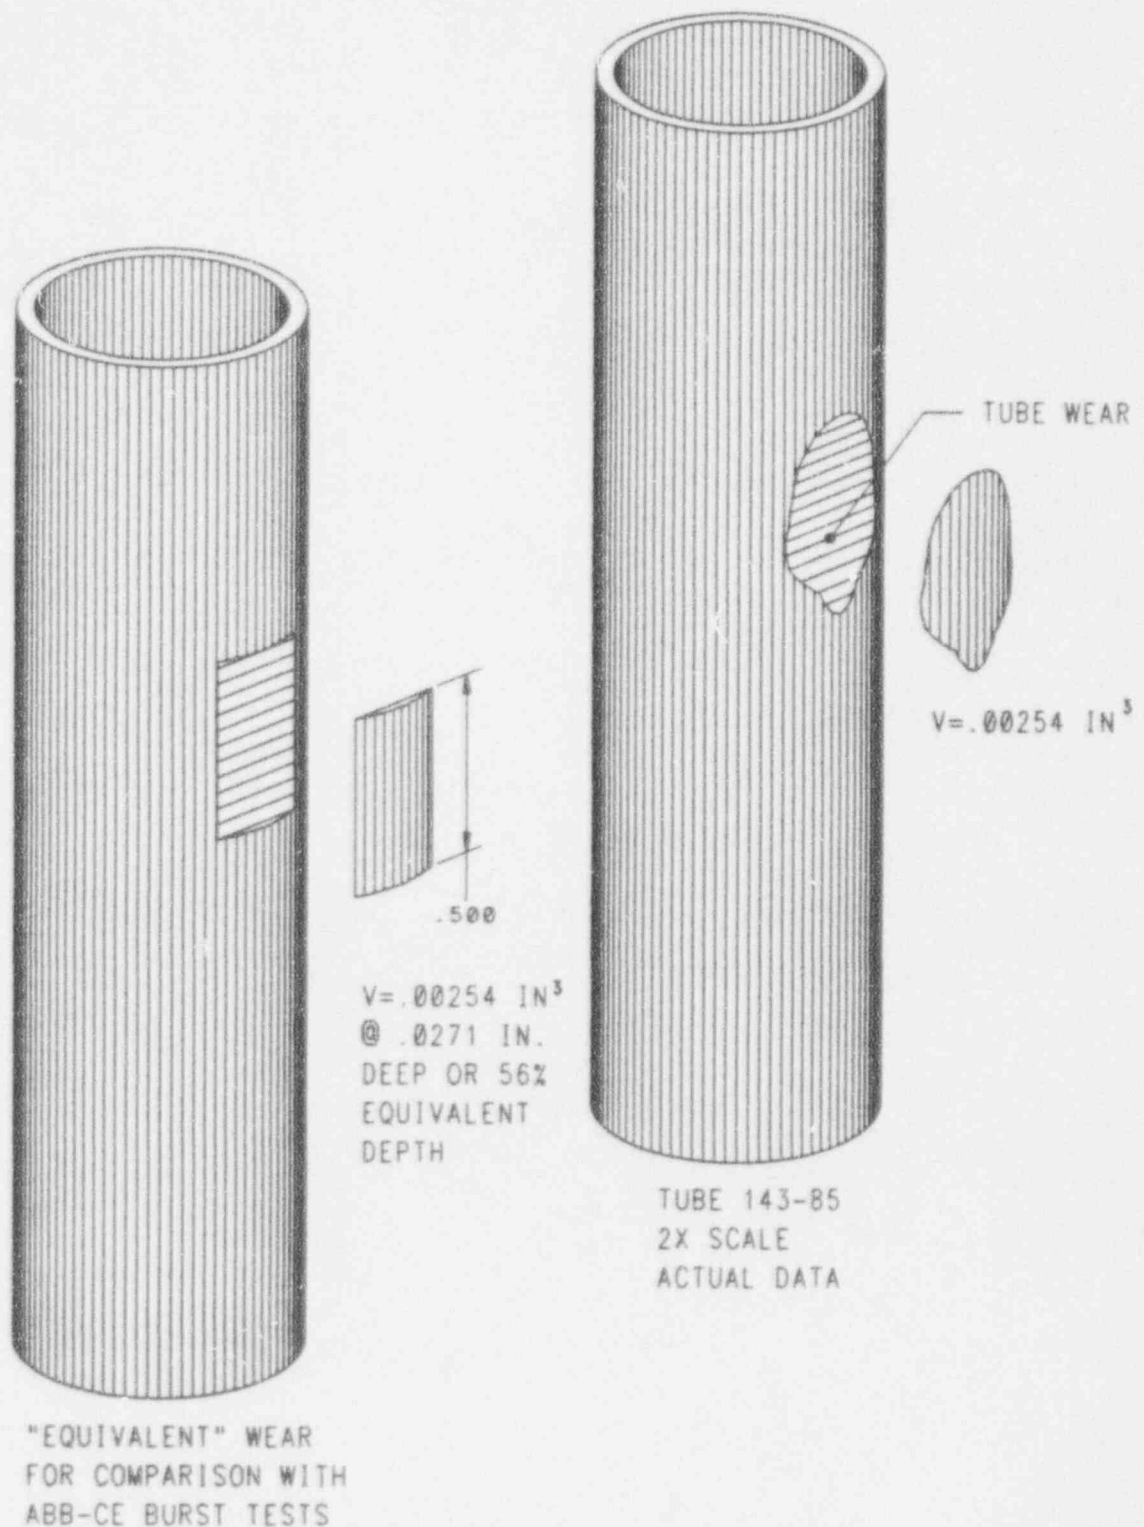
Calculated Equivalent Wear Depth for
Comparison of SCE Tube Degradation
with ABB-CE Test Results
Figure 3.5-1

Based on the 1985 ABB-CE tests, the burst pressure of an Inconel steam generator tube with 70% flat wear over a 1/2 inch axial defect is 6700 psig. This burst pressure is conservatively used without accounting for the difference between a 70% wear defect of the test and a 56% equivalent wear defect of Unit 3 Tube 143-85.

Using this burst pressure, the calculated margin to burst (difference between burst pressure and delta pressure) for normal and accident conditions is 4.9 and 2.7, respectively. This margin is well within the tube design criteria.

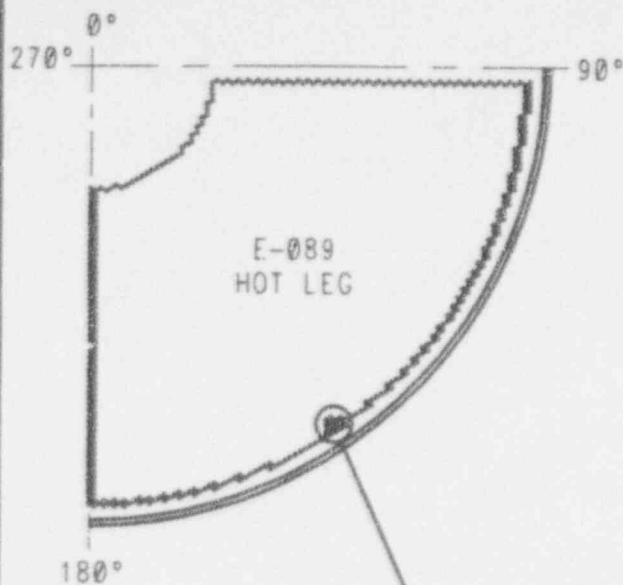
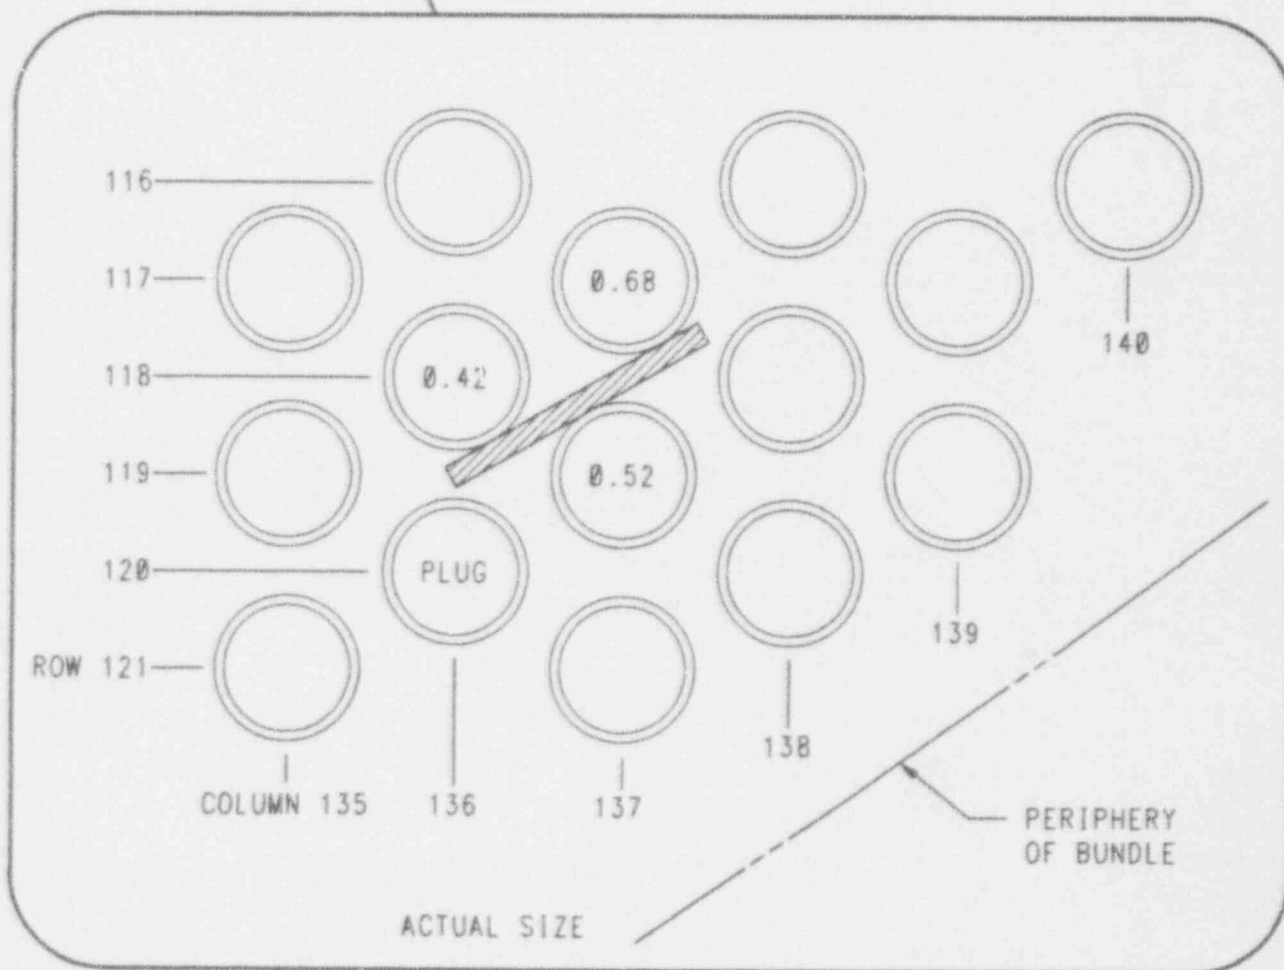
Location of Potential Loose Object 89-2
Figure B-4

LOOSE OBJECT ORIENTATION
ASSUMED FOR CONSERVATISM

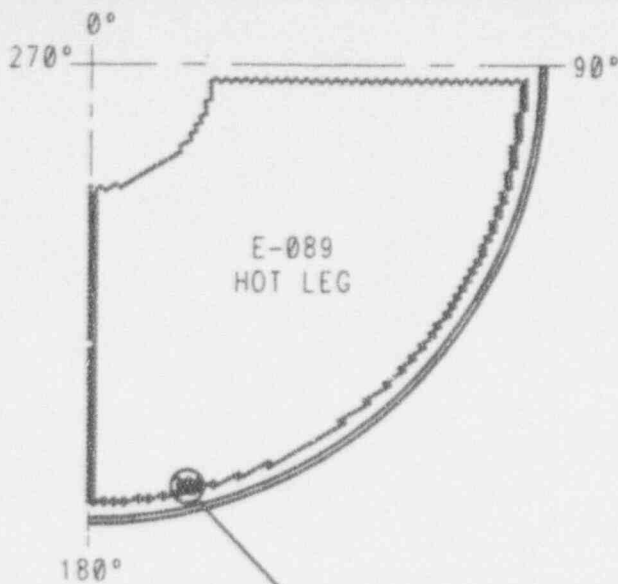
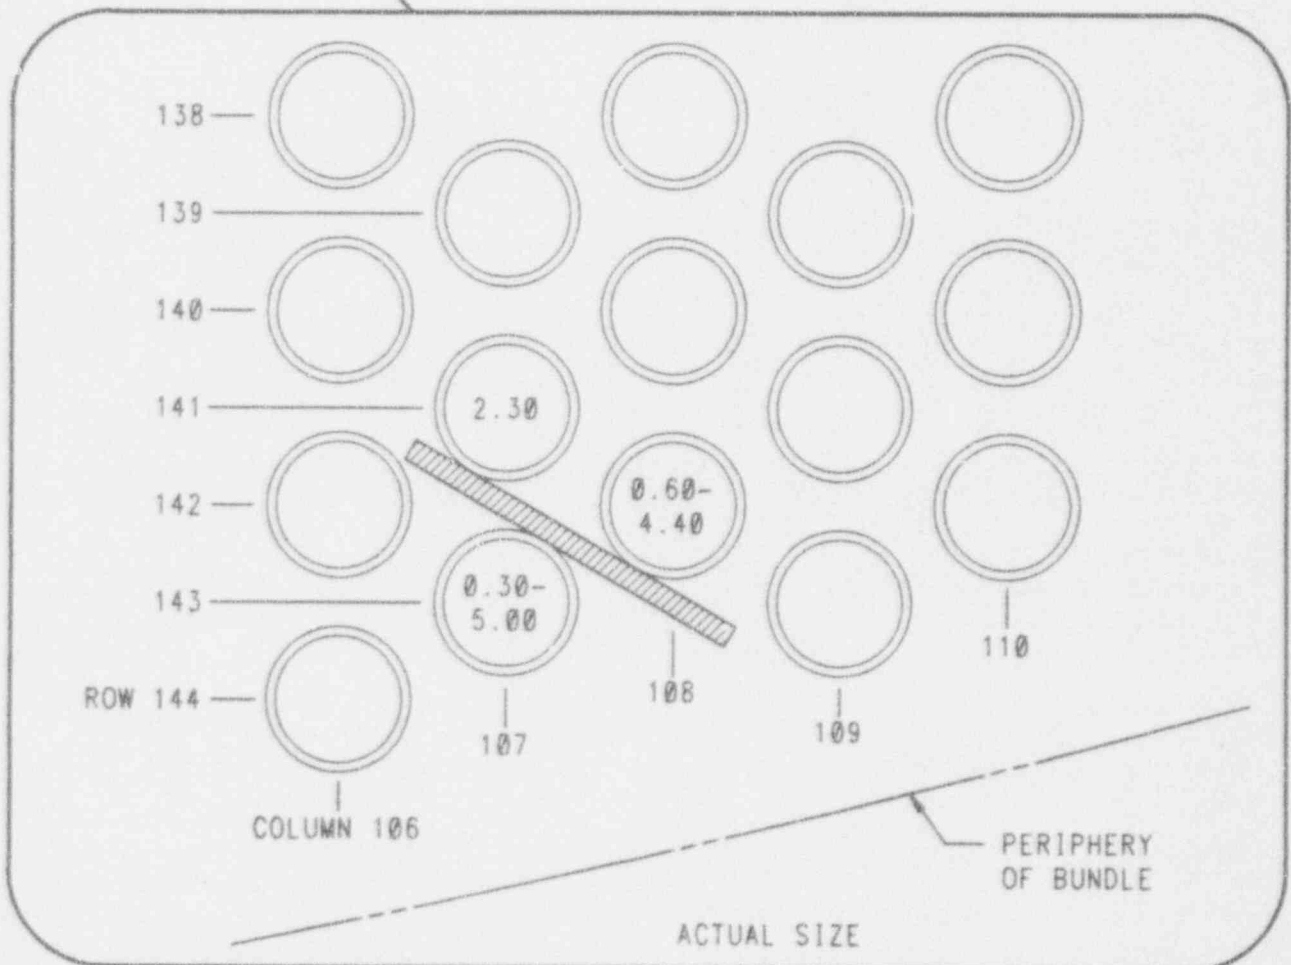
Location of Potential Loose Object 89-4
Figure B-6

LOOSE OBJECT
ORIENTATION BASED ON
VISUAL OBSERVATION (1993)

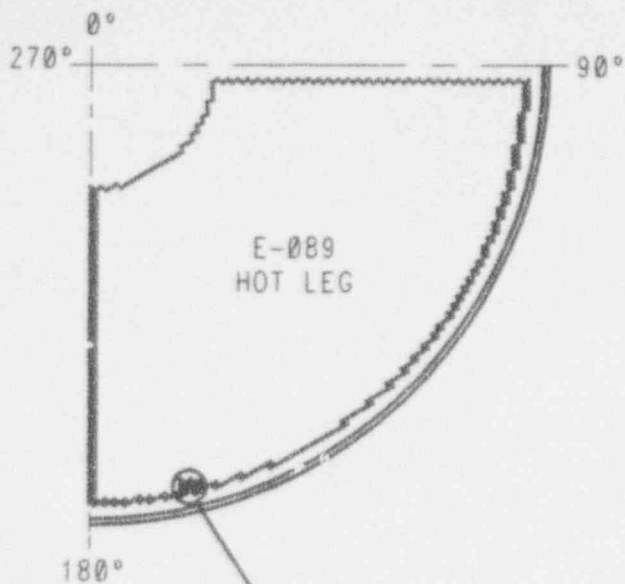
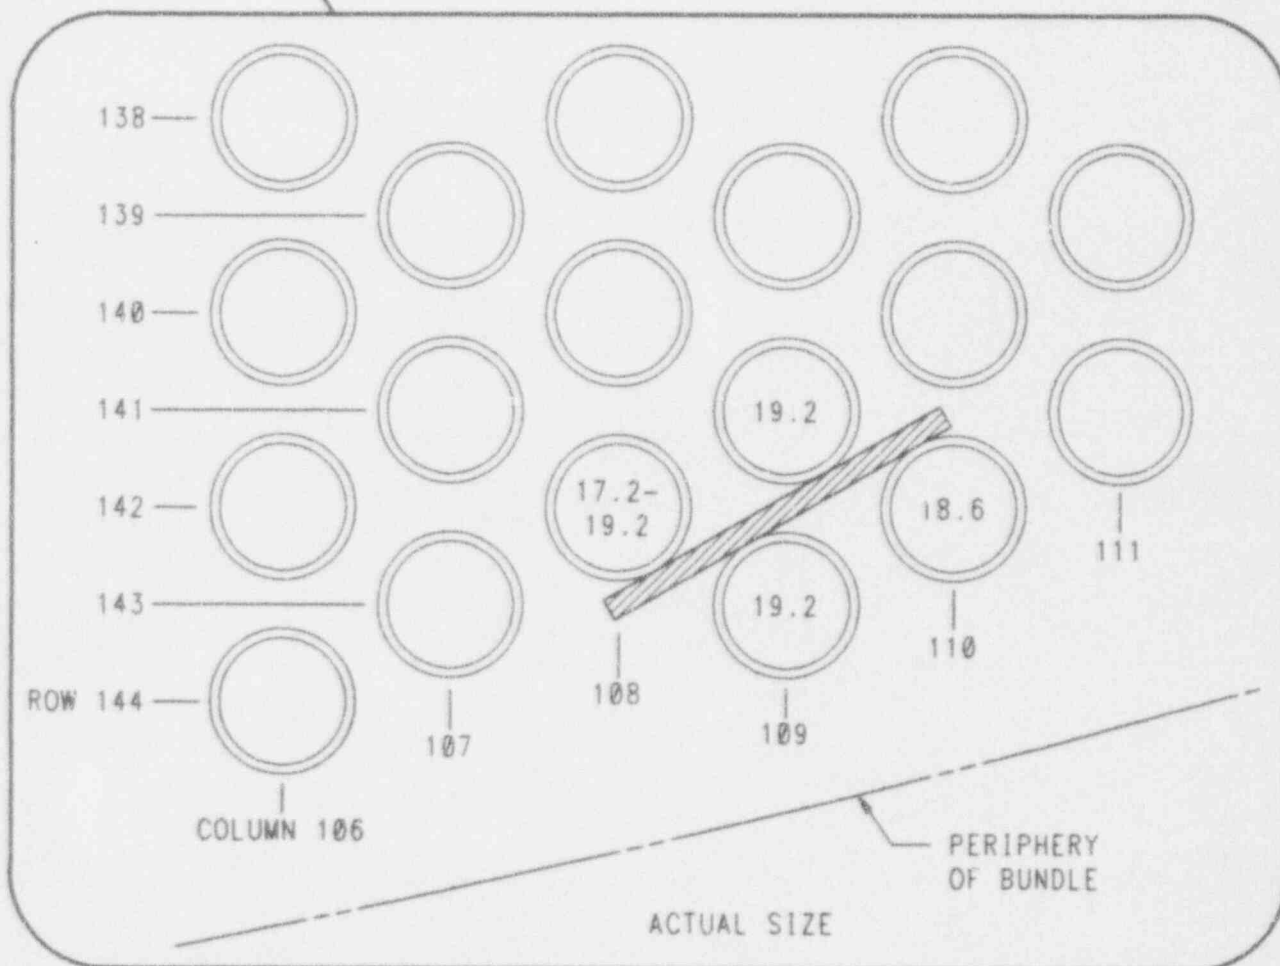
Location of Potential Loose Object 89-5
Figure B-7

LOOSE OBJECT
ORIENTATION BASED ON
VISUAL OBSERVATION (1993)
