LICENSEE EVENT REPORT (LER)

FACILITY NAME (1) South Texas Unit 2	DOCKET NUMBER (2) 05000 499	PAGE (3) 1 OF 5
---	--------------------------------	--------------------

TITLE (4) Unplanned Engineered Safety Feature Actuation of an Isolation Valve for the Above Seat Drain Line

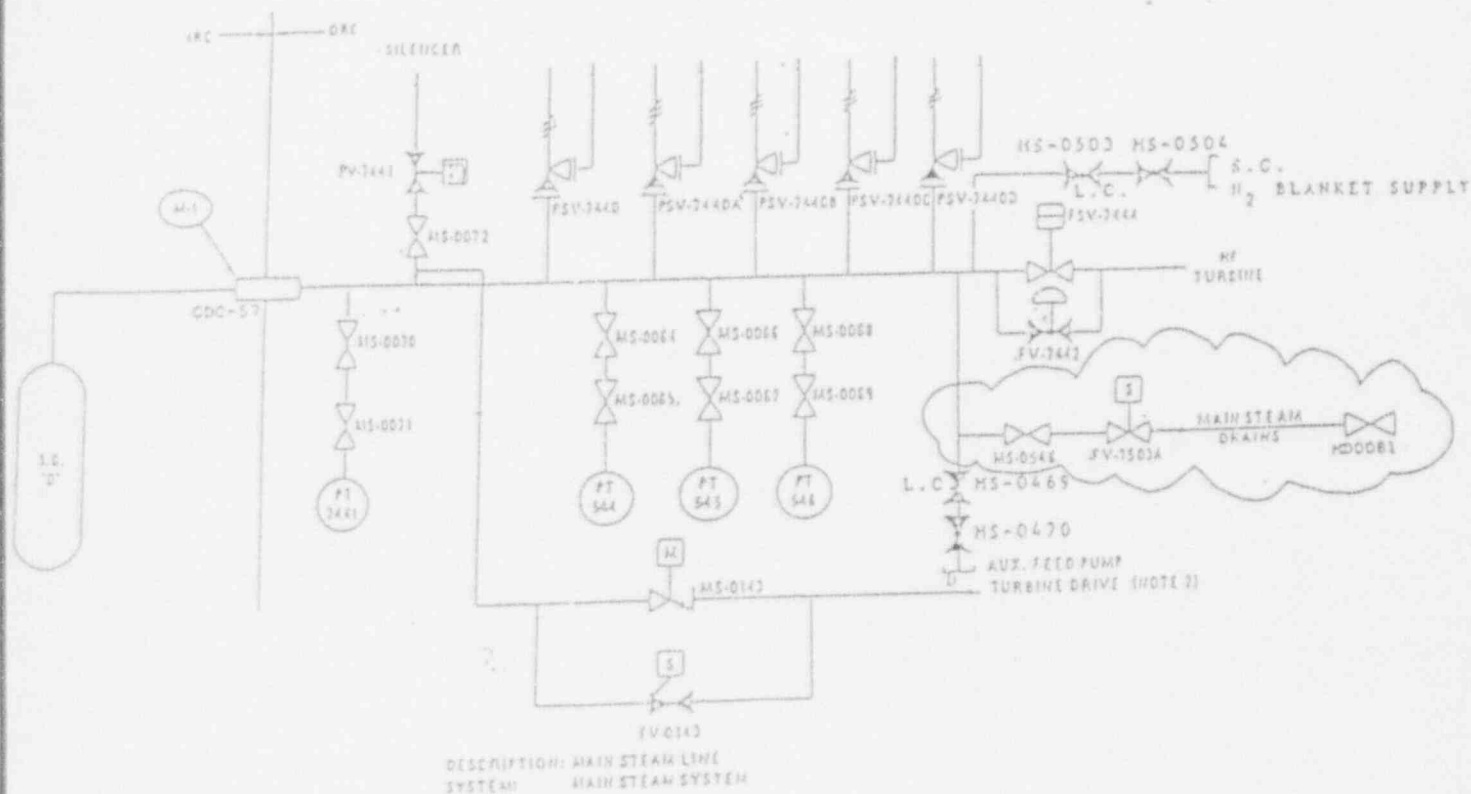
FIGURE

On August 31, 1992, a Unit 2 Equipment Clearance Order (ECO) was written for Unit 2 to close the Main Steam drain isolation valve (MS0546), a normally locked open valve and the isolation valve for the above seat drain line on Main Steam line "D" (MS7903A) to isolate a leak on a downstream valve. MS0546 was manually closed and the Control Room handswitch for MS7903A was placed in the "CLOSE" position. MS7903A is a normally energized open Solenoid Operated Valve (SOV) and automatically closes on a Containment Isolation signal. (See Figure)

The cause of the unexpected opening of the isolation valve for the above seat drain line (MS7903A) is the unintentional opening of an SOV, an undesirable, but avoidable characteristic of piloted SOVs. EPRI/NMAC Solenoid Valve Maintenance and Application Guide, NP-7414, addresses the phenomenon. The unintentional opening of an SOV occurs for a fraction of a second, when a rapid inlet pressure transient occurs. The unintentional opening is characteristic of piloted SOVs installed in steam/gas systems. The unintentional opening of SOV MS7903A could have been avoided if the SOV had been opened prior to opening the upstream isolation valve (MS-0546). The unintentional opening of piloted SOVs is not a widely recognized characteristic and had not been addressed in training.
