The following HED  
Implementation  
Documents or  
Dispositions Have Been  
Modified  
See Addendum For  
Update

DAVIS-BESSE HUMAN ENGINEERING DISCREPANCY REPORT  
ADDENDUM

DAVIS-BESSE NUCLEAR POWER STATION  
UNIT No. 1  
FIRE HAZARD ANALYSIS REVIEW OF FACILITY  
CHANGE REQUEST (FCR)

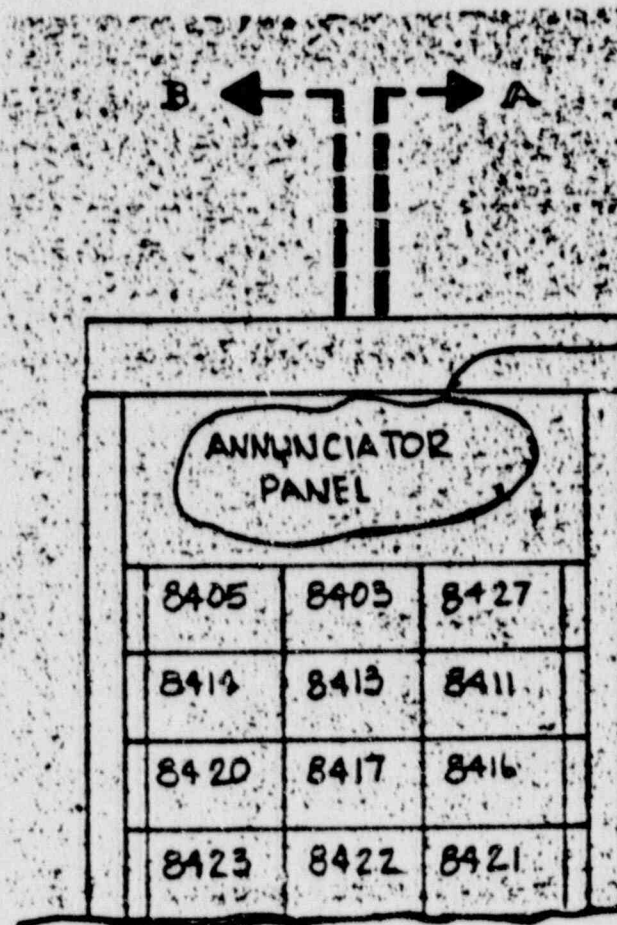
ANNUNCIATOR Internal View From Rear of Cabinet  
HAS BEEN  
DISCONNECTED  
AND REMOVED

\* Non-Functional Annunciator HAS BEEN  
Removed.

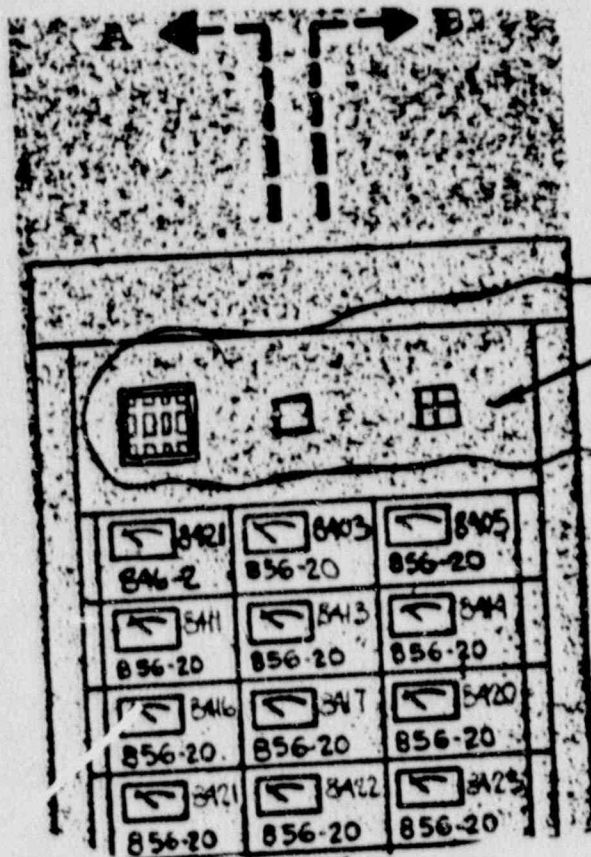
904804 Annunciator  
Panel

Area of  
change  
TO BE REMOVED
