CLARK ASSOCIATES, INC.
QUALITY ASSURANCE DEPARTMENT
AUDIT OF THE ERECTION OF THE SOUTHEAST
NORTHEAST AND SOUTHWEST QUADRANTS OF THE CONTAINMENT
VESSEL BOTTOM LINER, SKUCKLE
AND TORICONICAL SECTIONS TO
ELEV. 95' ± 3"

AUDIT REPORT #10

CLIENT: Florida Power Corporation

UNIT: Crystal River Unit #3

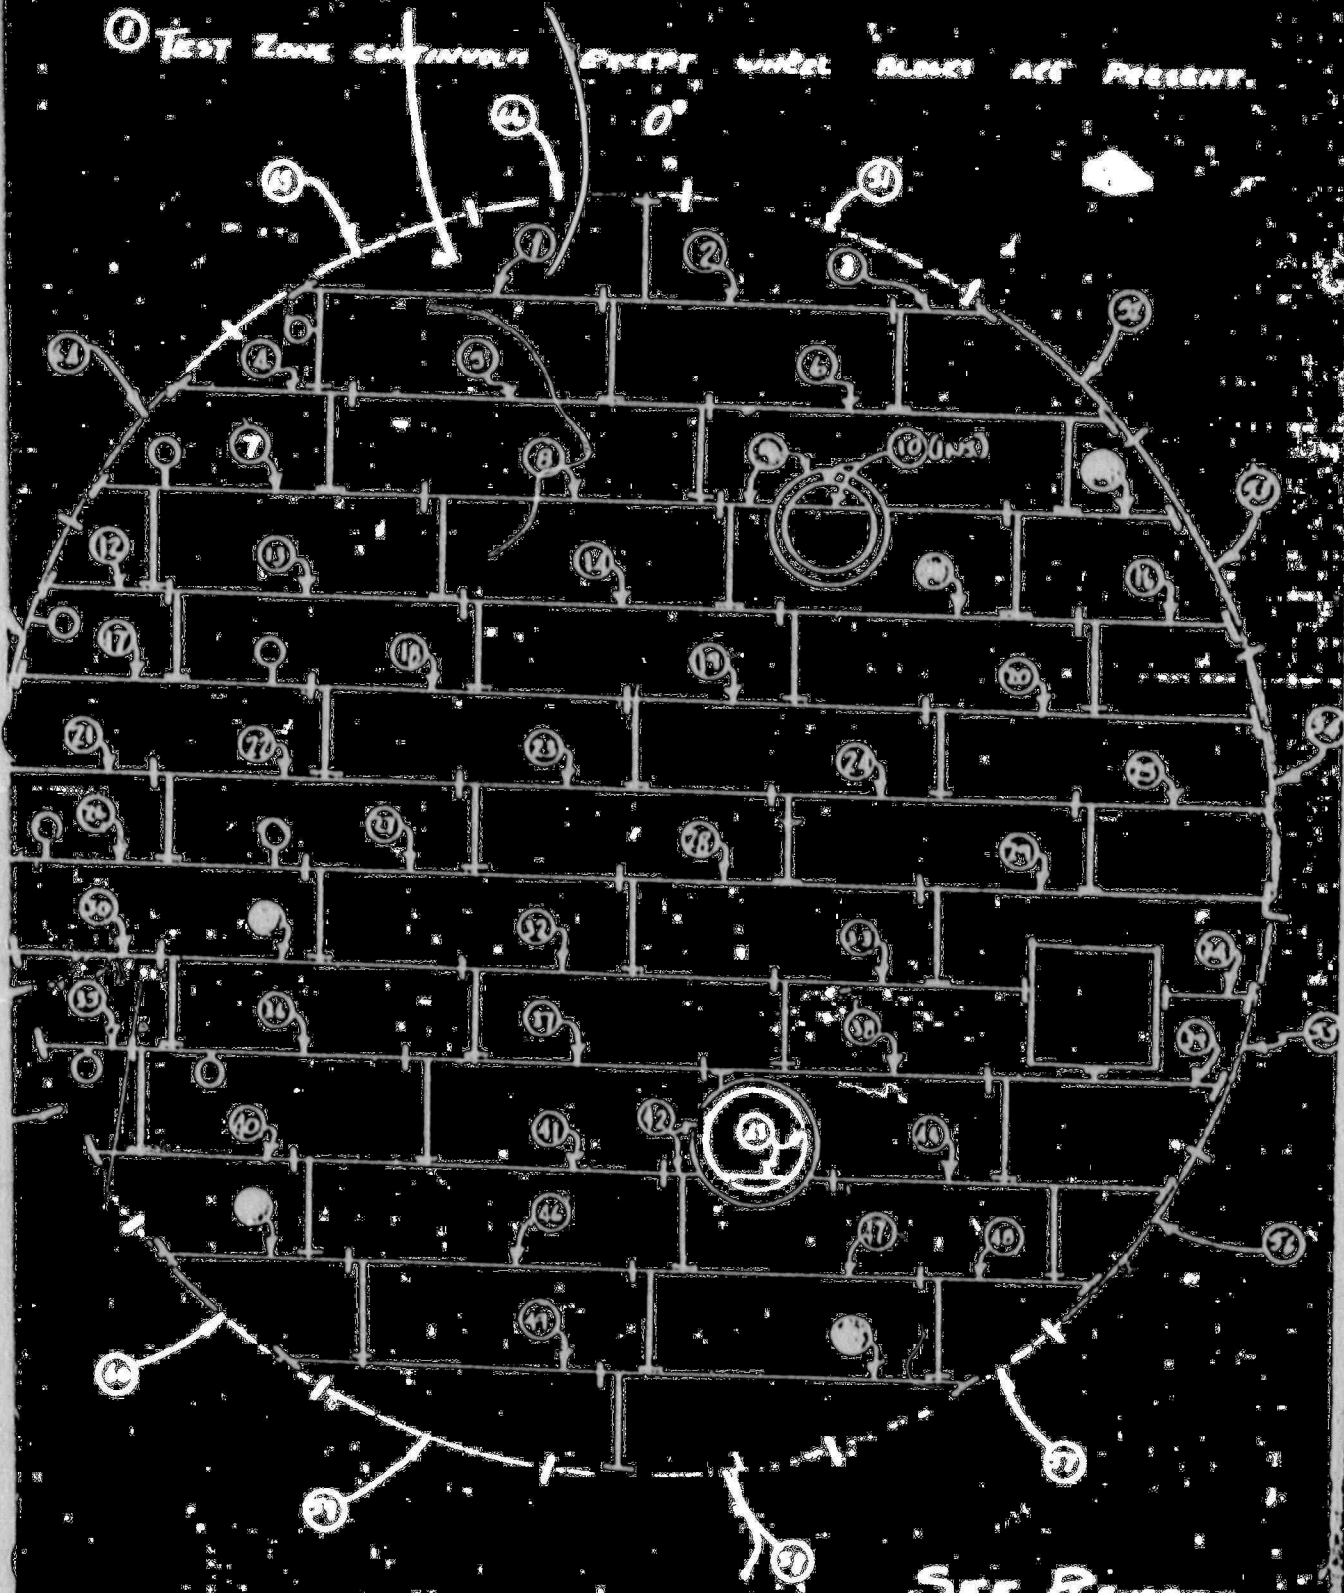
9-0532

① Test Zone continuous except under blank air present.

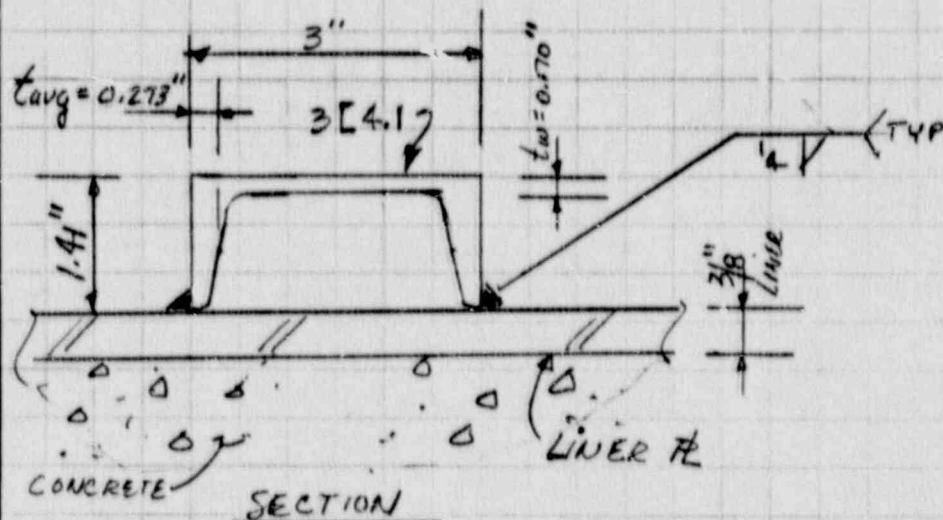
REF. CBI DWG. 29 REV. 2 (SEE P. 10)
FOR TYPICAL TEST CHANNEL DETAILS

CHECK TYPICAL CHANNEL ATTACHMENT FOR CONTROLLING LOAD⁺
CASE OF 1.15 TIMES THE DESIGN PRESSURE (63.3 psig)
DURING THE STRUCTURAL PROOF TEST.

* FOR LINER AND
LINER ATTACHMENT DESIGN
THE LOAD FACTORS ARE
ONE IN ALL CASES.
THEREFORE, MAX. PRESSURE
EVER EXPERIENCED BY THE
TEST CHANNELS IS 1.15
TIMES DESIGN PRESSURE
AT STRUCTURAL INTEGRITY
TESTING.
