INDIAN POINT UNIT 2 - FINAL REPORT  
ON THE STEAM GENERATOR INSPECTION,  
REPAIR, AND RESTORATION EFFORTS  
DURING THE 1990 MID-CYCLE INSPECTION

ISSUE DATE: JULY 1990

PREPARED FOR CONSOLIDATED EDISON COMPANY

WESTINGHOUSE ELECTRIC CORPORATION  
NUCLEAR SERVICES DIVISION  
P. O. BOX 355  
PITTSBURGH, PENNSYLVANIA 15230

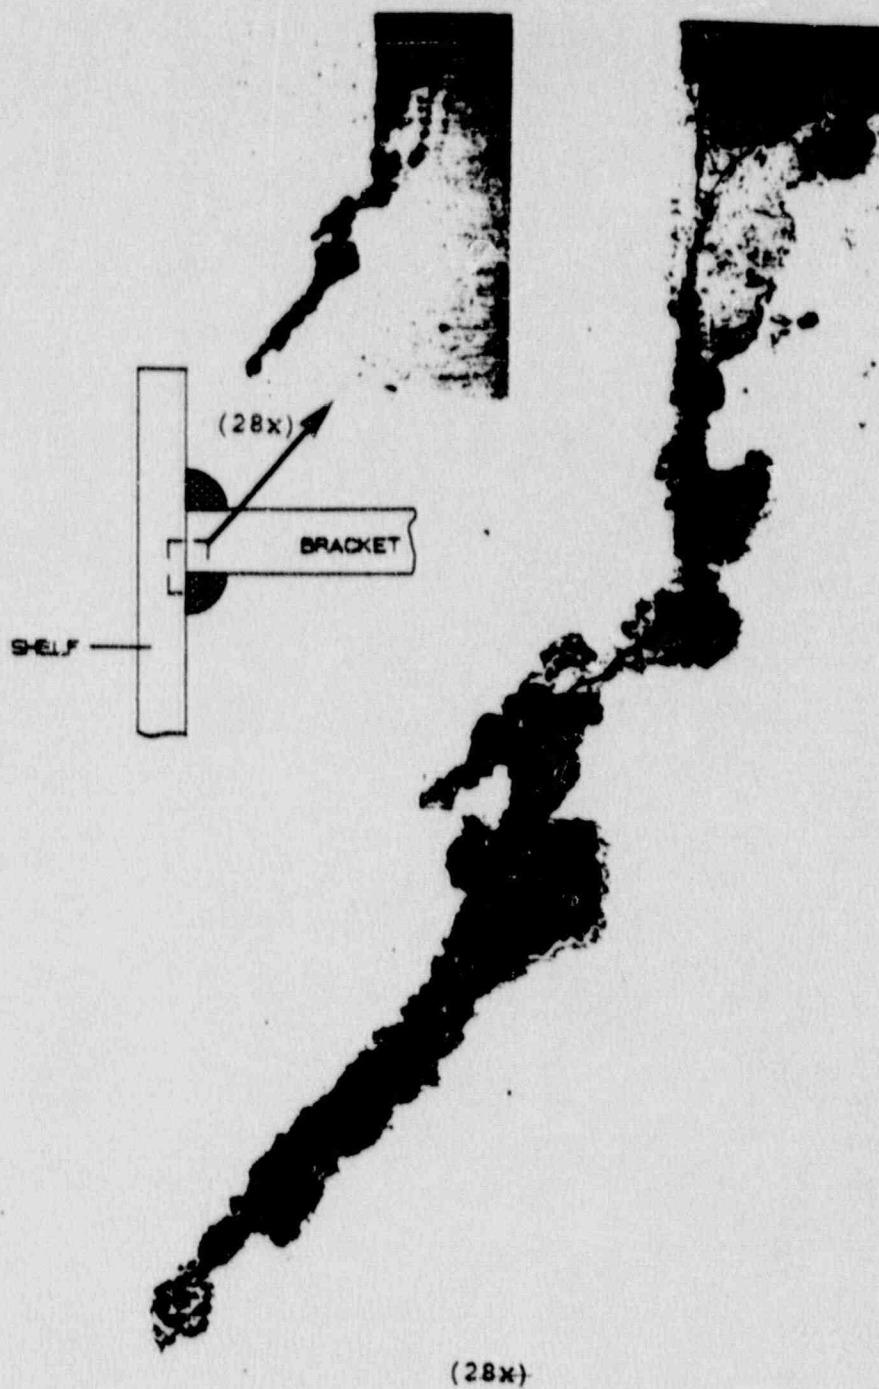
Figure 3.2-4 Metallography results illustrating the morphology of cracking at the feedring thermal liner plate to weld interface. (SG 21 1990 outage examinations)

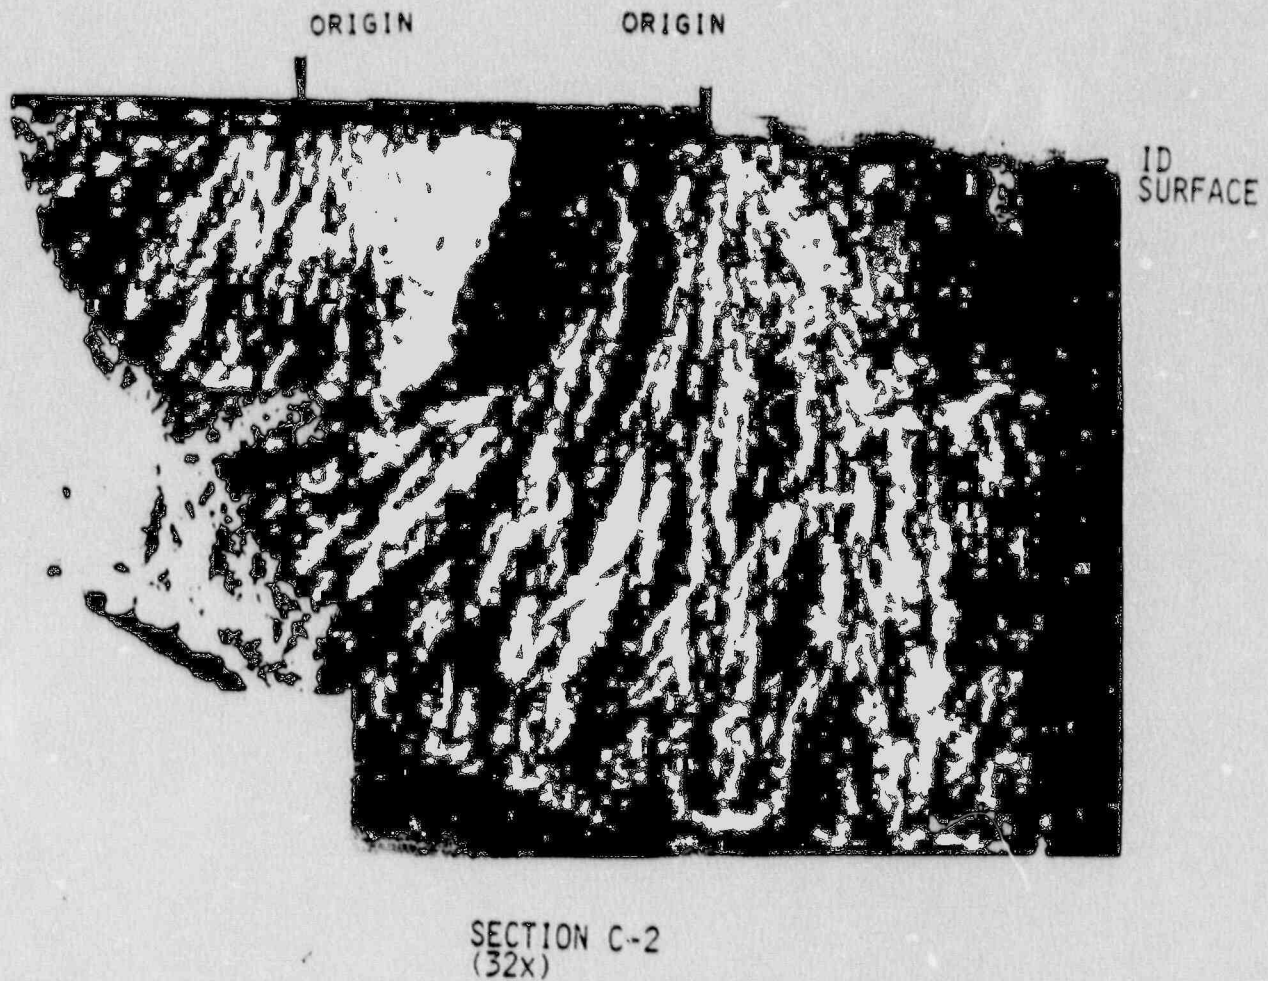
Figure 3.2-6 Light optical fractograph illustrating the fracture morphology seen in the SG #22 boat sample from the 1989 outage.

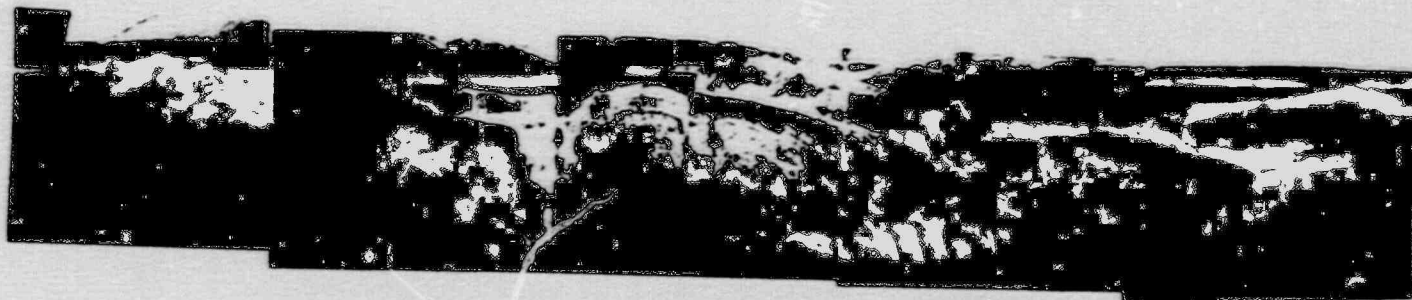
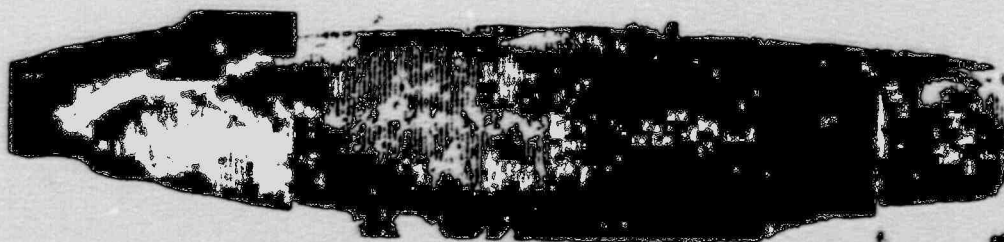
Figure 3.2-7 Light optical fractograph of the crack in the boat from the nozzle bore. (SG #24 1990 outage examinations)

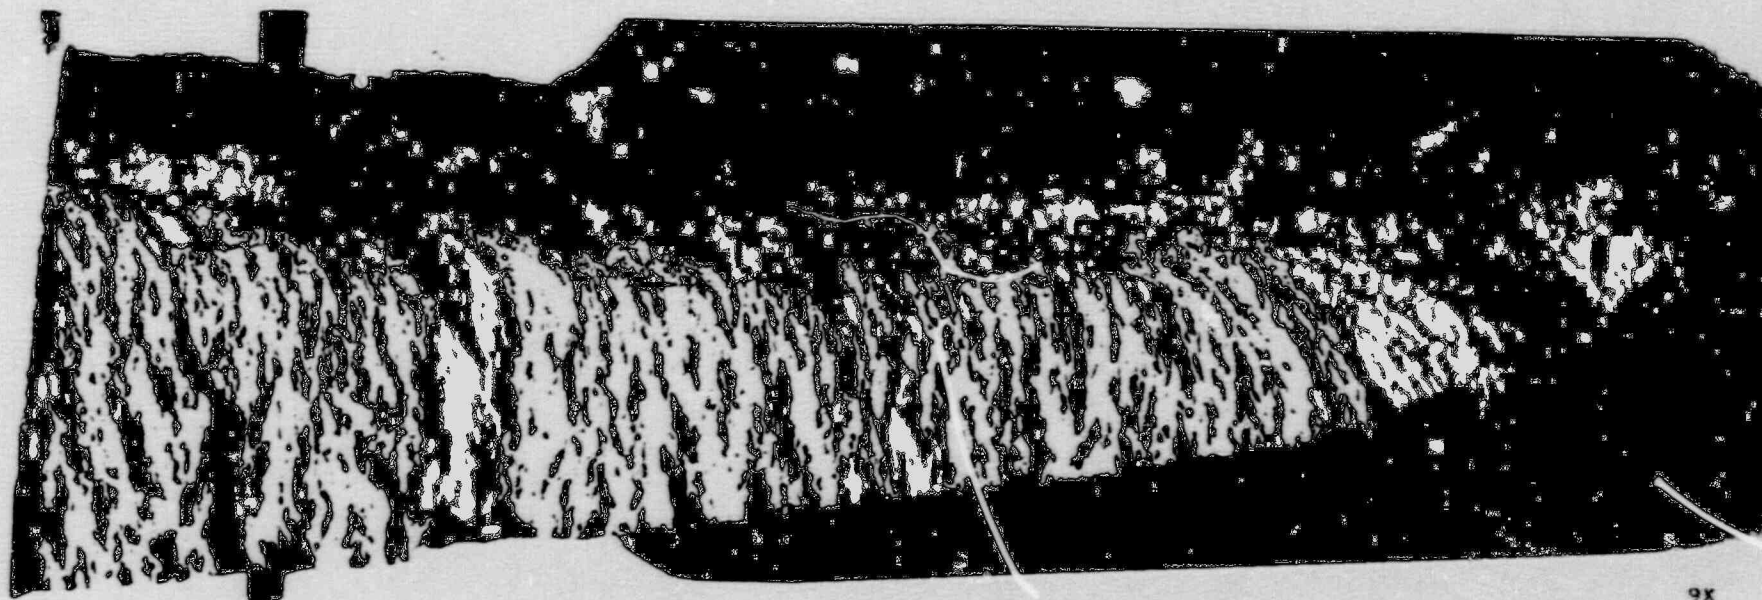
Figure 3.2-8 Light optical fractograph showing smooth river pattern in the boat from the cone region below the girth weld. (SG #22, 1990 outage examinations)

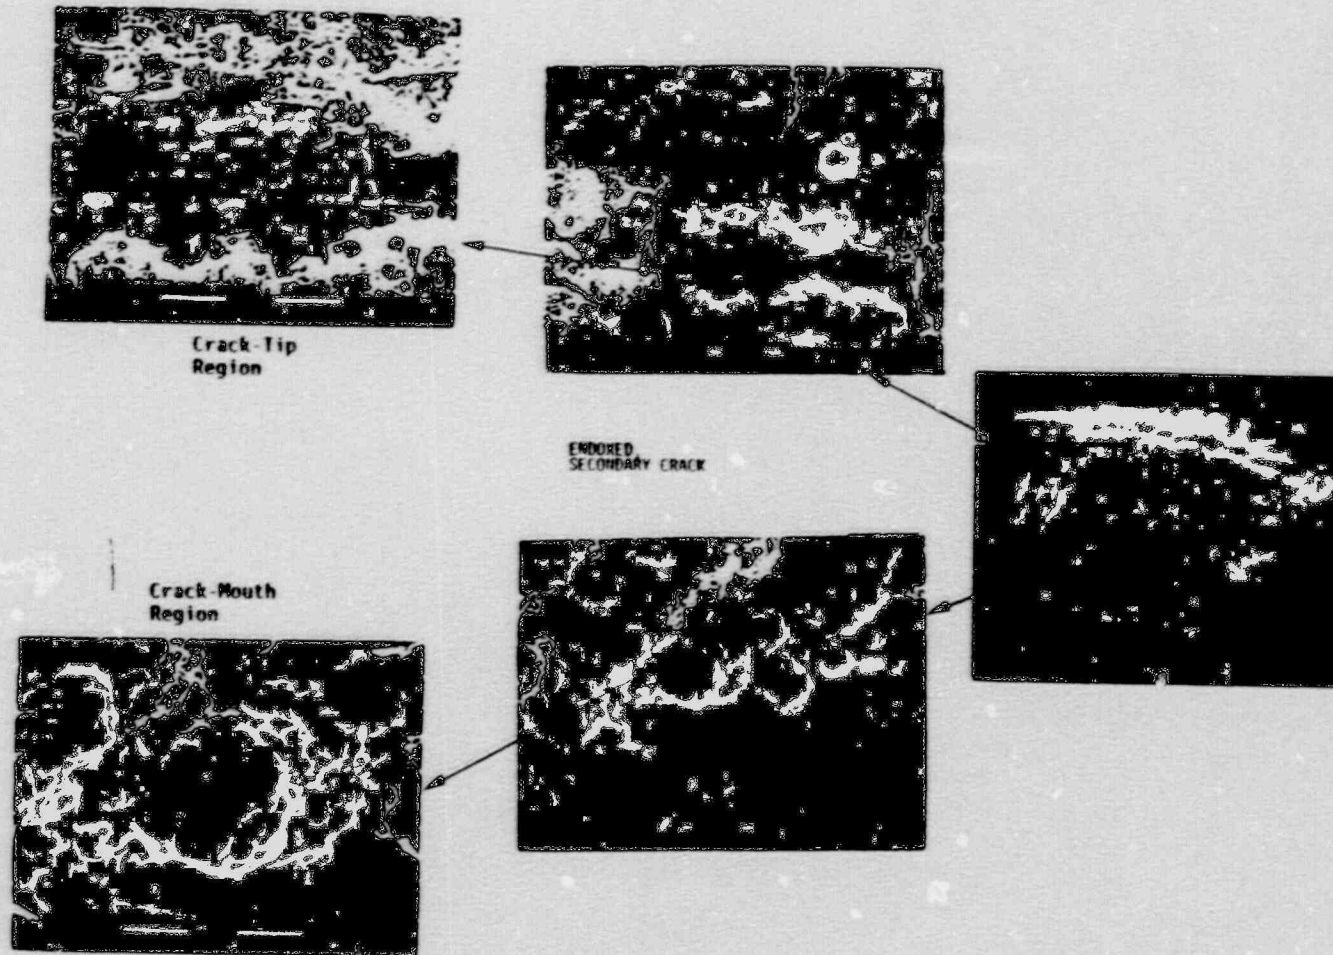
Figure 3.2-9 Scanning electron fractograph of the endoxed fracture face illustrating the presence of fatigue striations in the girth weld sample from the 1989 outage. (SG #24, 1989 outage examinations)

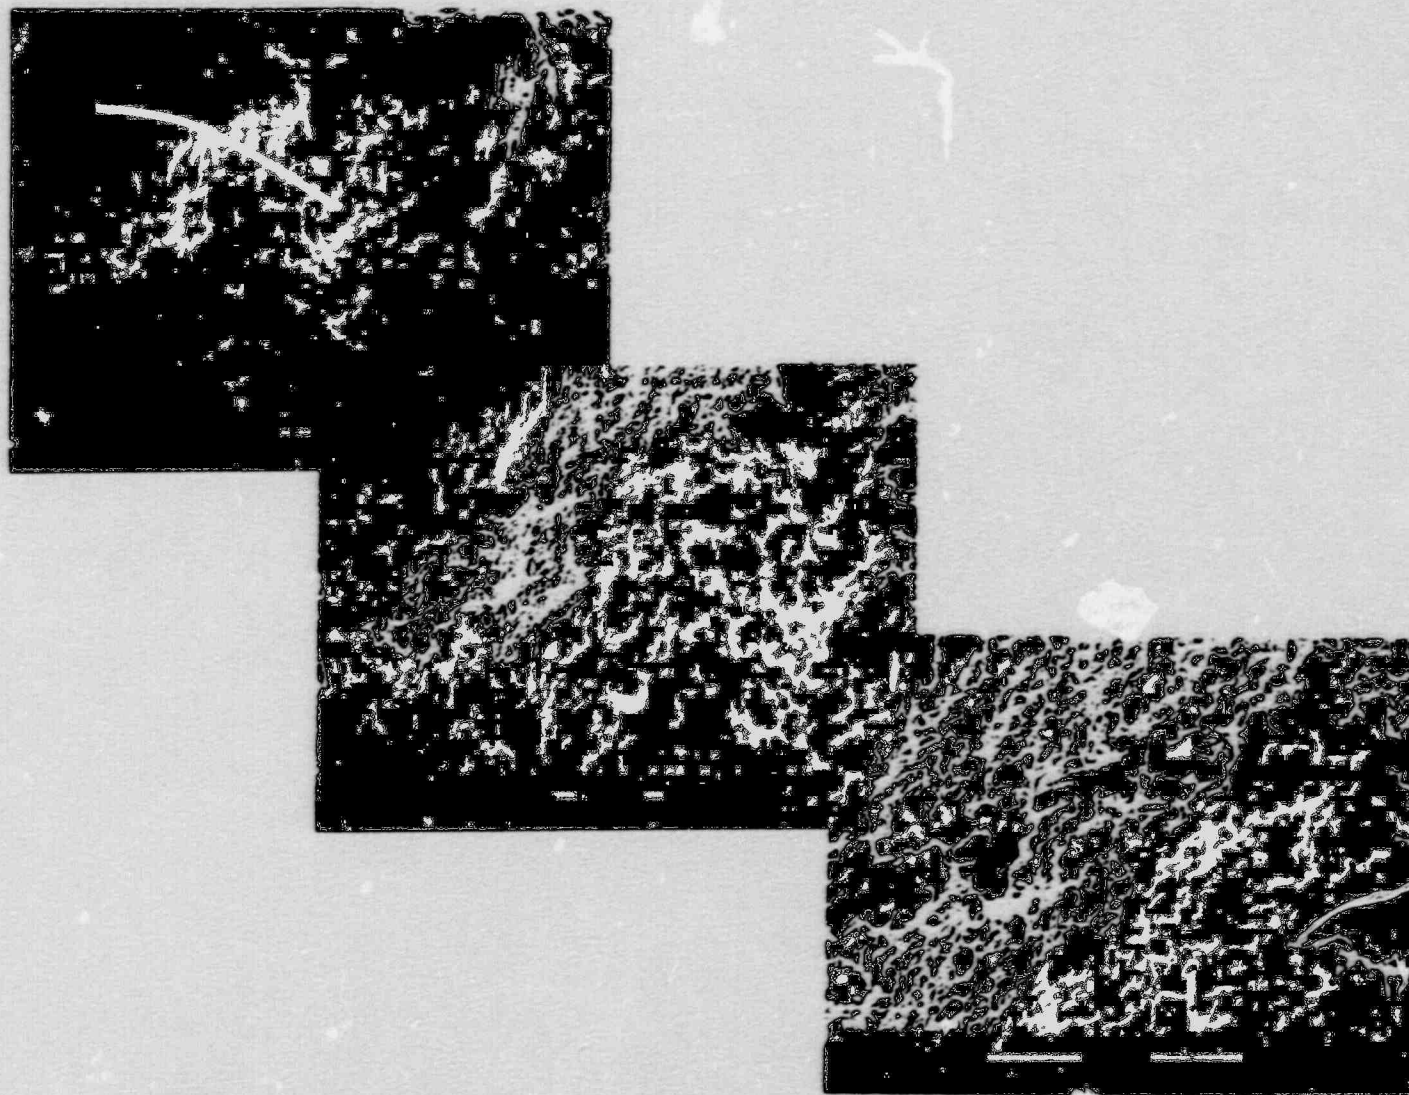
Figure 3.2-10 Scanning electron fractographs illustrating fine fatigue striations in the nozzle bore samples. (SG #24, 1990 outage examinations)

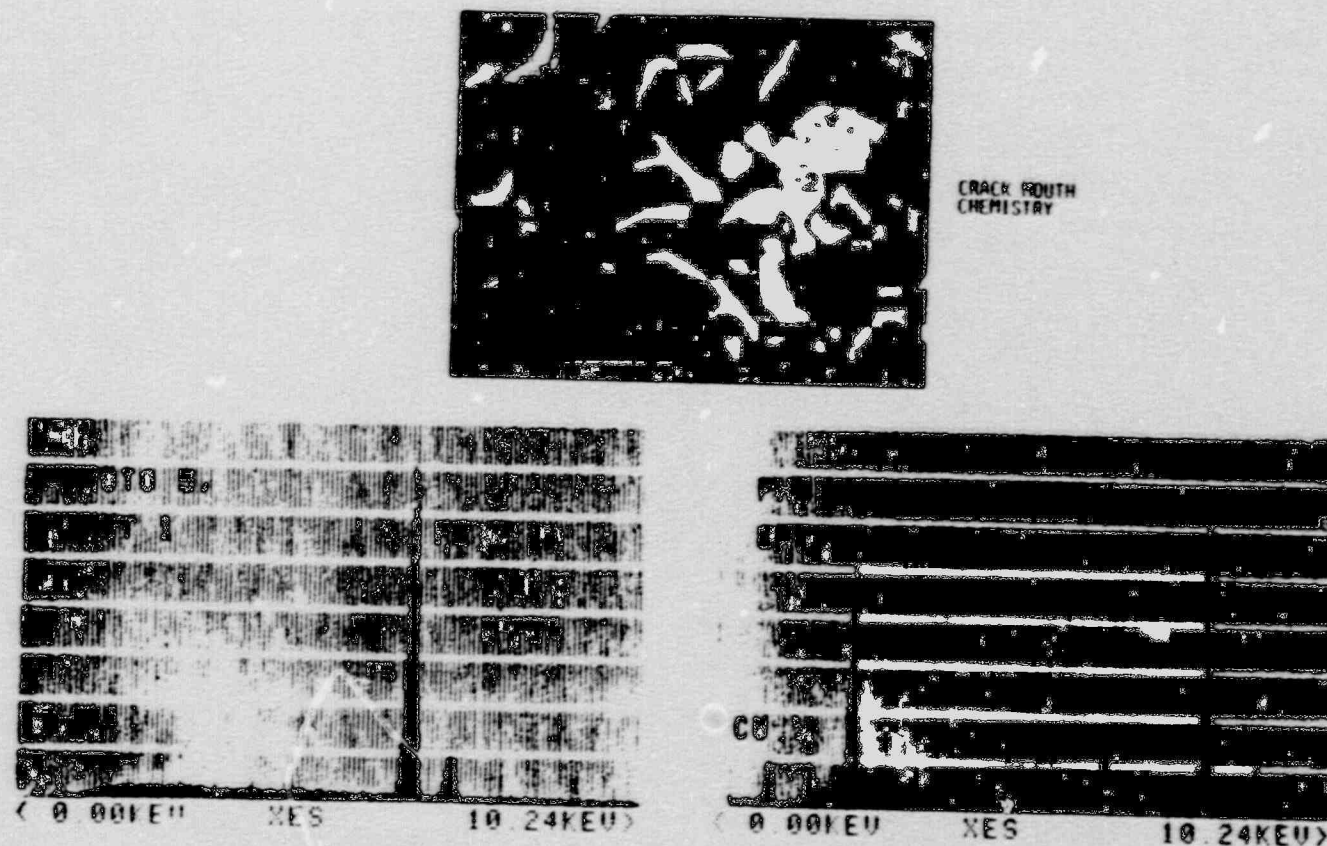
Figure 3.2-11 Energy dispersive X-ray analysis results from the SG #24 girth weld boat sample crack, 1989 outage.

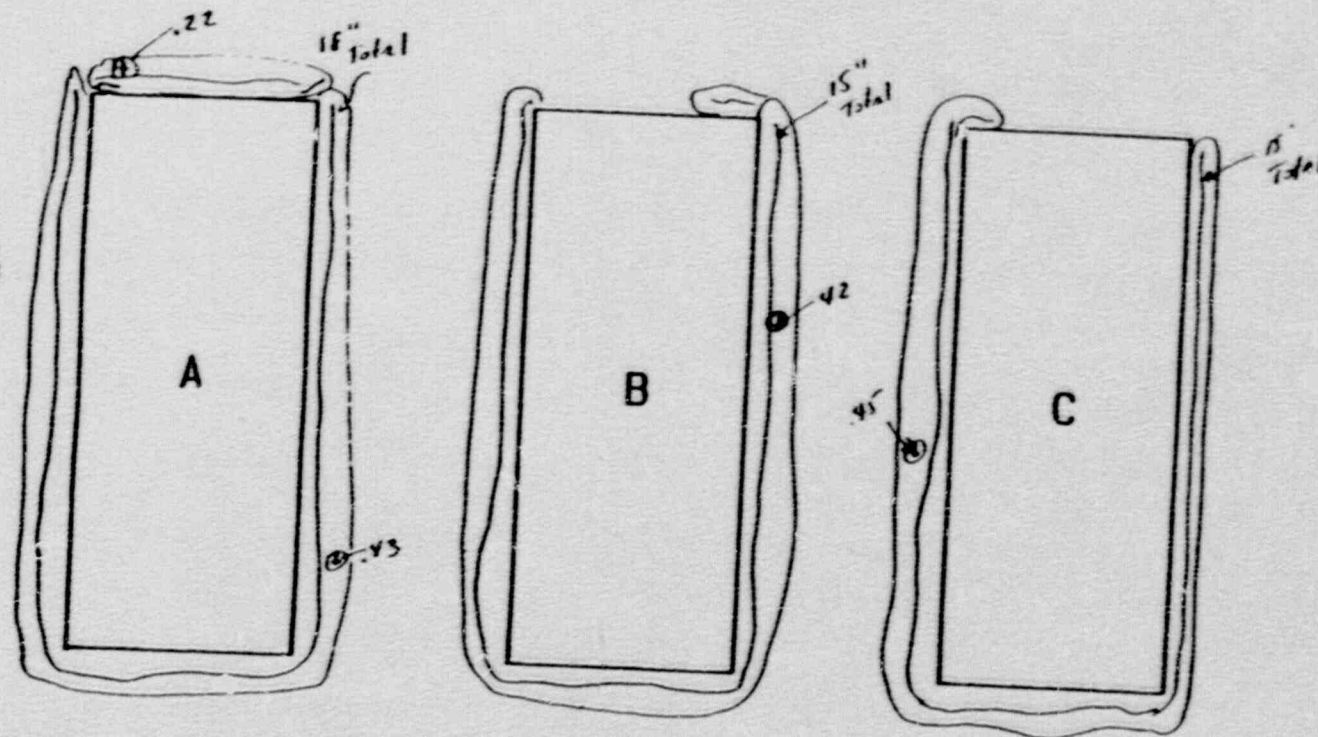
# INDIAN POINT 2 STEAM GENERATOR 21 FEED RING SUPPORT BRACKETS

~~~~~ CRACKS  
 ( ) GRIND AND WELD REPAIRS  
 MAXIMUM DEPTH  
 EXISTING GRINDOUT - NO INDICATION  
 (1) MAX DEPTH

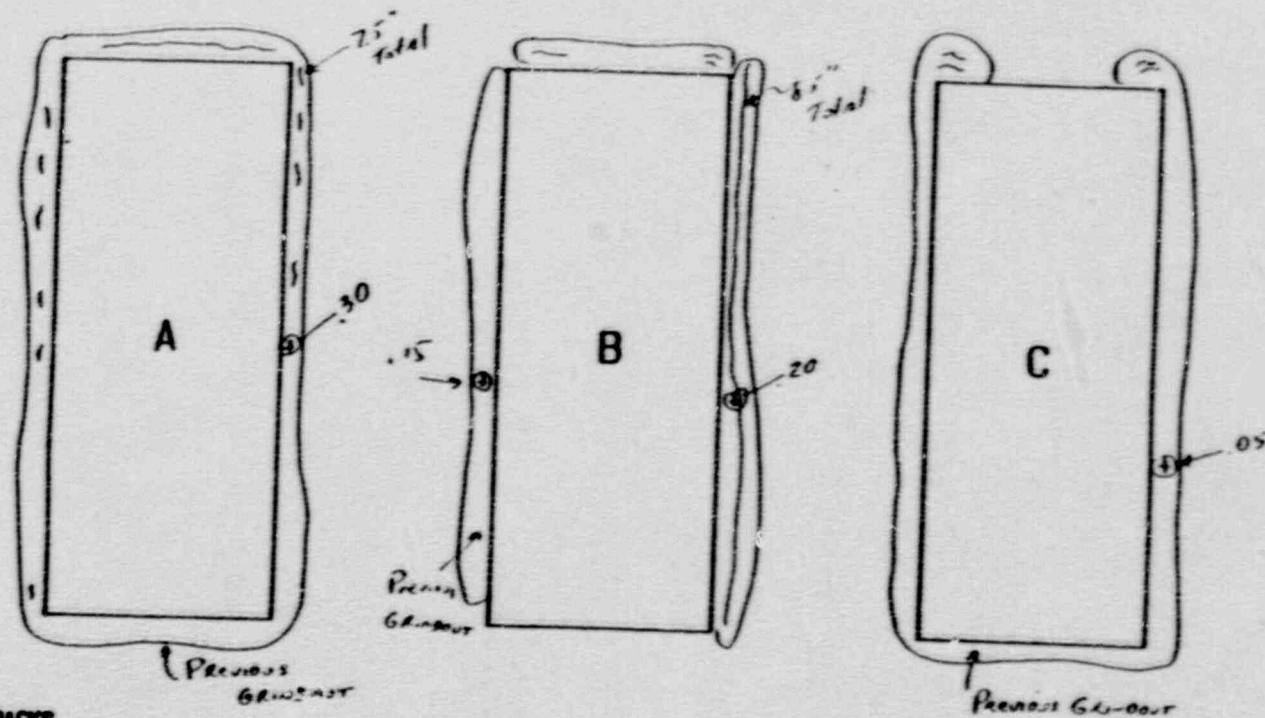
# INDIAN POINT 2 STEAM GENERATOR 22 FEED RING SUPPORT BRACKETS

CRACKS  
GRIND AND WELD REPAIRS  
MAXIMUM DEPTH  
EXISTING GRINDOUT - NO INDICATIONS  
MAX DEPTH
