Subject: NSAL-20-1 Revision 0, "Reactor Vessel Head Control Rod Drive Mechanism Penetration Thermal Sleeve Cross-Sectional Failure"

# Nuclear Safety

## Advisory Letter

Subject: <b>Reactor Vessel Head Control Rod Drive Mechanism Penetration Thermal Sleeve Cross-Sectional Failure</b>	Number: <b>NSAL-20-1</b>
Basic Component: Thermal Sleeve in CRDM Reactor Head Penetration	Date: February 14, 2020
Substantial Safety Hazard or Failure to Comply Pursuant to 10 CFR 21.21(a)	Yes <input checked="" type="checkbox"/> No <input type="checkbox"/> N/A <input type="checkbox"/>
Transfer of Information Pursuant to 10 CFR 21.21(b)	Yes <input type="checkbox"/>
Advisory Information Pursuant to 10 CFR 21.21(d)(2)	Yes <input type="checkbox"/>

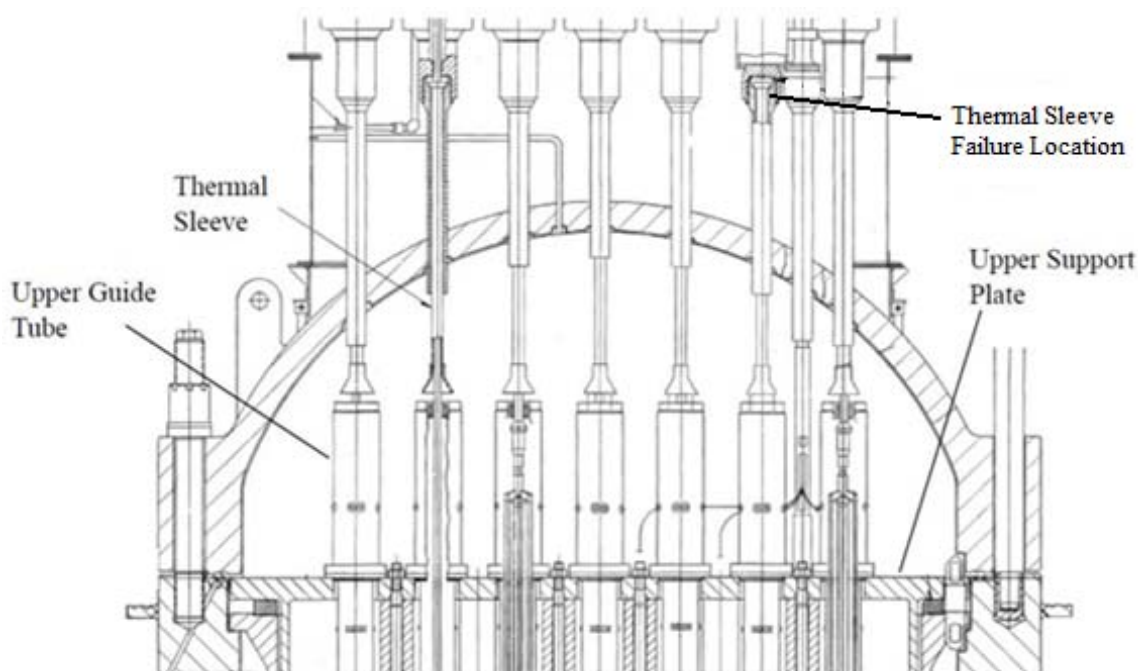
**Figure 1 Thermal Sleeve Location in the RVCH**

During a planned 2019 refueling outage at a Westinghouse NSSS plant, a thermal sleeve (Figure 1) was observed to be fractured and resting upon an upper internals upper guide tube (UGT). The OE showed that a mechanical failure of the thermal sleeve had occurred across its cross-section. The failure mechanism was different from the thermal sleeve flange wear discussed in NSAL-18-1 and TB-07-2, Revision 3 [3]. The fracture occurred beneath the “collar” (illustrated in Figure 2) which is present on a subset of thermal sleeves supplied by Westinghouse (The affected plant was operating with its original reactor vessel closure head [RVCH] and CRDM thermal sleeves.)

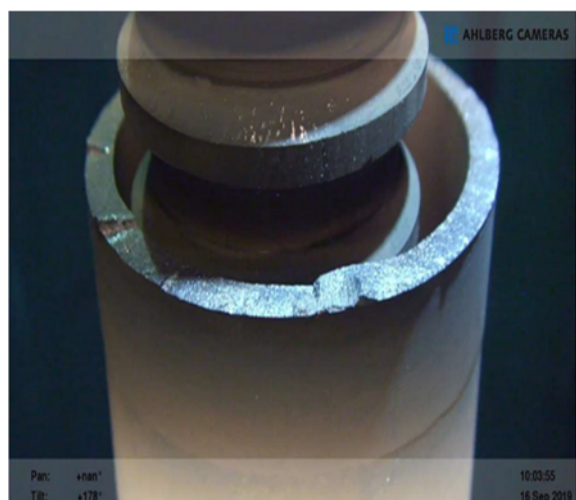
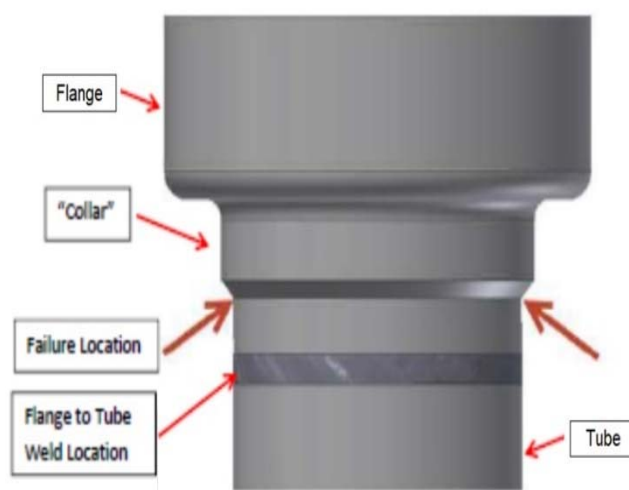
**Figure 2 Thermal Sleeve Flange Failure Location**

New operating experience (OE) has shown that Westinghouse nuclear steam supply system (NSSS) plants that operate in a T-cold configuration and have control rod drive mechanism (CRDM) thermal sleeves with a collar below the flange (Figure 2), are potentially susceptible to cracking and separation of the flange from the sleeve. This separated condition, when combined with the type of flange wear discussed in NSAL-18-1 [1], can potentially impede control rod movement and RCCA insertability. To date, two plants at the same site identified crack-like indications. One plant experienced complete flange separation at one location; however, the separation did not impede control rod motion.

In response to this OE, the affected utility performed a causal analysis with support from Westinghouse. Based on metallurgical examination of the separated sleeve, the analysis concluded that the most likely cause of failure was fatigue crack propagation. The analysis identified the transition between the collar and the tubular section on the outer diameter of the thermal sleeve to be a potential contributor, due to the stress concentration resulting from the tube wall thickness transition and potentially sharp transition radius in this location; however, this was not substantiated through the identification of a crack initiation site. Thermal sleeve designs without the collar have a large controlled transition radius between the tubular section and the flange. This transition results in a much lower stress concentration, which is less susceptible to this failure mechanism. Therefore, plants operating with thermal sleeve designs without a collar below the flange are not included in Table 1.

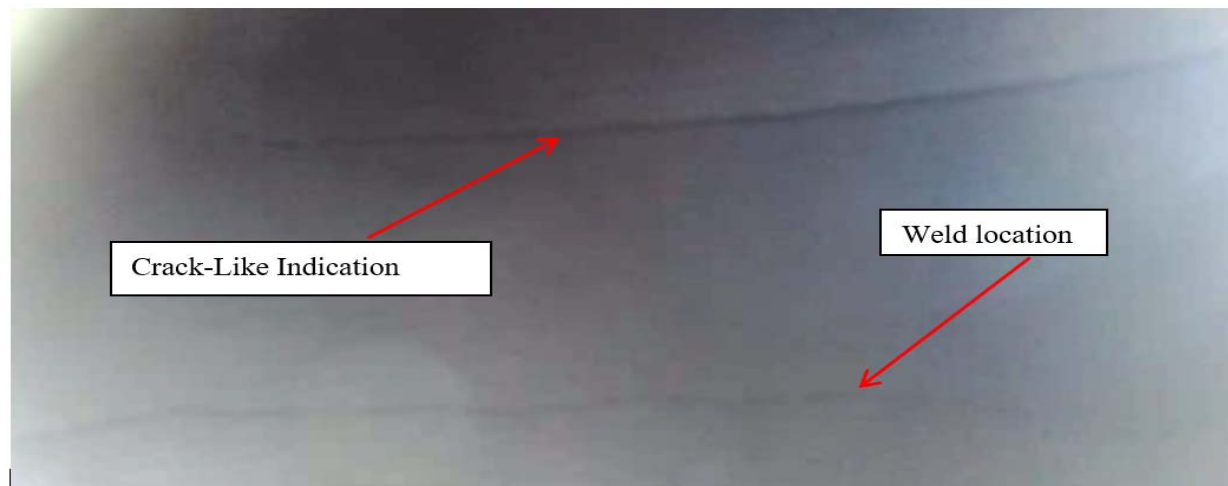
**Figure 3 Crack-Like Indication Identified by Visual Inspection**

The utility performed extent of condition inspections on the remaining thermal sleeves at the affected plant as well as on a second plant at the same site. Both plants have the same thermal sleeve design. The inspections were performed via visual examination of the inner surface of the thermal sleeve. A total of thirteen thermal sleeve locations (Unit 1 – twelve, Unit 2 – one) had visible crack-like indications, as shown in Figure 3. No additional locations had failed. The locations of the affected sleeves were distributed throughout the RVCH, with a higher concentration of cracked sleeves toward the center of the head. Crack-like indications of varying lengths were identified with no correlation to the amount of flange wear experienced. The affected utility did not identify any issues associated with drive rod movement during operation prior to identifying the failure.

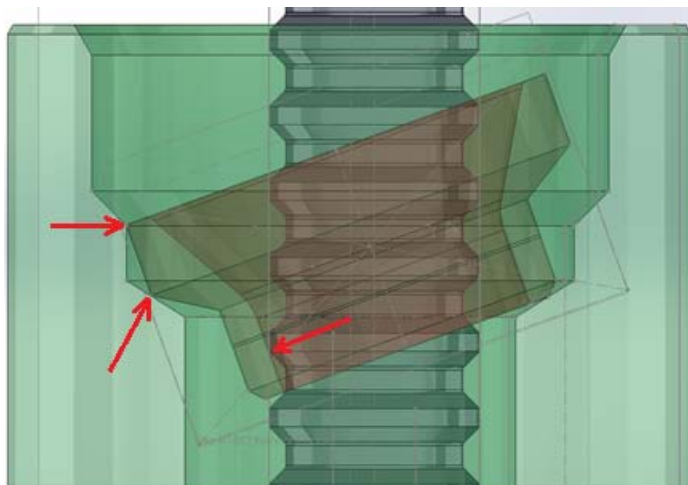
**Figure 4 Potential Flange Wedging Scenario**

In certain conditions in which the CRDM housing is worn (as discussed in NSAL-18-1) and the thermal sleeve flange is separated from the sleeve, the flange remnant can move from its normal position and

potentially wedge between the drive rod and the pocket worn into the CRDM housing as is shown in Figure 4. The minimum amount of combined thermal sleeve flange and CRDM housing wear required for this to potentially occur is approximately 0.80 inches. This wear, measured in terms of the gradual “lowering” of the thermal sleeve from its as-installed position, is referred to as the flange wear lowering criterion. Wedging of the drive rod is unlikely if this flange wear lowering criterion is not exceeded.
