FAILURE ANALYSIS OF INCONEL 600®
TUBES FROM OTSG A AND B OF
THREE MILE ISLAND UNIT-1

GPU-NUCLEAR

June 30, 1982

BATTELLE
Columbus Laboratories
505 King Avenue
Columbus, Ohio 43201

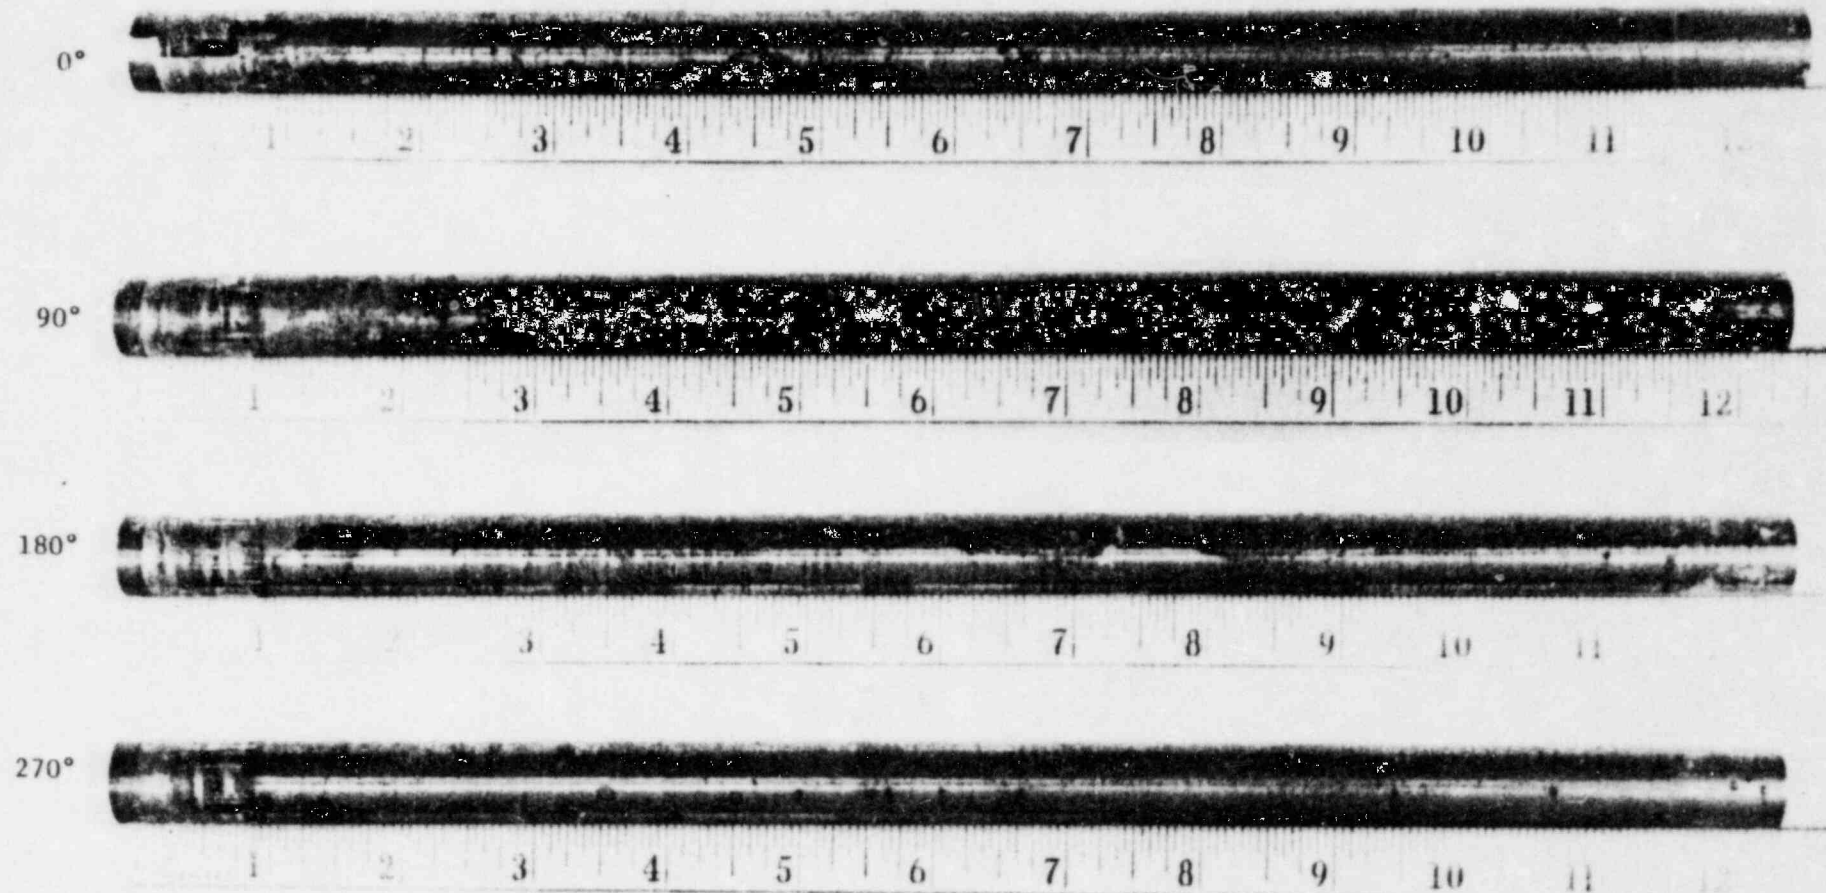
FIGURE 1. APPEARANCE OF AS-RECEIVED TUBE B-8-25 AT 0, 90, 180 AND 270 DEGREE POSITIONS

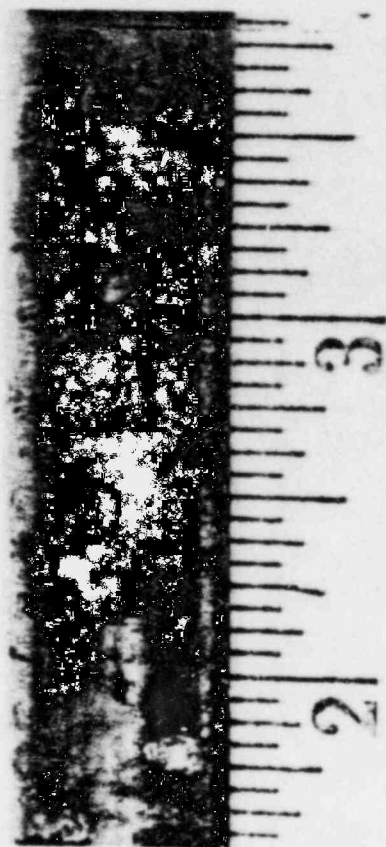
FIGURE 2. A CLOSEUP VIEW OF THE DRYOUT MARKS ON
TUBE B-8-25 AT 90 DEGREE POSITION

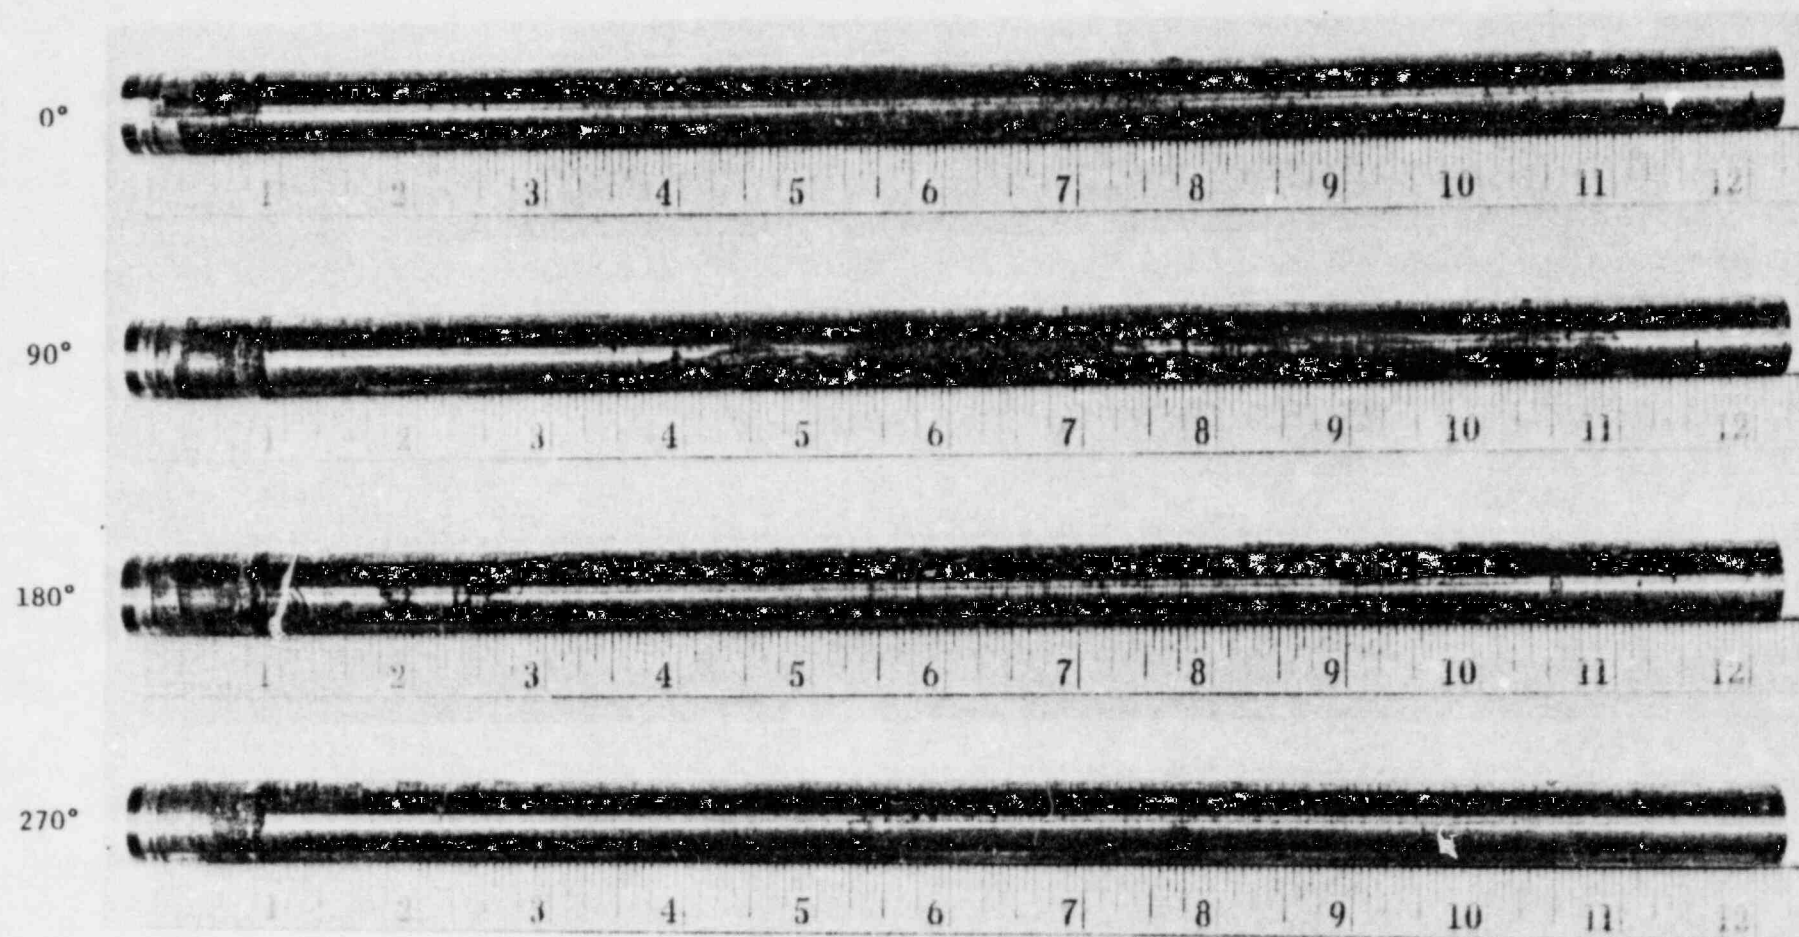
FIGURE 3. APPEARANCE OF AS-RECEIVED TUBE B-11-23 AT 0, 90, 180 AND 270 DEGREE POSITIONS

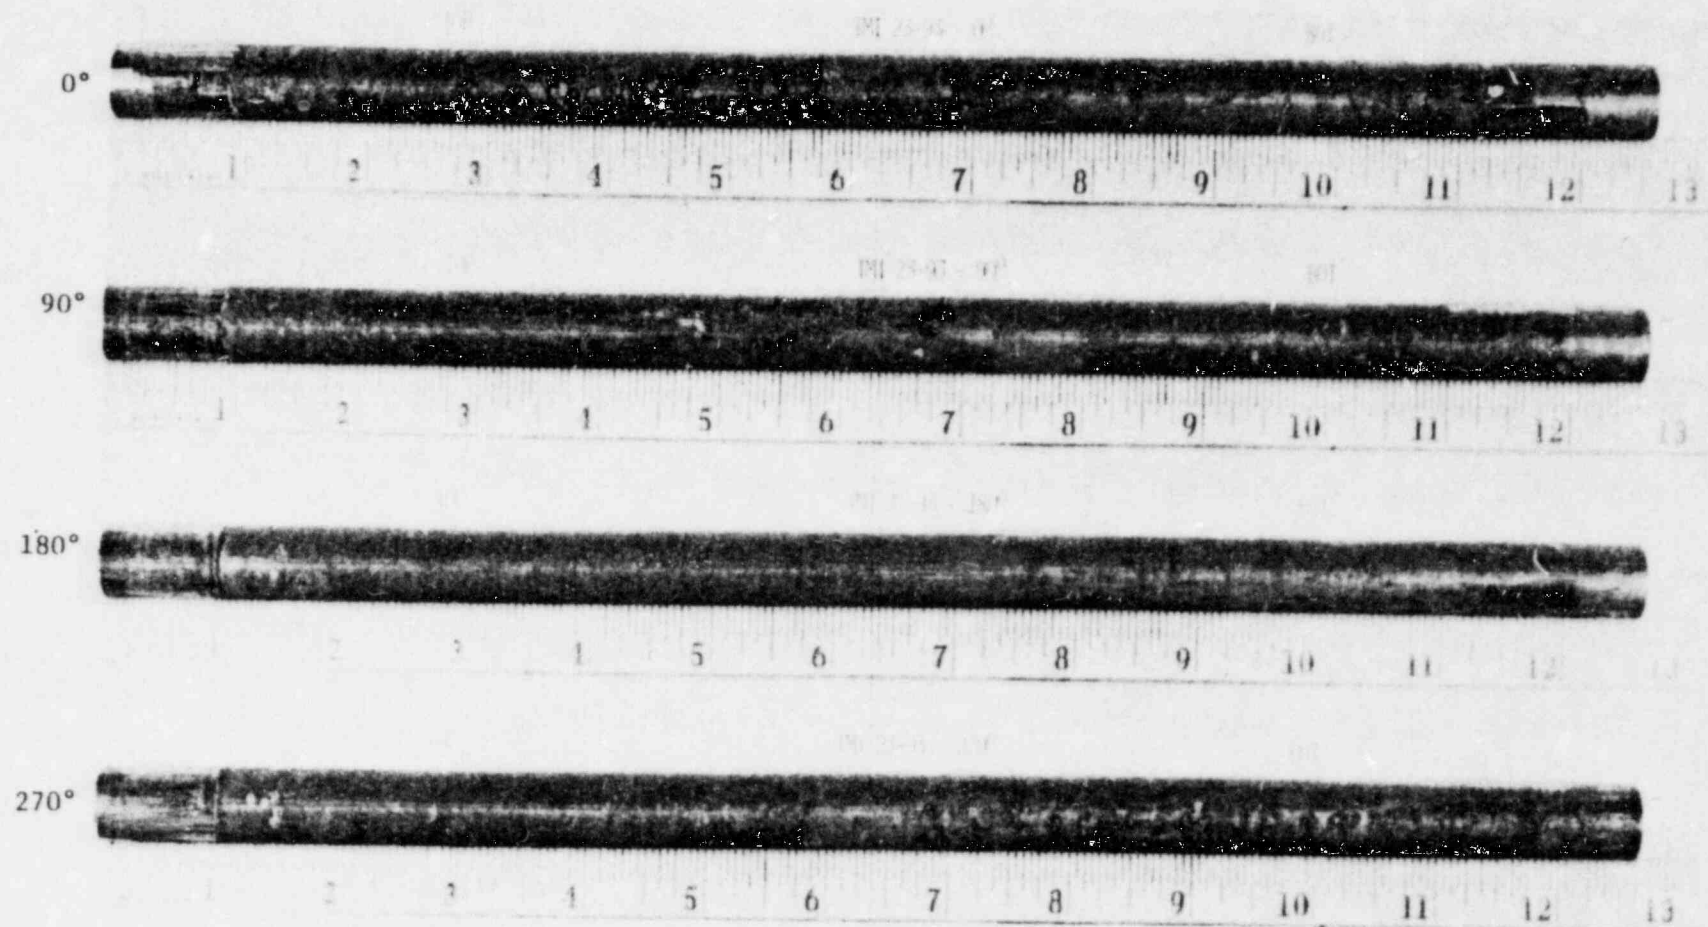
FIGURE 4. APPEARANCE OF AS-RECEIVED TUBE A-23-93 AT 0, 90, 180 AND 270 DEGREE POSITIONS

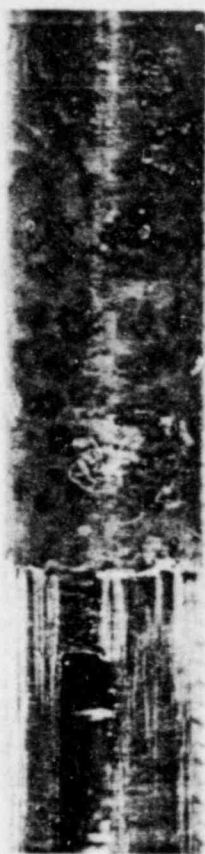
FIGURE 5. A CLOSEUP VIEW OF THE DRYOUT MARKS ON
TUBE A-23-93 AT 90 DEGREE POSITION

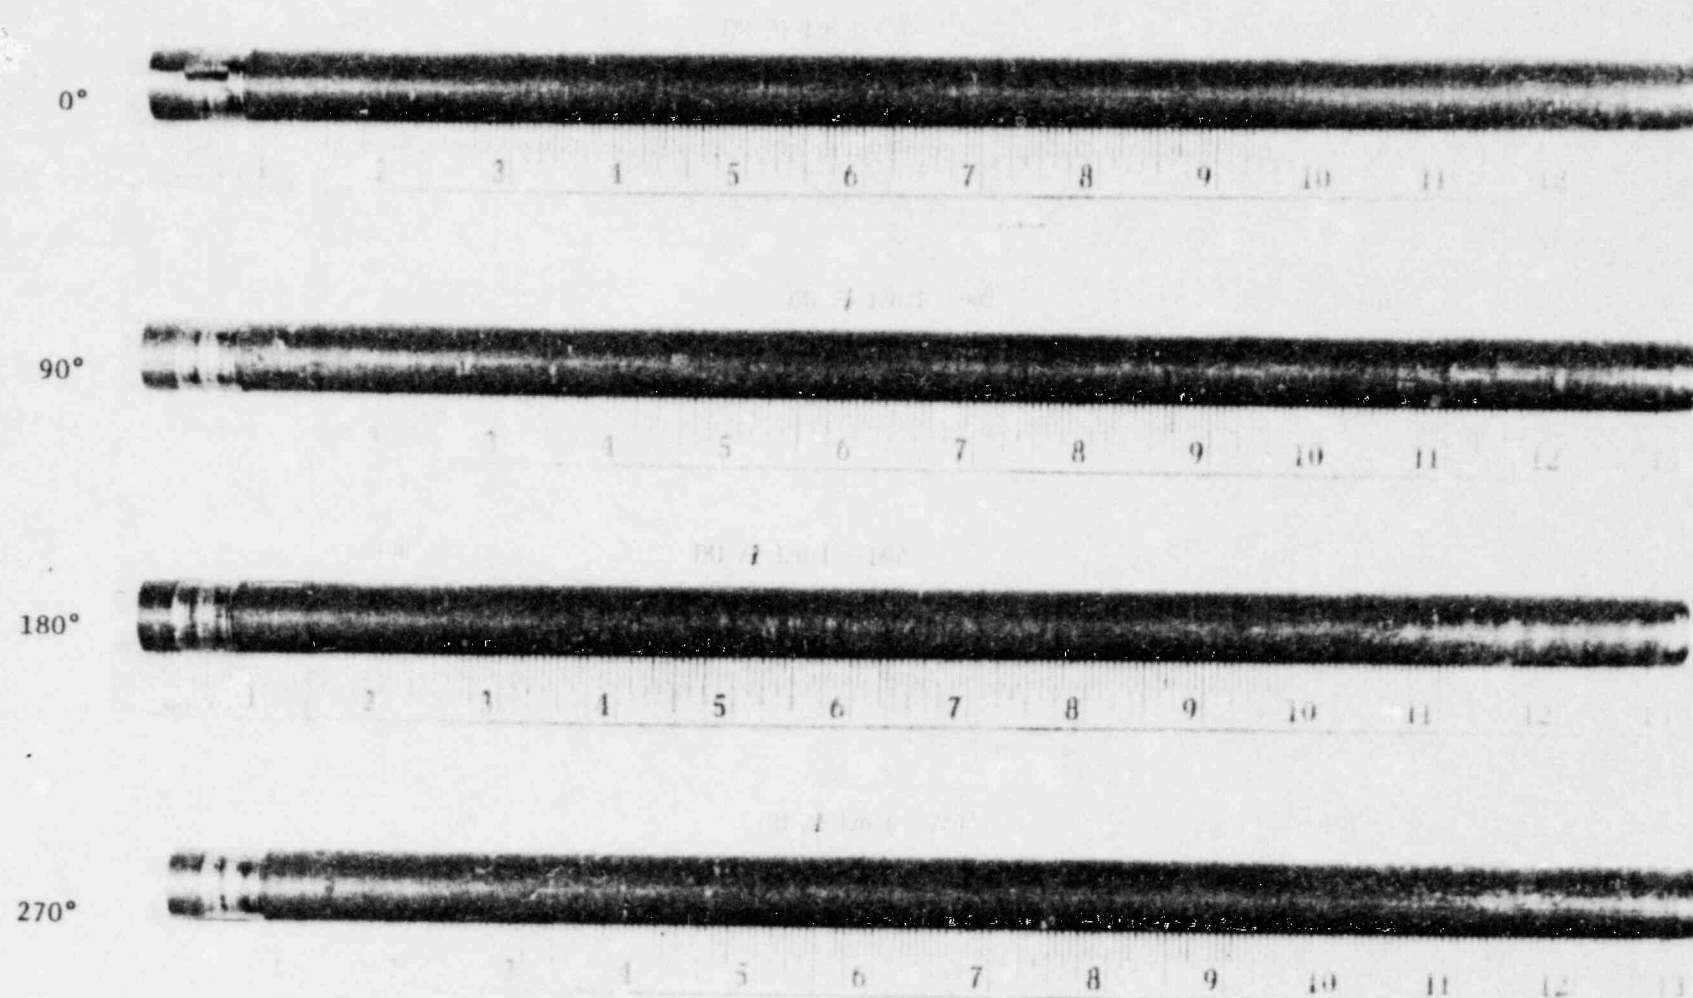
FIGURE 6. APPEARANCE OF AS-RECEIVED TUBE A-71-126 SEGMENT 1 0, 90, 180 AND 270 DEGREE POSITIONS

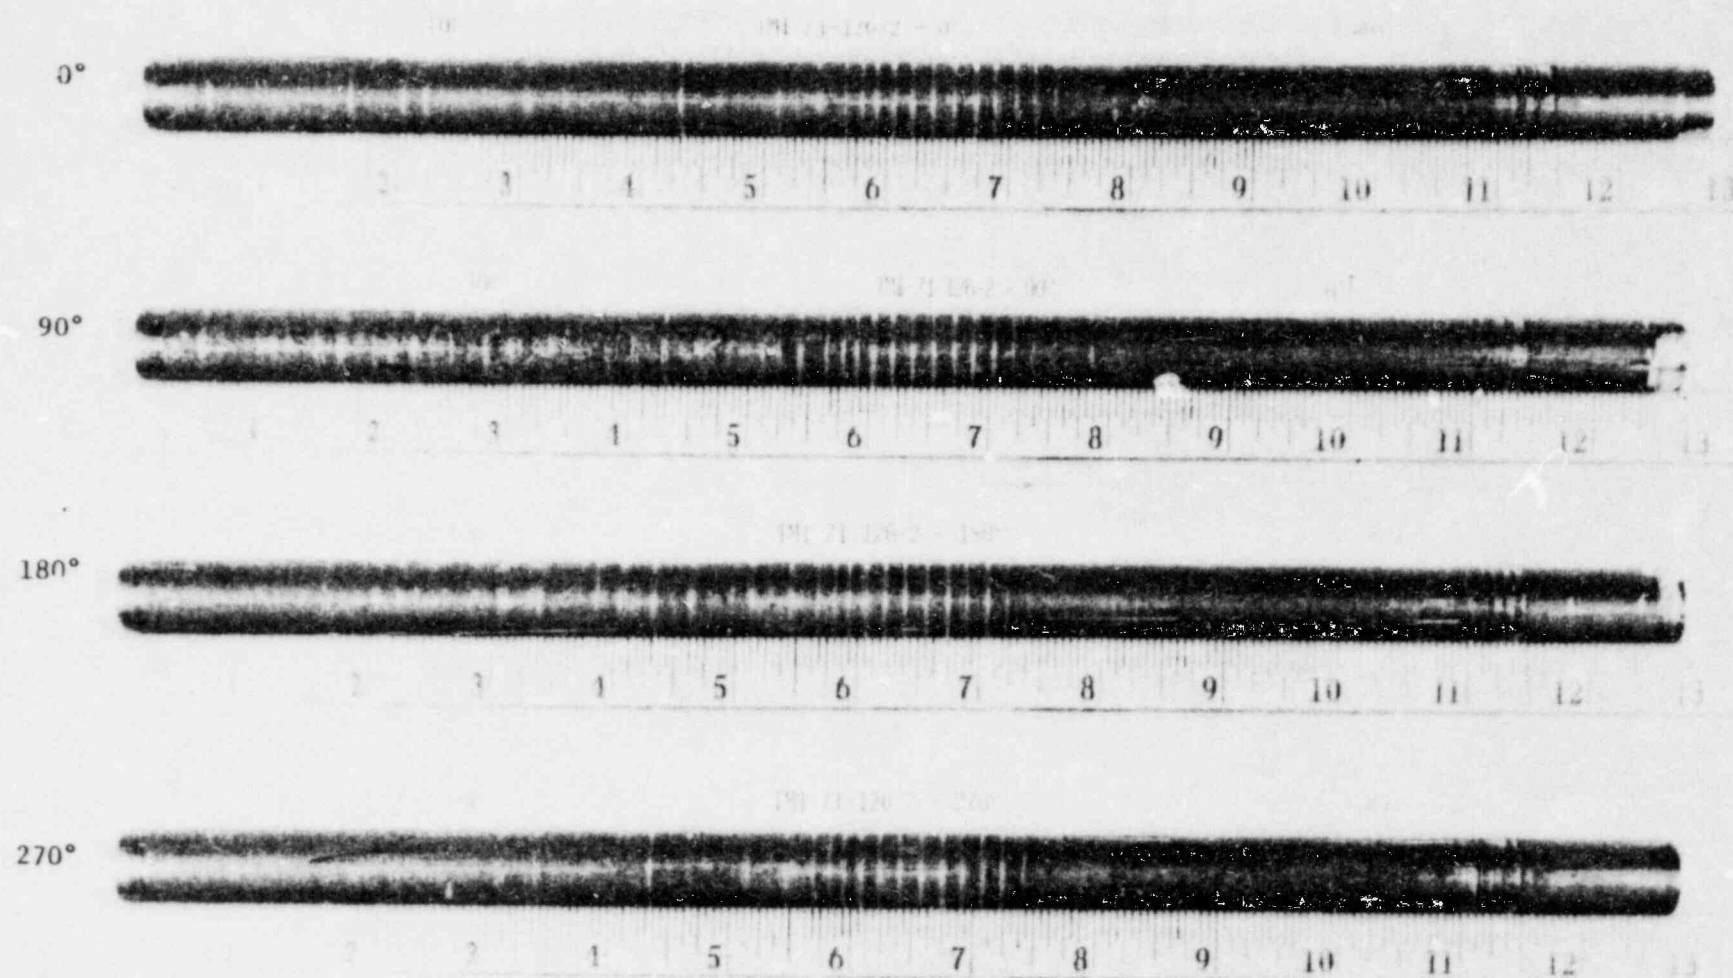
Figure 7 for tube A-71-126 segment 2 shows circumferential shiny ring pattern over most of the tube surface, particularly in the first 7 inches of the segment. These rings are obviously from the mechanical operation of tube removal, but such an extensive marking was not observed on any other tubes.

FIGURE 7. APPEARANCE OF AS-RECEIVED TUBE A-71-126 SEGMENT 2 AT 0, 90, 180 AND 270 DEGREE POSITIONS

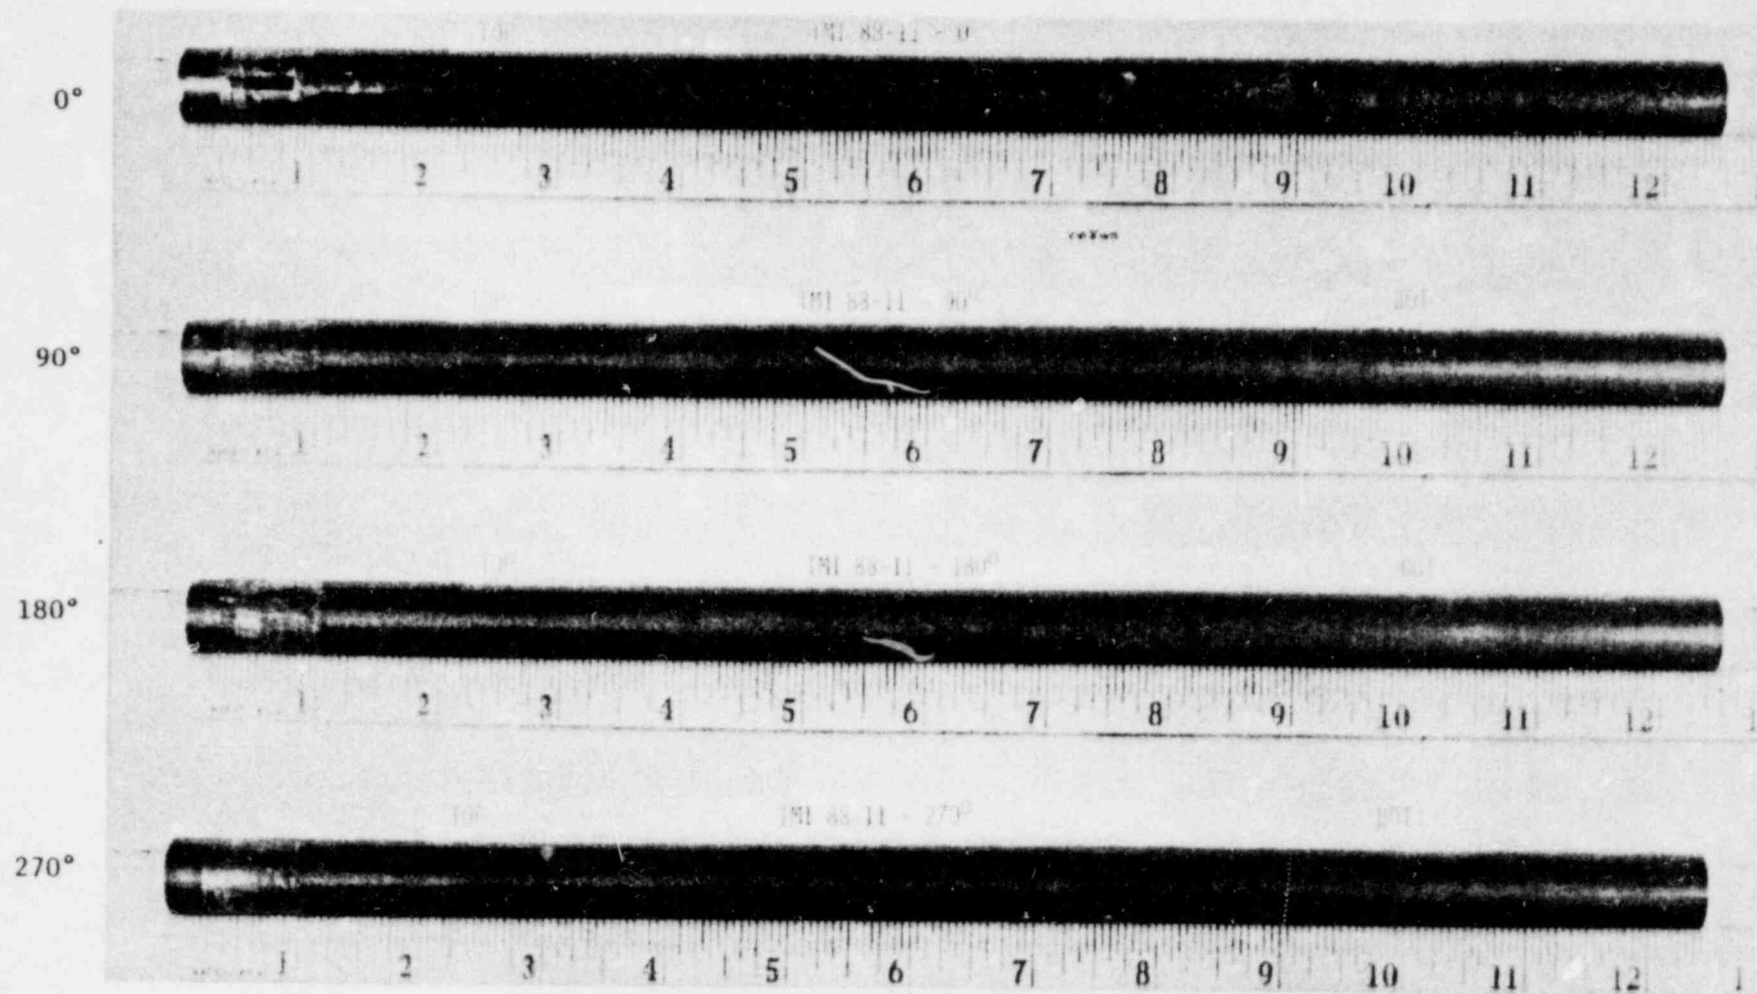
Photographs of tube A-88-11 are shown in Figure 11, water marks on the 0° quadrant are relatively heavier than on the other three quadrants.

FIGURE 11. APPEARANCE OF AS-RECEIVED TUBE A-88-11 AT 0, 90, 180 AND 270 DEGREE POSITIONS

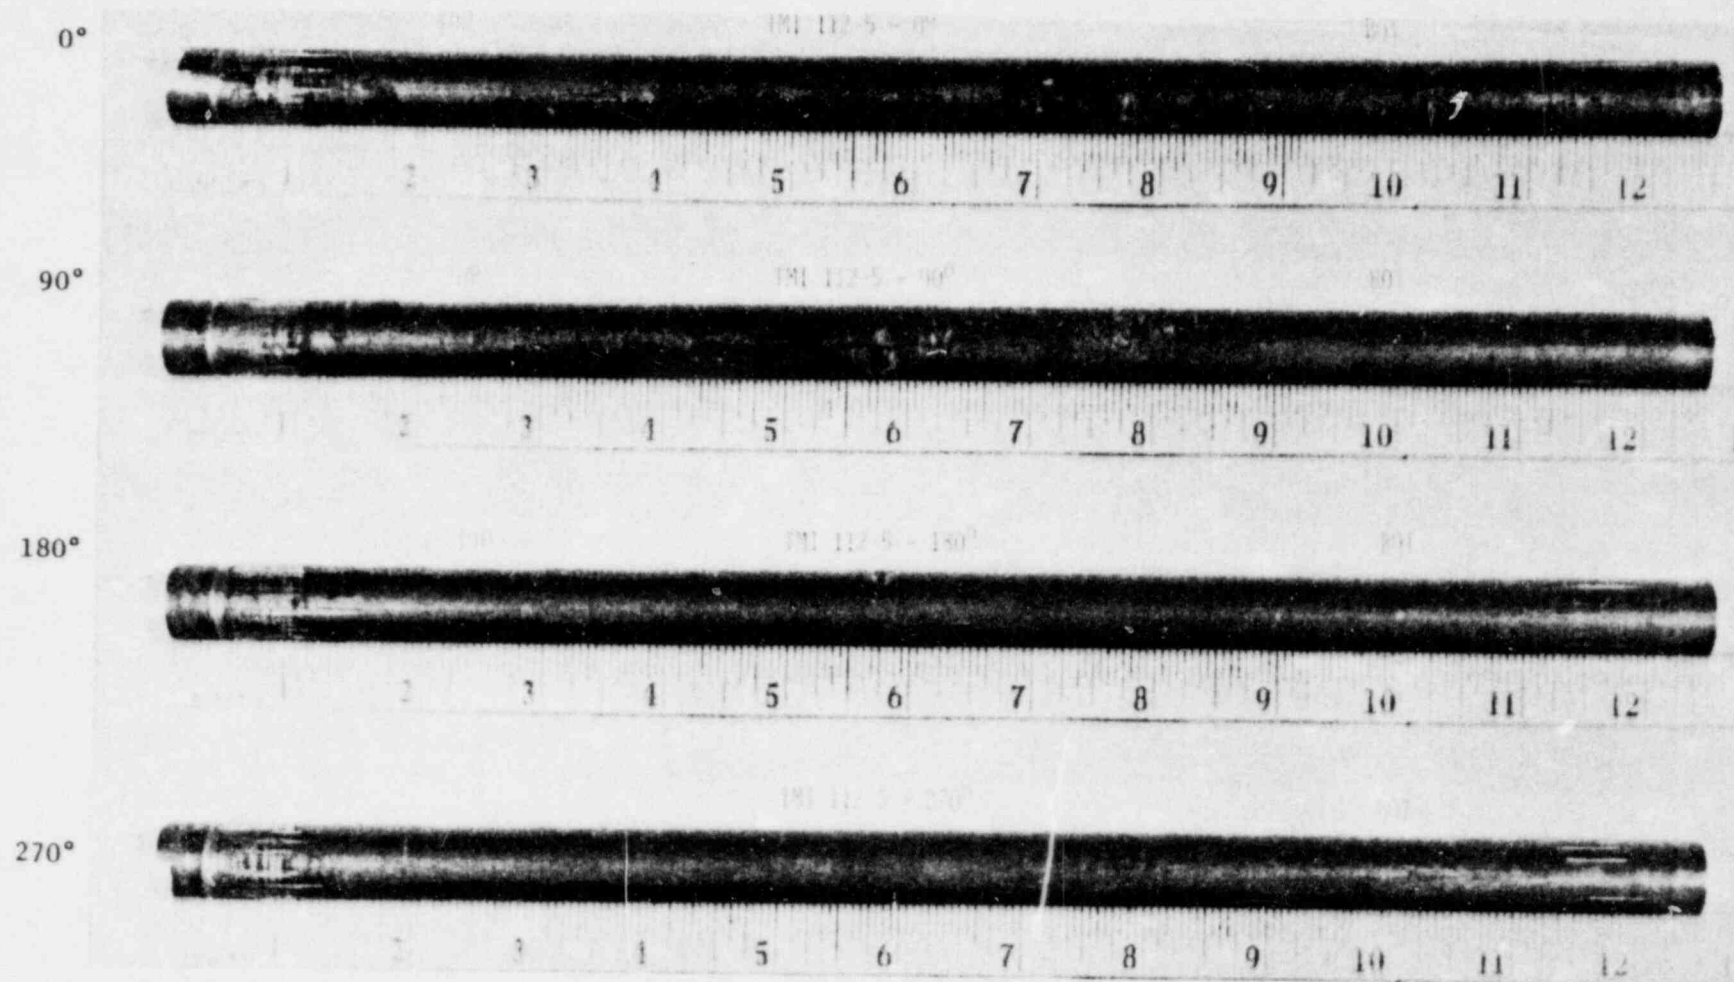
In Figure 13 a lip-crack can be seen extending from the slot in tube A-112-5. A similar lip-crack is visible in tube A-146-8 in Figure 15.

FIGURE 13. APPEARANCE OF AS-RECEIVED TUBE A-112-5 AT 0, 90, 180 AND 270 DEGREE POSITIONS

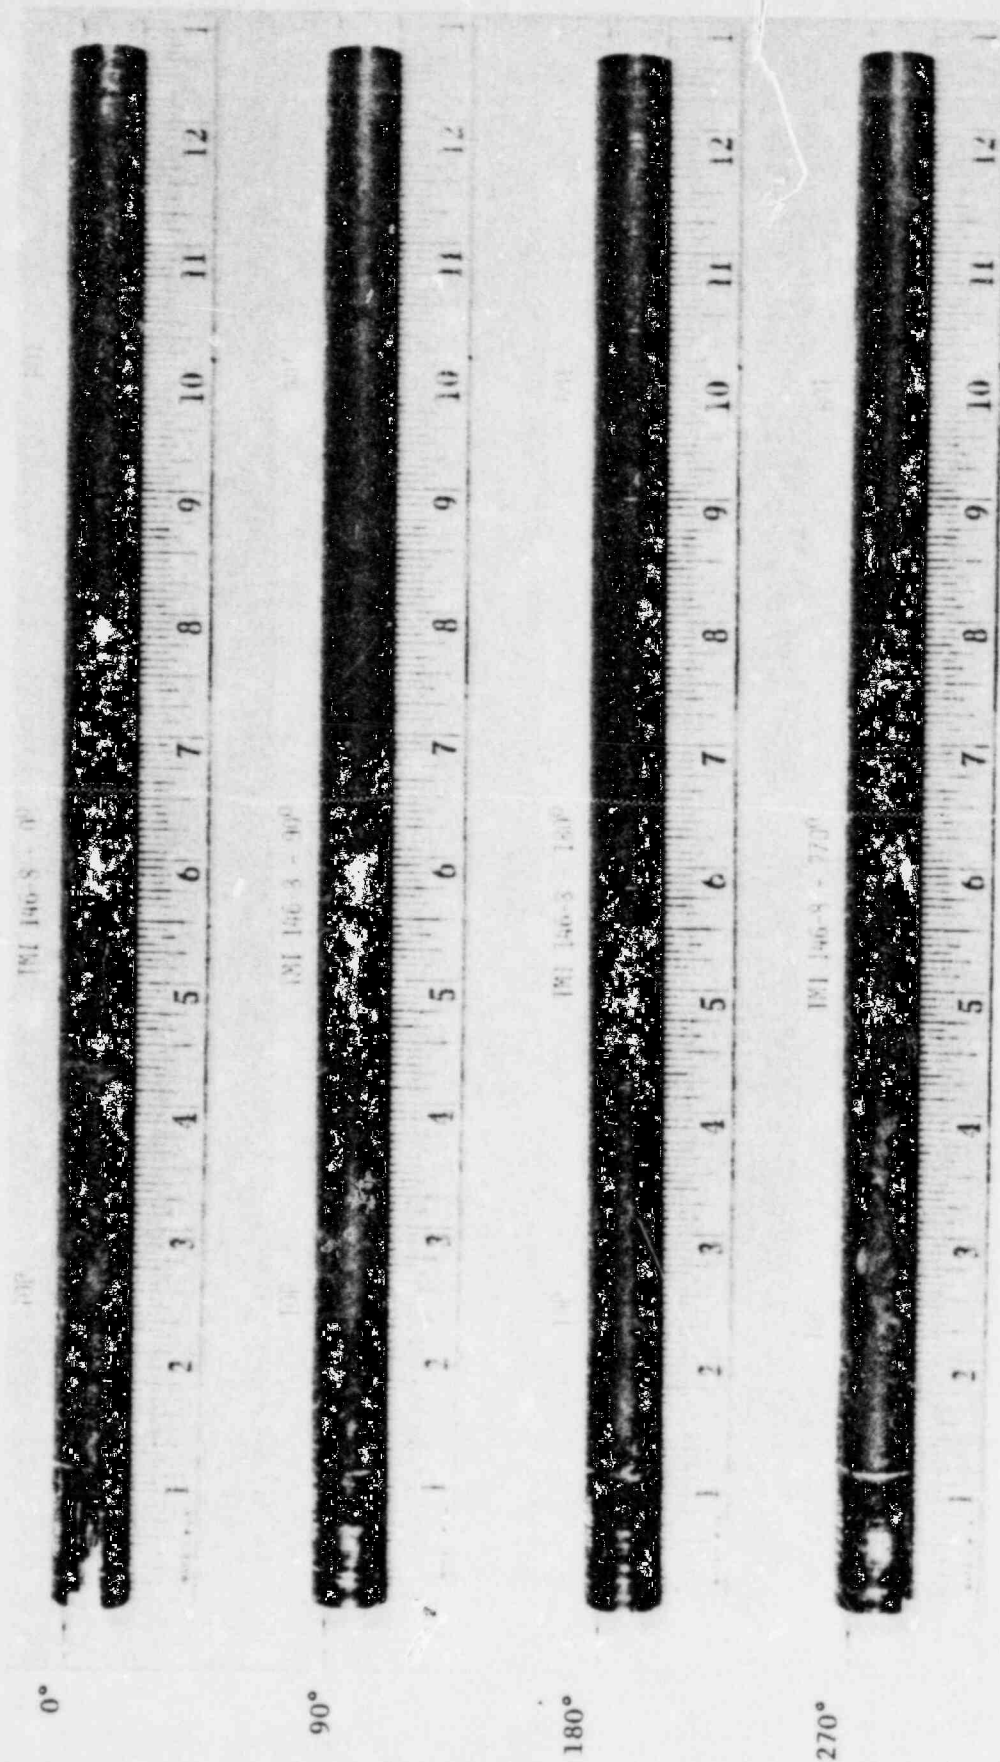
FIGURE 15. APPEARANCE OF AS-RECEIVED TUBE A-146-8 AT 0, 90, 180 AND 270 DEGREE POSITIONS

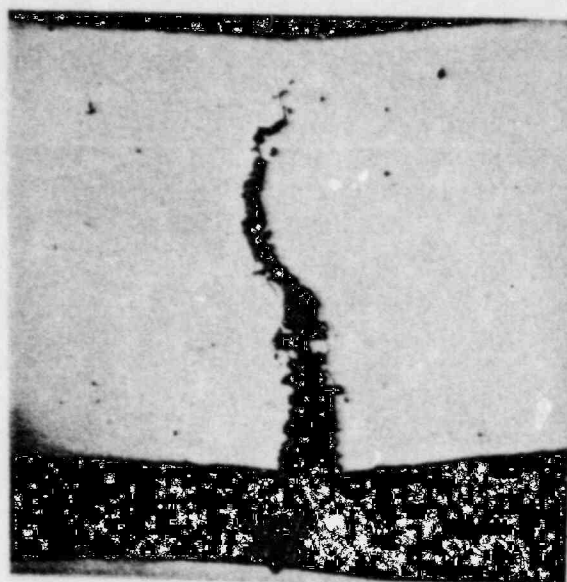
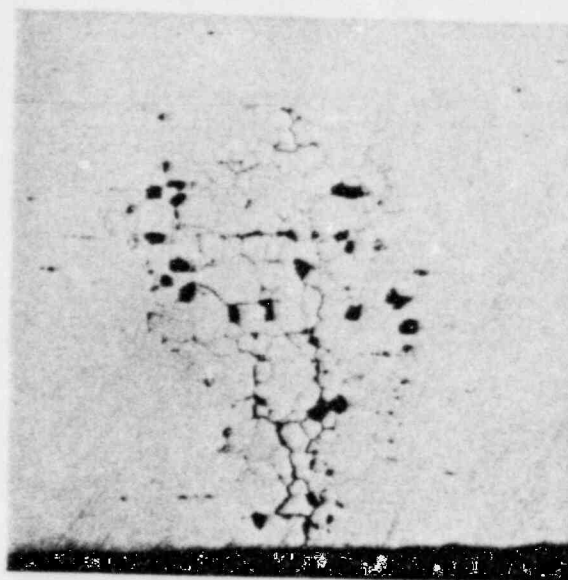
Photomicrographs of the cross section of bent specimen A2 is shown in Figure 17. A crack with 90 percent wall penetration is clearly visible in Figure 17. The crack origin is at the ID surface of the tube.

(a) MAIN CRACK

(b) INTERGRANULAR ATTACK

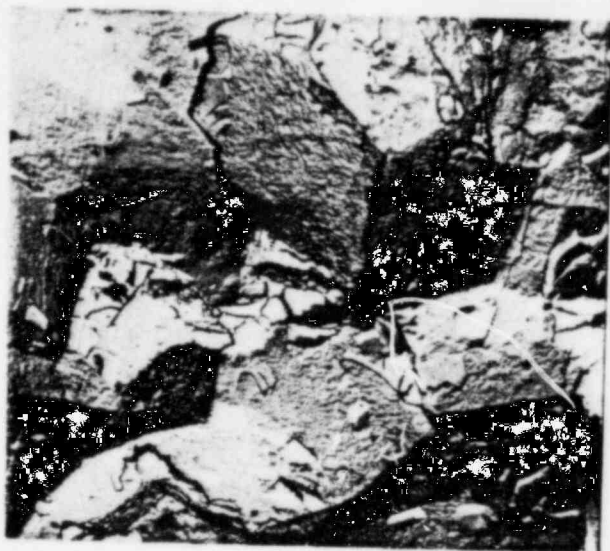
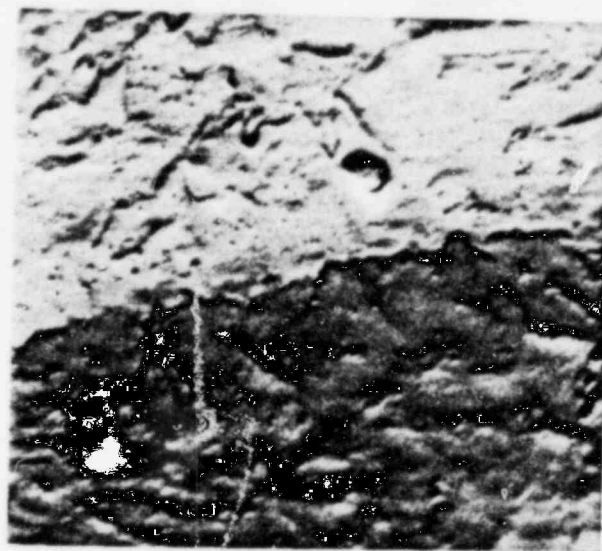
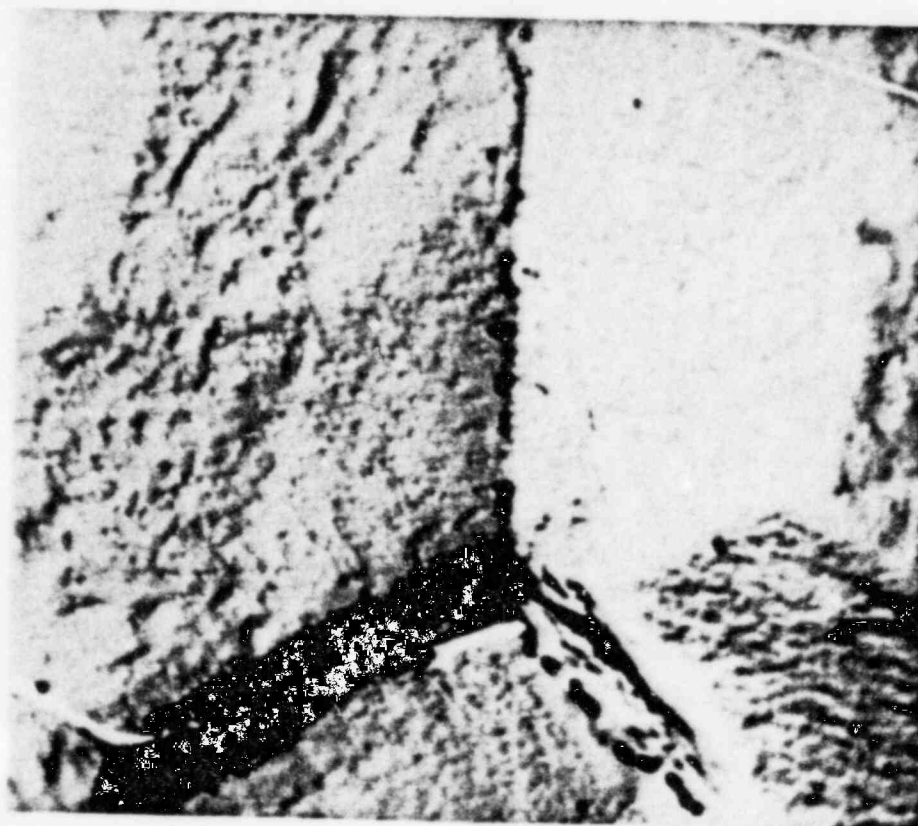
FIGURE 19. TEM PHOTOMICROGRAPHS OF THE REPLICA OF FRACTURE SURFACE OF SPECIMEN A4 FROM TUBE B-8-25 AFTER DESCALING

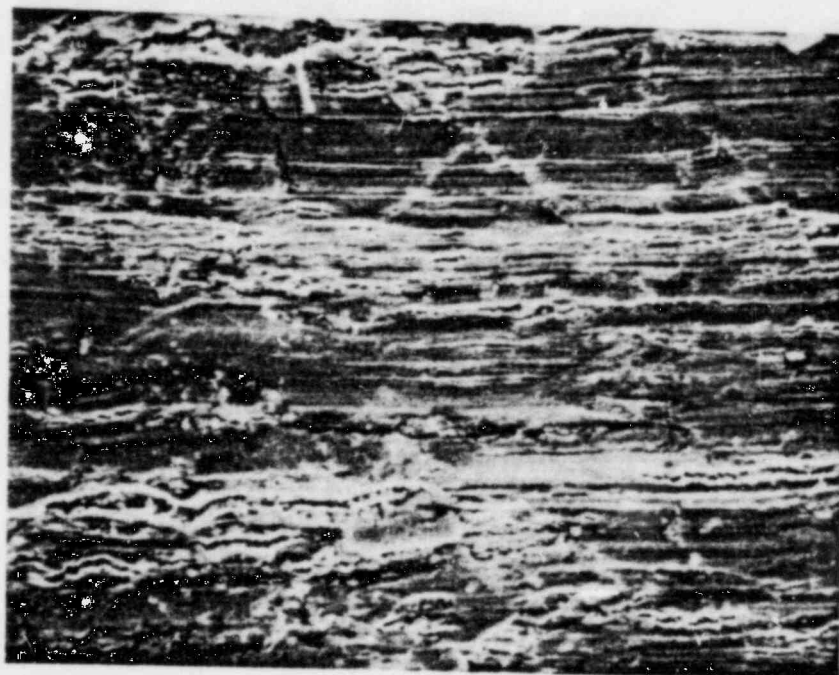
FIGURE 20. SEM PHOTOGRAPH OF THE APEX OF U-BEND OF SPECIMEN
A7 FROM TUBE B-8-25

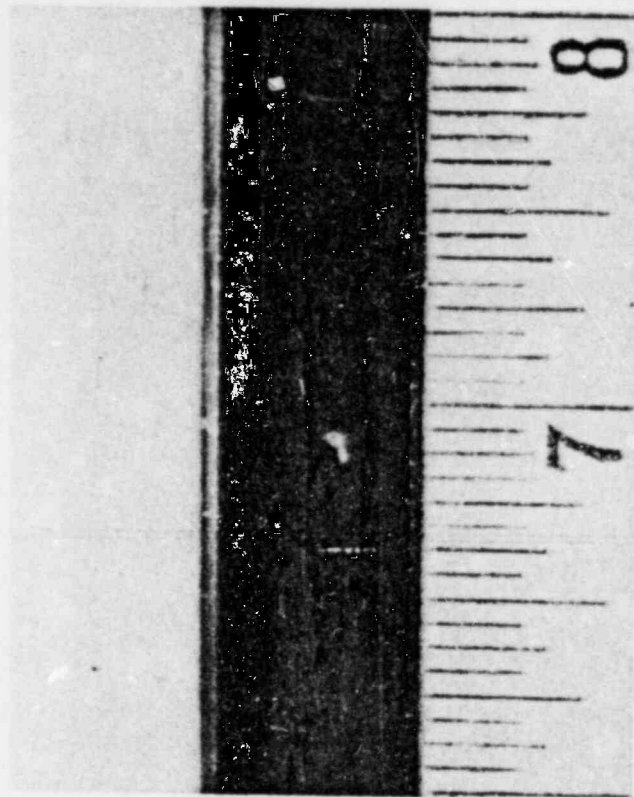
FIGURE 22. A TREE-LIKE BROWN DEPOSIT ON THE ID SURFACE
OF TUBE B-8-25

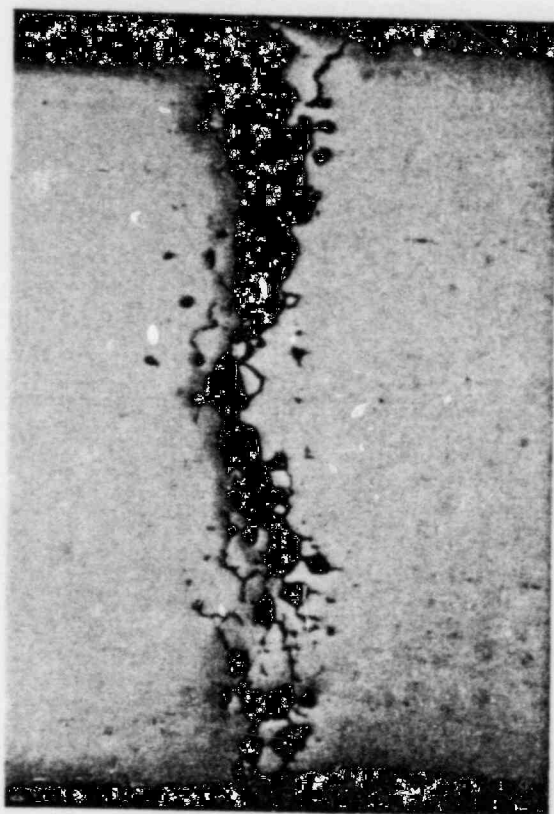
FIGURE 23. PHOTOMICROGRAPH OF IGC IN SPECIMEN E FROM TUBE B-11-23

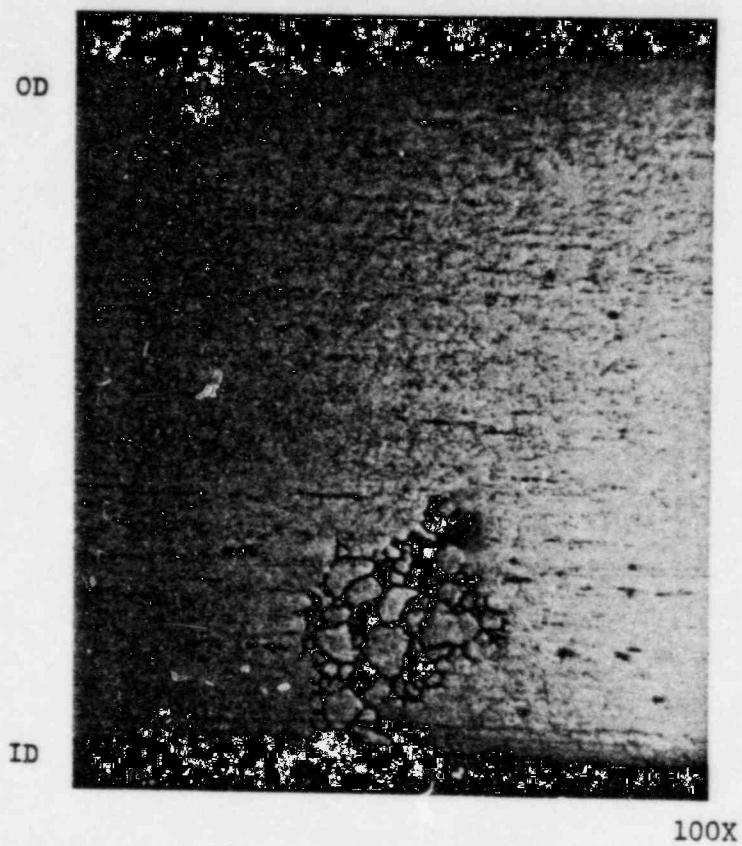
FIGURE 24. PHOTOMICROGRAPH OF IGA IN SPECIMEN E FROM TUBE B-11-23.

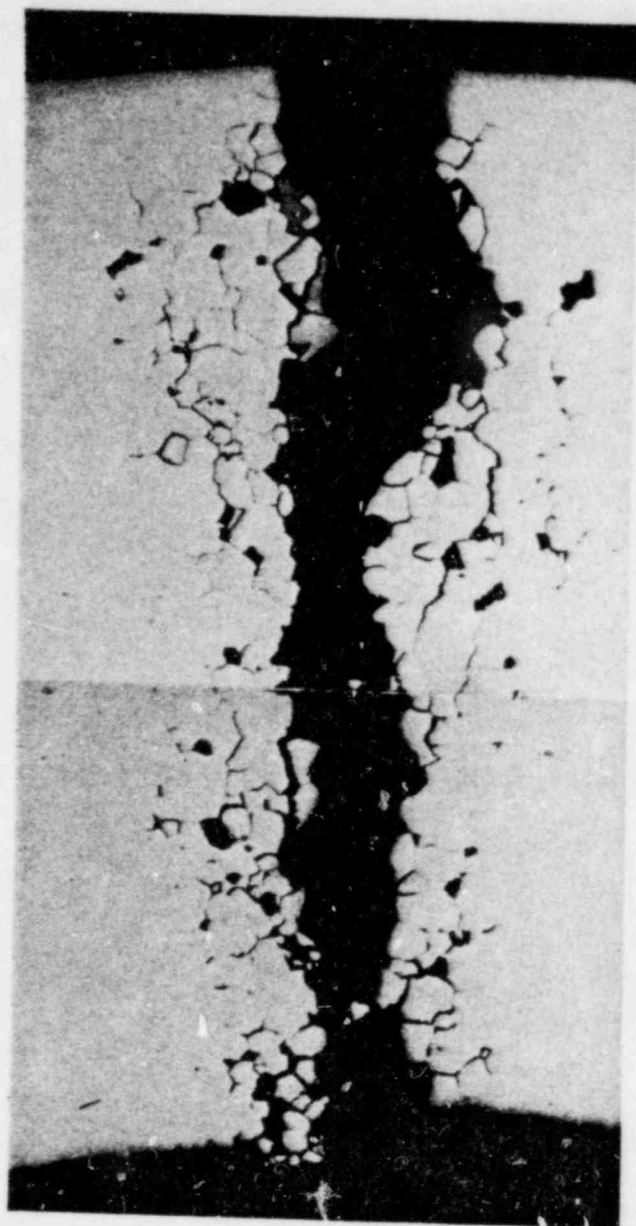
FIGURE 25. PHOTOMICROGRAPH OF SPECIMEN A FROM TUBE B-11-23
SHOWING IGC AND SEVERE IGA ON EITHER SIDE OF
THE CRACK

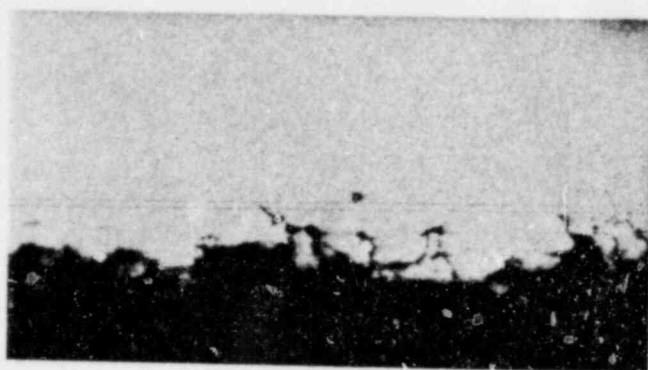
FIGURE 26. PHOTOMICROGRAPH OF IGA ON THE ID SURFACE OF
SPECIMEN A FROM TUBE B-11-23

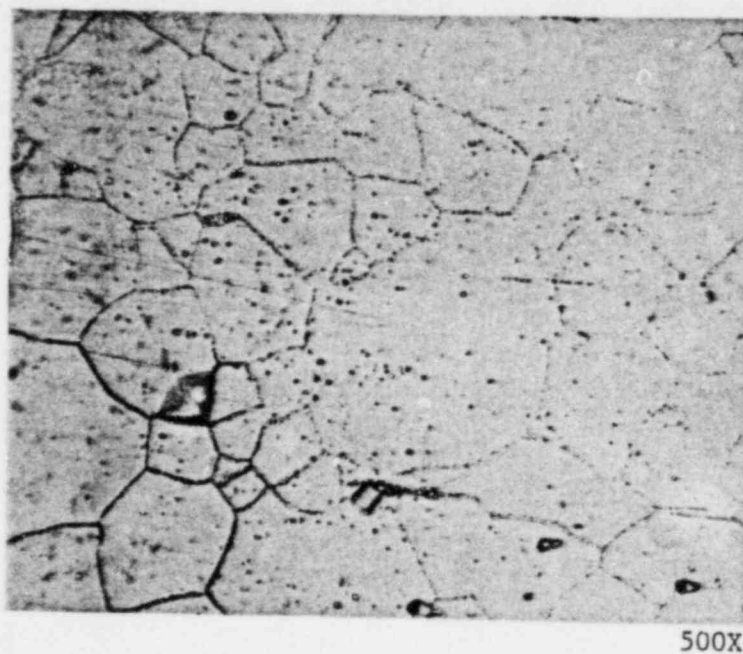
FIGURE 27. PHOTOMICROGRAPH OF THE MICROSTRUCTURE OF
SPECIMEN A FROM TUBE B-11-23

chromium carbide precipitates inside the grains and also on the grain boundaries are visible. The grain boundaries already affected by IGA were heavily attacked on etching with phosphoric acid.

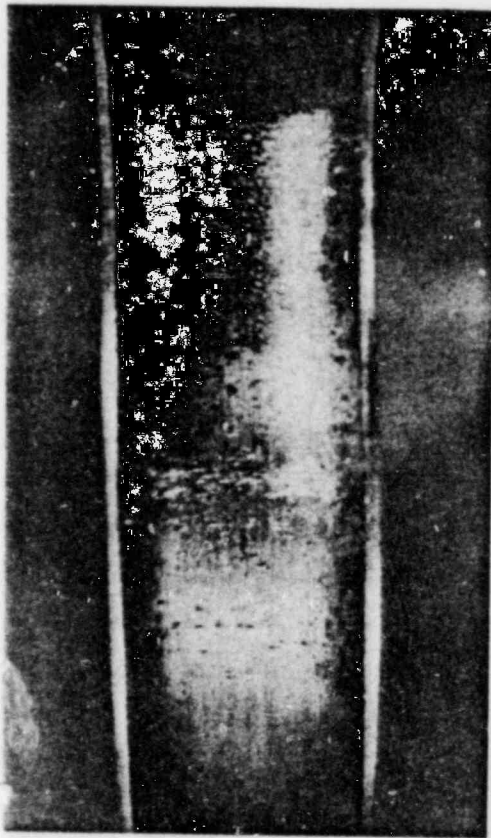
FIGURE 28. PHOTOGRAPH OF THE DESCALED SPECIMEN F FROM
TUBE A-71-126 SHOWING HEAVY SCORING

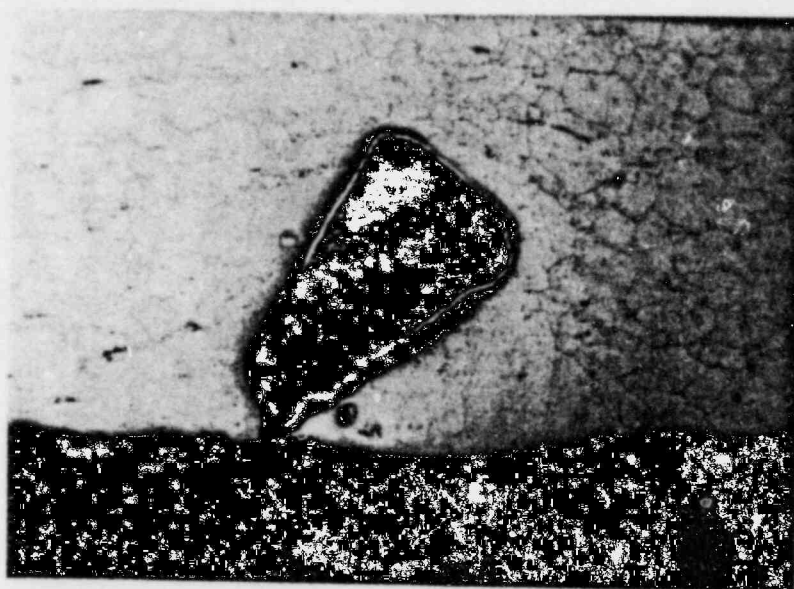
FIGURE 30. PHOTOMICROGRAPH OF THE TRANSVERSE CROSS SECTION OF
SPECIMEN I FROM TUBE A-71-126

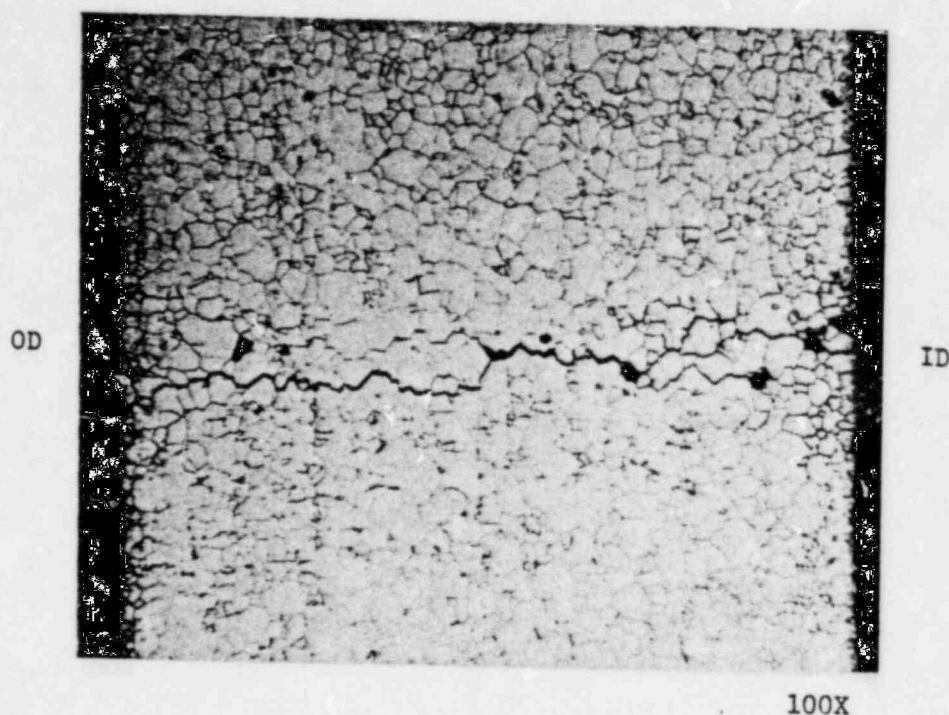
FIGURE 35. PHOTOMICROGRAPH OF THROUGH WALL IGC IN
SPECIMEN C FROM TUBE A-146-6

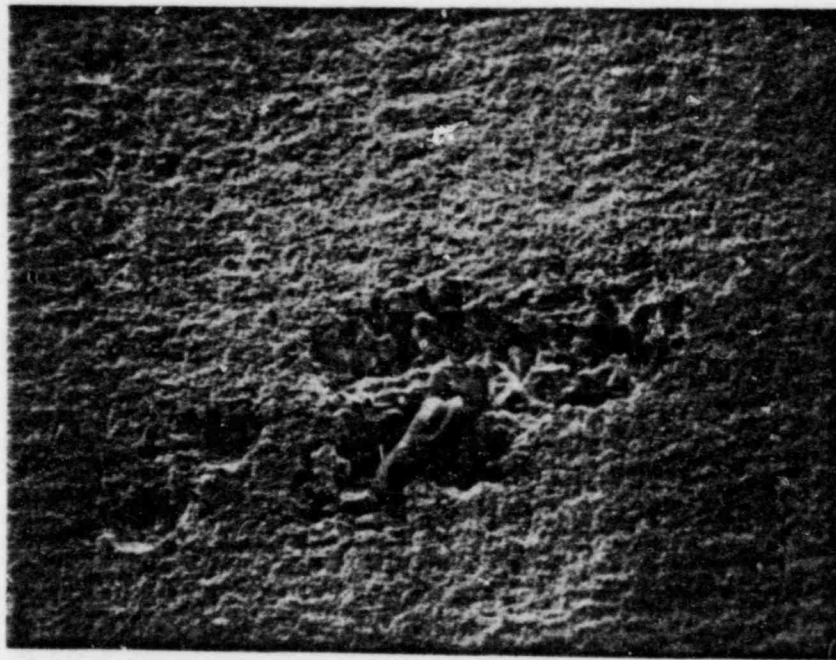
FIGURE 37. SEM PHOTOGRAPH OF AN IGA PIT ON DESCALED
SPECIMEN D FROM TUBE A-146-6
