FAILURE ANALYSIS OF INCONEL 600®
TUBES FROM OTSG A AND B OF
THREE MILE ISLAND UNIT-1

GPU-NUCLEAR

June 30, 1982

BATTELLE
Columbus Laboratories
505 King Avenue
Columbus, Ohio 43201

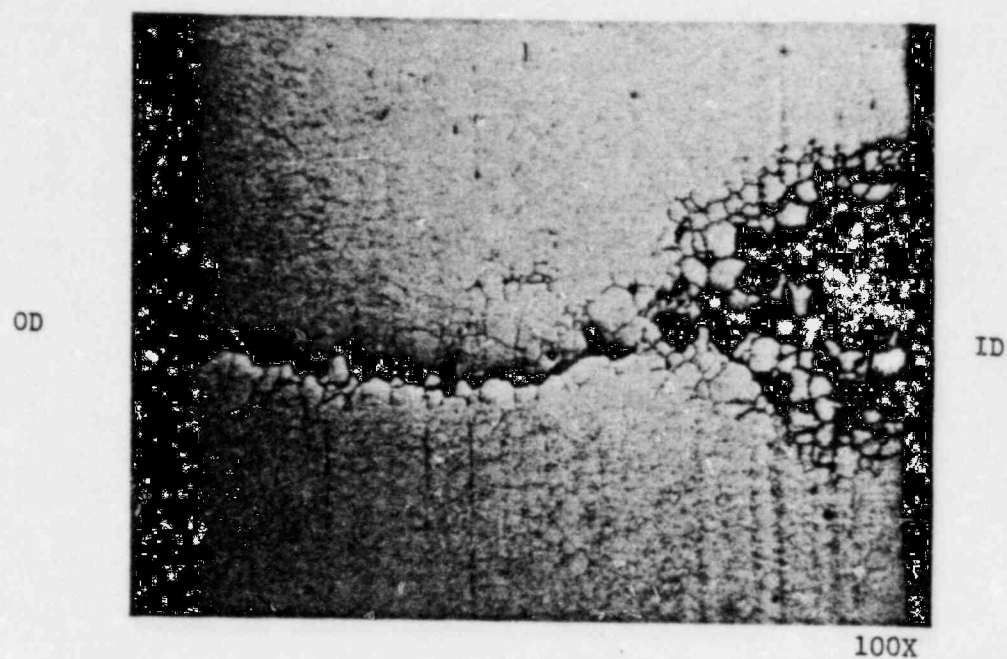
FIGURE 38. PHOTOMICROGRAPH OF THE CROSS SECTION OF A PIT IN SPECIMEN D FROM TUBE A-146-6

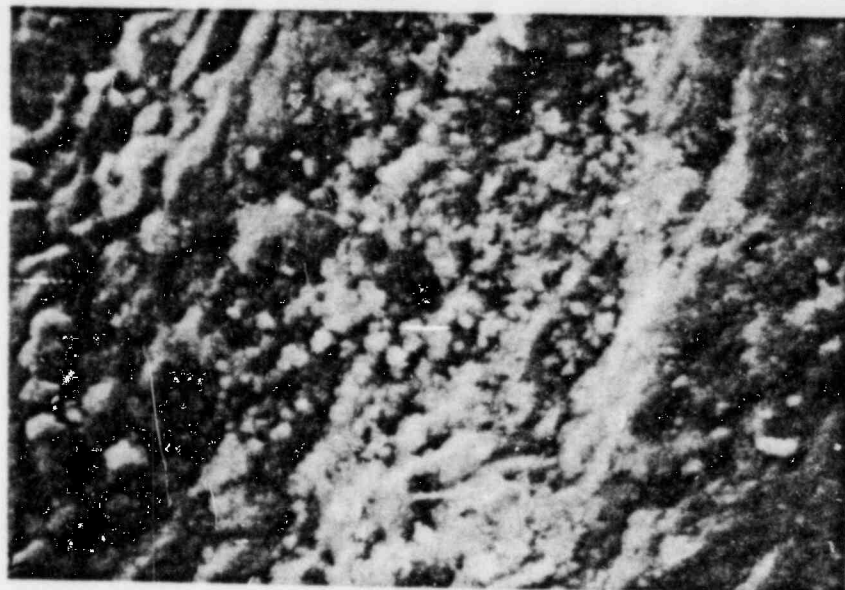
FIGURE 44. SEM PHOTOGRAPH OF A BROWN DECORATION ON THE ID SURFACE OF SPECIMEN E2 FROM TUBE A-146-8

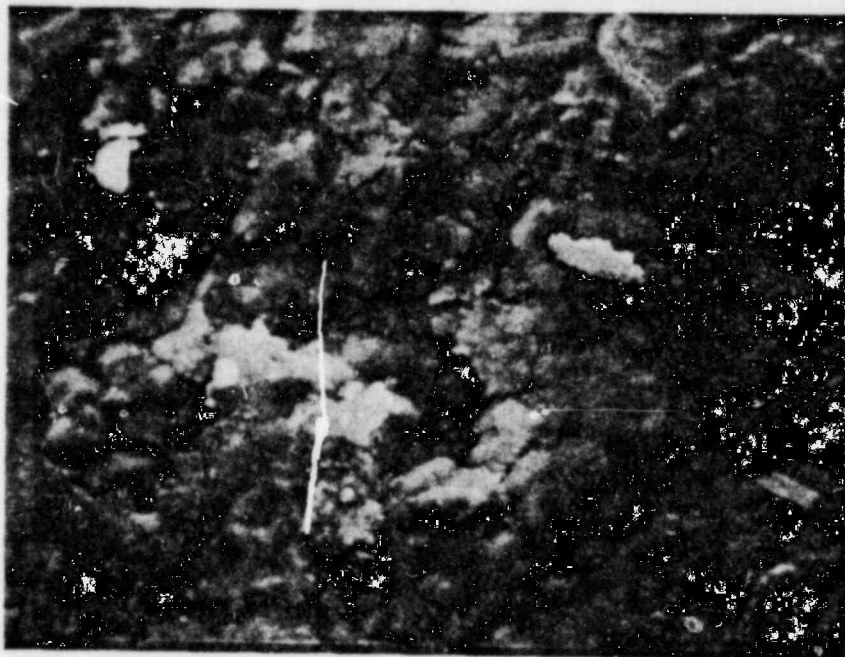
FIGURE 45. SEM PHOTOGRAPH OF A CRUSTY DEPOSIT IN A BROWN SPOT ON THE ID SURFACE OF SPECIMEN E1 FROM TUBE A-146-8

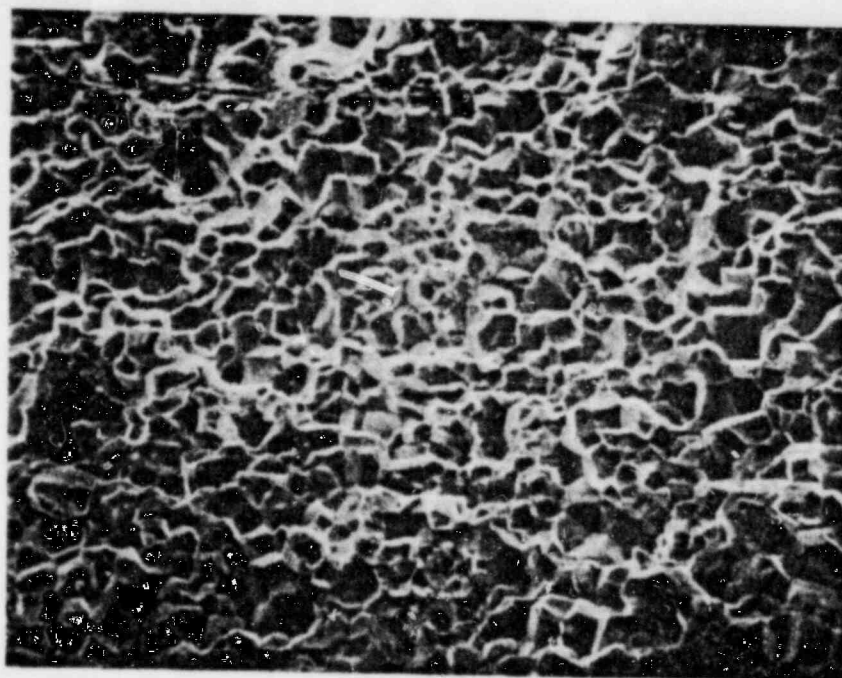
The apparent crack in specimen E2 was mechanically pulled apart, and the fracture surface was examined in the SEM. A SEM photograph of the fractured surface in Figure 46 shows the intergranular nature of the crack. A photomicrograph of the same crack present in metallographic specimen E1 is shown in Figure 47. The crack is intergranular and penetration is ~70 percent through wall. No IGA was noticed on the ID or OD surface of the tube in the vicinity of the crack.

FIGURE 46. SEM PHOTOGRAPH OF THE FRACTURE SURFACE OF SPECIMEN E2
FROM TUBE A-146-8

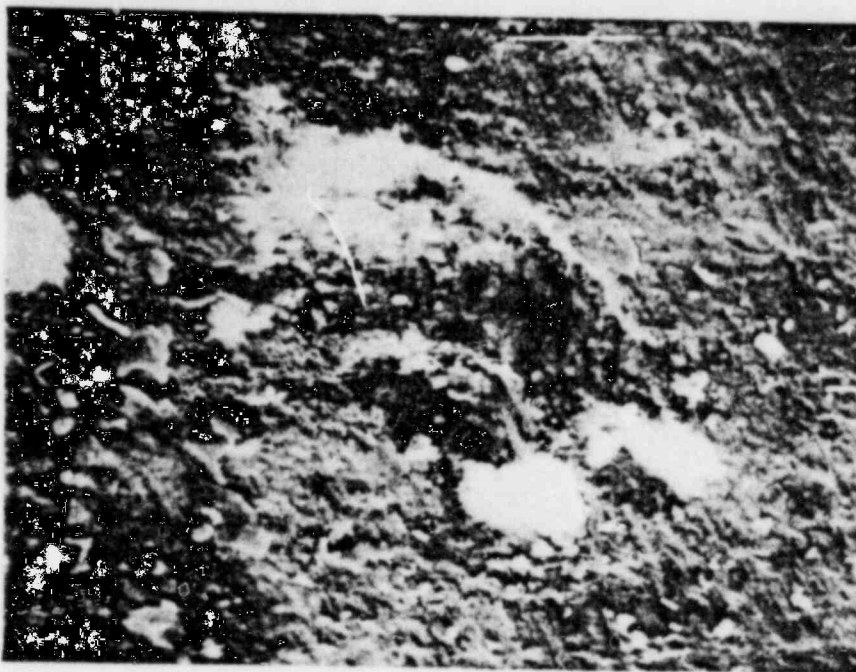
FIGURE 48. SEM PHOTOGRAPH OF A SHALLOW PIT ON THE ID SURFACE OF SPECIMEN I FROM TUBE A-146-8

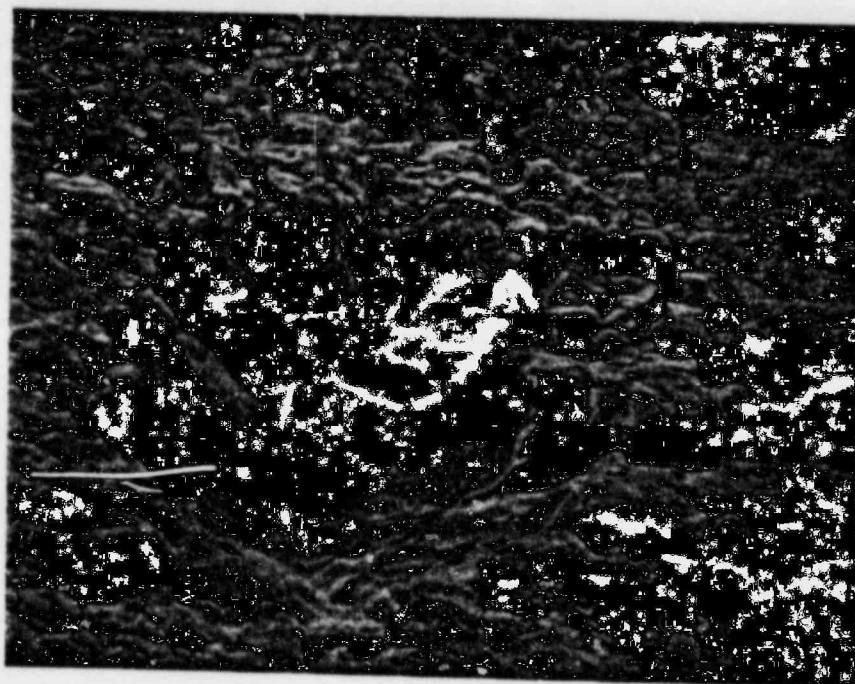
FIGURE 49. SEM PHOTOGRAPH OF A DESCALED PIT ON THE ID SURFACE OF SPECIMEN I FROM THE TUBE A-146-8

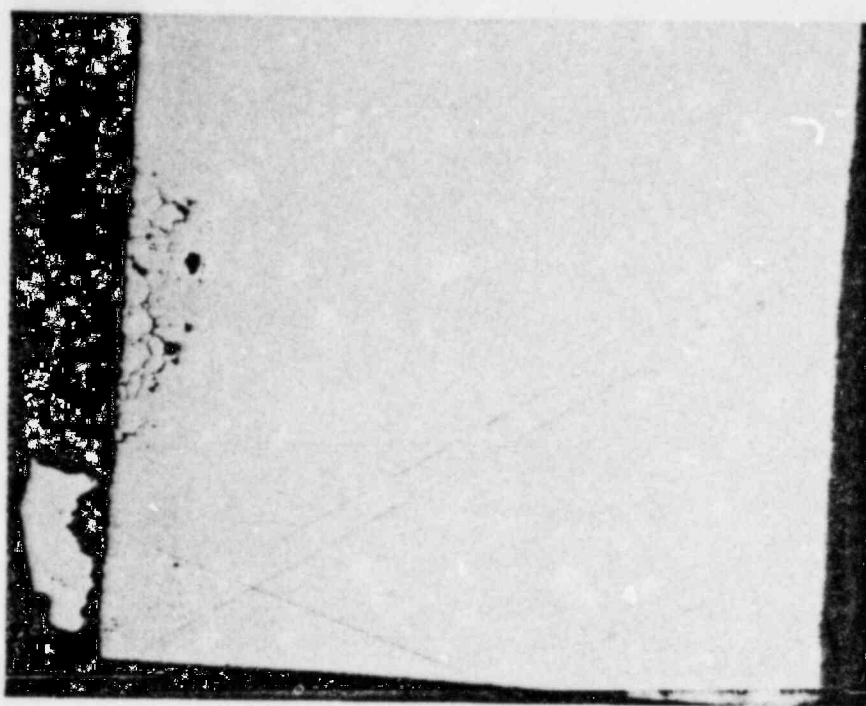
FIGURE 50. PHOTOMICROGRAPH OF AN IGA ON SPECIMEN G
FROM TUBE A-146-8

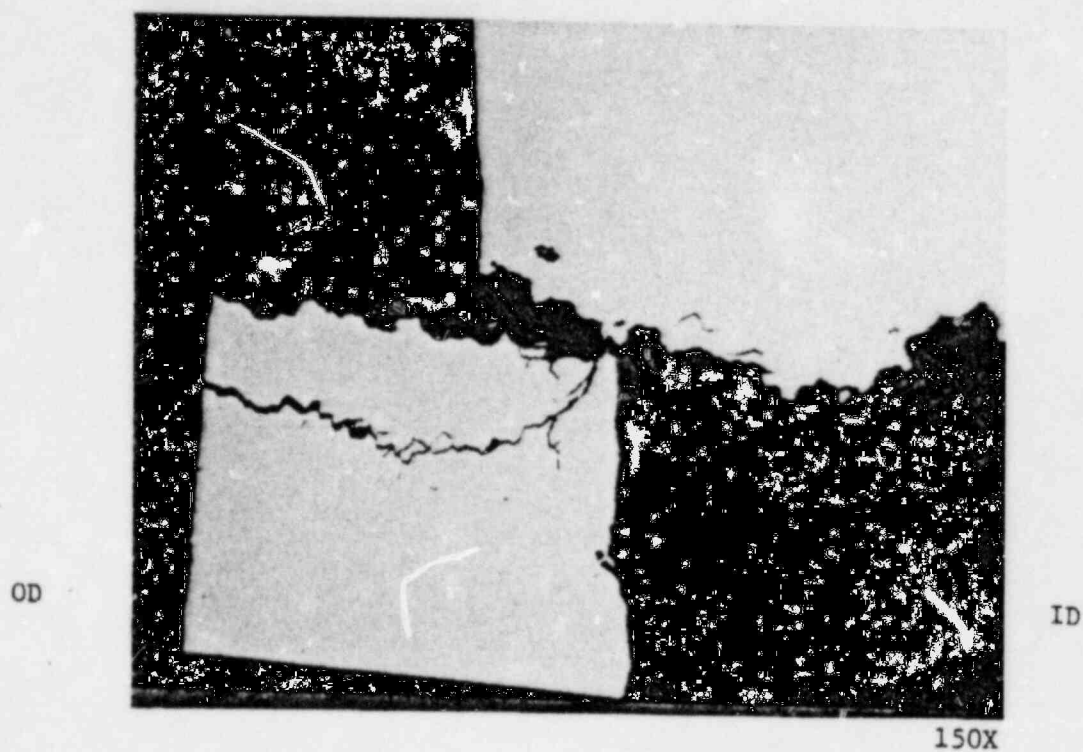
Micrographs of specimens A and C are shown in Figures 51 and 52, respectively. In specimen A, the tube wall separated at the main crack while preparing the metallographic mount, the separated wall is visible in Figure 51. A second crack which appears to be a major branch of the main crack also is nearly through wall. The transverse section in specimen C showed three different unconnected cracks. One such crack only is shown in Figure 52; the other cracks were similar in nature.

FIGURE 51. PHOTOMICROGRAPH OF AN IGC IN LONGITUDINAL CROSS SECTION OF SPECIMEN A FROM TUBE A-146-8
