Subject: Broken Swing Check Valve Arm

No. 9102-77-002

Swing Check Valves

... Inspection of internal components recommended ...

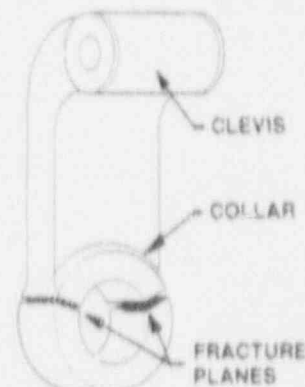
SWING ARM

The fracture planes of the failed arm were in the collar region where arm attaches to the disc (see Figure). Corrosion products were found on the fracture faces. Failure analyses, performed by third parties under utility funding, included metallurgical examinations of five similar arms removed from valves in service that had not failed.

Examination showed a poor material condition in the failed arm consisting of casting defects, inadequate heat treatment and minor chemistry deviations. The significant casting defects were the presence of microcracks and shrinkage cavities formed during solidification of the casting and its subsequent cooling. These microcracks were not detectable using normal LP, MP and RT techniques. No microcracks were present in the other arms inspected.

It is hypothesized that the failure initiated at the surface connected casting defects which provided preferential sites for crevice corrosion. The simultaneous presence of corrosion sites and a microstructure susceptible to hydrogen assisted cracking enabled stress corrosion cracking to occur when the material was exposed to the relatively high chloride content service water. The cracks propagated along the dendrite grain boundaries which were not broken up by a sufficient heat treatment until failure occurred.

Based on the metallurgical tests and analyses, the dominant cause is considered to be the casting quality. Poor material properties were also contributory in the corrosive service water environment. Casting quality and material chemistry of the other swing arms examined were good. The failure of the swing arm is thus considered to be an isolated event.

Although this failure is considered to be an isolated occurrence, BW/IP International, Inc., considers it prudent to inspect all swing arm check valves at the next opportunity. Valves installed in systems with a high chloride content should receive special attention.

- Perform visual inspection of valve internal components.
- Perform PT/MT examinations if indicated by visual inspection.
- Replace any defective components.
