- I. LER NUMBER: LER/RO 83-02/03L-0
- II. LICENSEE NAME: Commonwealth Edison Company
Quad-Cities Nuclear Power Station
- III. FACILITY NAME: Unit One
- IV. DOCKET NUMBER: 050-254
- V. EVENT DESCRIPTION:

On January 19, 1983, at 1300 hours, while performing the monthly HPCI Pump Operability Surveillance, QOS 2300-2, the High Pressure Coolant Injection (HPCI) Motor Speed Changer would not move from its Low Speed Stop. An Electrician was sent to investigate the problem. The HPCI Subsystem was declared inoperable and the HPCI Outage Surveillance was initiated as required in Technical Specification 4.5.C.2. Unit One was in the RUN mode at 814 MWe and 2485 MWt.

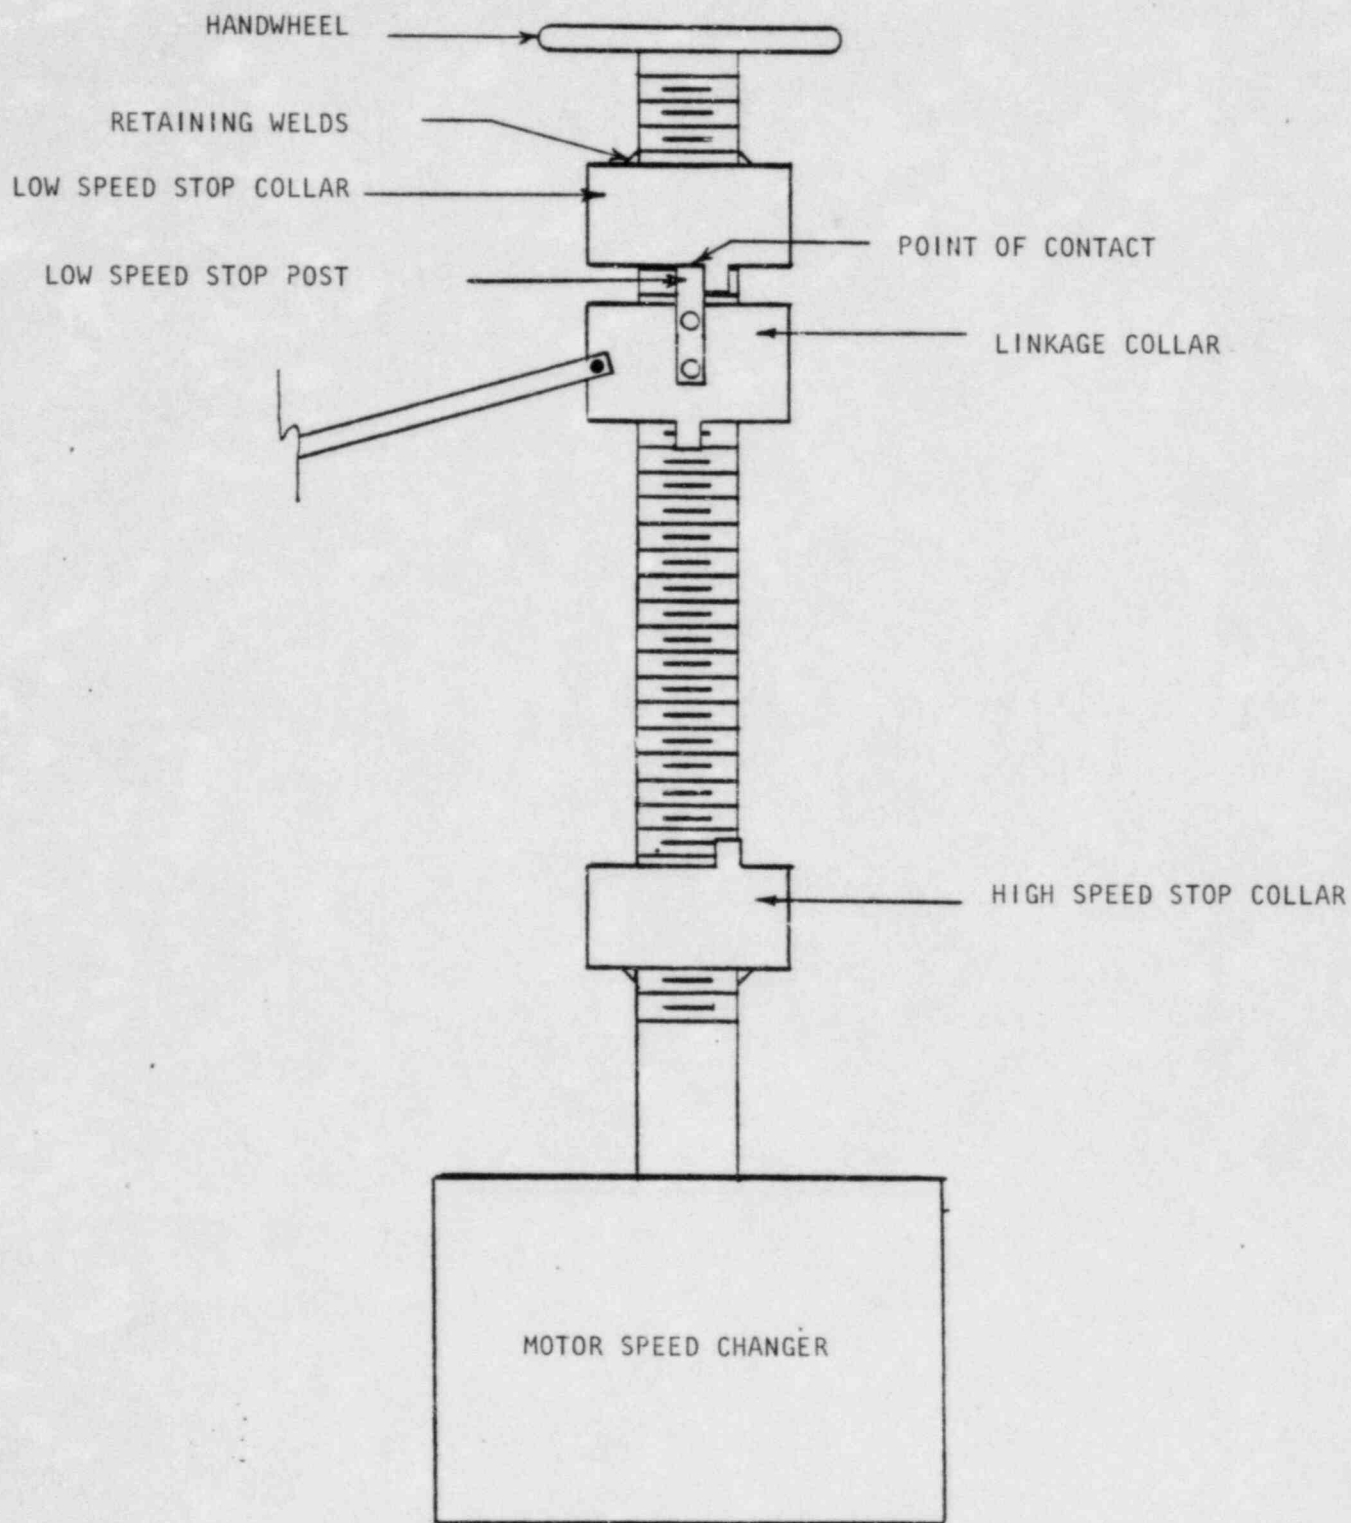
1 0 Excessive friction was caused when the low speed stop post wedged itself against

1 1 the low speed stop collar. The low speed stop post may have been installed too

1 2 high on the moveable linkage collar, which caused gouging into the stationary stop

The reason the Motor Speed Changer shaft would not rotate was due to excessive friction caused by the Low Speed Stop post, which may have been installed too high on the linkage collar. The post caused some gouging on the rotating Low Speed Stop collar body instead of merely resting against the collar tab (see attached diagram). The friction between the stop post and stop collar was more than the Motor Speed Changer motor could overcome. The HPCI Turbine and associated controls were manufactured by the General Electric Company.

1 3 collar during normal operation. The low speed stop post was filed down until the

1 4 post merely rested against the stop collar tab. The HPCI pump operability test was

The immediate corrective action was to manually cycle the Motor Speed Changer. The Motor Speed Changer was then satisfactorily operated three times from the Control Room. Subsequent investigation revealed a lack of clearance between the Low Speed Stop collar body and the corresponding Low Speed Stop post on the linkage collar. This was remedied by filing down the post on the linkage collar to obtain a clearance between the stop collar. The Unit Two Motor Speed Changer and the Unit One and the Unit Two Motor Gear Units were inspected and were found to have adequate clearances to prevent a problem of a similar nature from occurring. No further corrective action is deemed necessary.
